Final Report

FATALITY OF CHIEF OFFICER ONBOARD SEACON OSLO AT SEA ON 28 OCTOBER 2025

TIB/MAI/CAS.216

Transport Safety Investigation Bureau
Ministry of Transport
Singapore

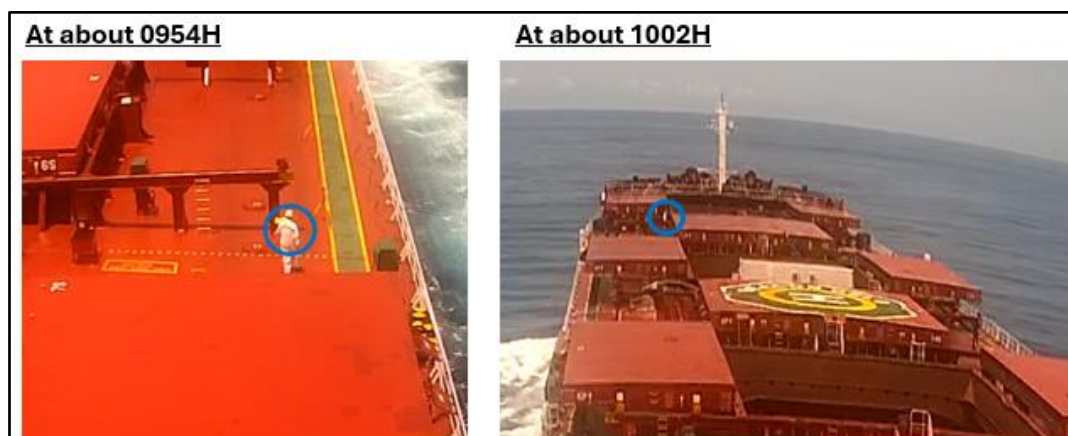
- 1.1.10 At about 0954H, the CO was observed, through CCTV playback, walking forward towards the bow on the starboard side of the main deck (see **Figure 2**). An image captured at about 1002H shows the CO last seen on the port side of the main deck, between cargo holds No. 1 and No. 2.

Figure 2 – Snapshots from CCTV playback
(Source: the Company, annotated by TSIB)

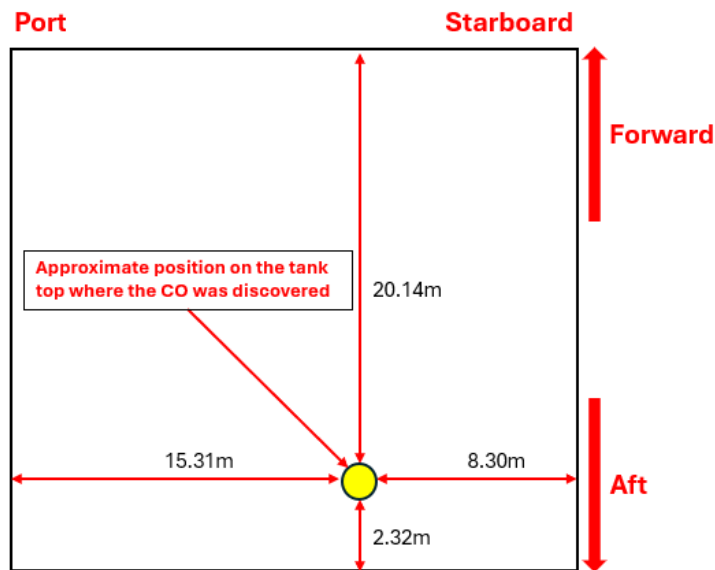
at the accommodation area, they continued their search towards the bow. At about 1155H, the CO was found lying motionlessly in the No.1 cargo hold (see **Figure 3**).

Figure 3 – Sketch of the top-down view of No. 1 cargo hold showing the location where the CO was found on the tank top

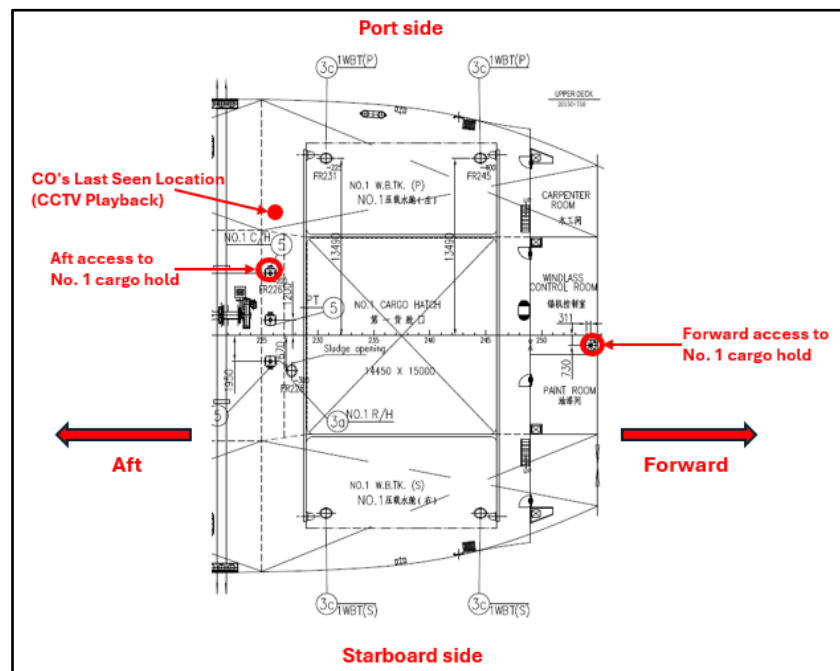
1.3.3 There were two points of access (see **Figure 5**) to No. 1 cargo hold, both located on the main deck:

- a) Forward access: via the booby hatch located forward of No. 1 cargo hold, leading to the cargo hold through a vertical ladder.
- b) Aft access: via the booby hatch located between No. 1 and No. 2 cargo holds, leading to the cargo hold through a spiral ladder.

Figure 5 – Forward and aft access to No. 1 cargo hold
(Source: the Company, annotated by TSIB)

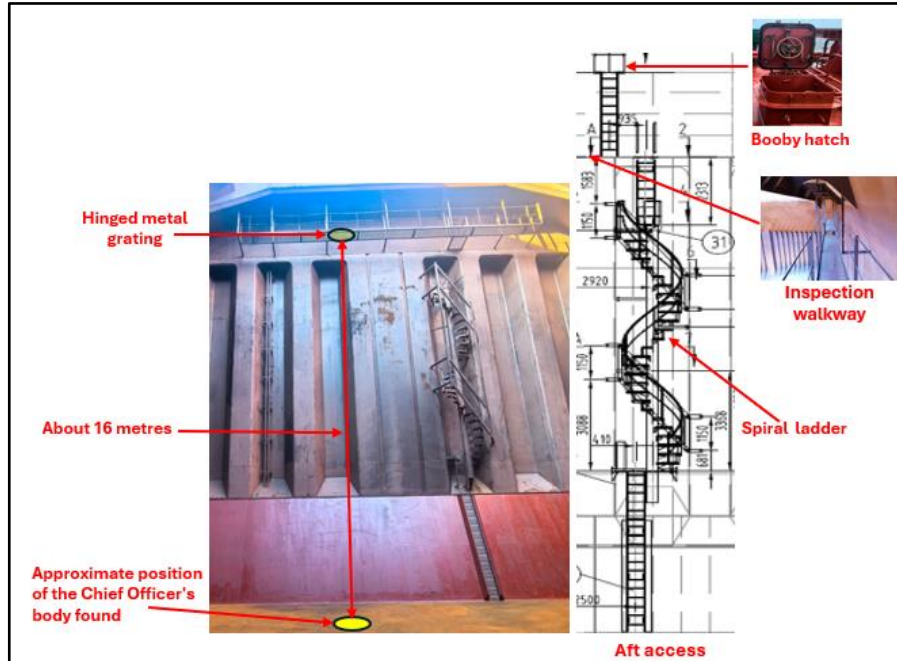
1.3.4 No.1 cargo hold was internally fitted with two fixed inspection walkways: one located at the forward part of the hold and the other at the aft part. The aft inspection walkway (see **Figure 6**) was situated at a height of about 16 metres above the tank top of the cargo hold. These walkways were intended to allow personnel to move within the hold at an elevated level and access parts of the hold structure for inspection and maintenance.

Figure 6 – Overview of the aft elevated inspection walkway and the spiral ladder
(Source: the Company, annotated by TSIB)

2.1.3 The CO likely entered No. 1 cargo hold via the aft booby hatch and climbed down to the elevated inspection walkway. When he walked along the elevated inspection walkway for the inspection of the cargo hold, he had likely missed seeing the opened metal grating in the mid-section and fell through the opening and landed on the tank top. The location on the tank top where the CO was found lying, was at a position approximately beneath the opened metal grating. The severe trauma and multiple blunt force injuries suffered by the CO could have been the result of falling from height (about 16m).

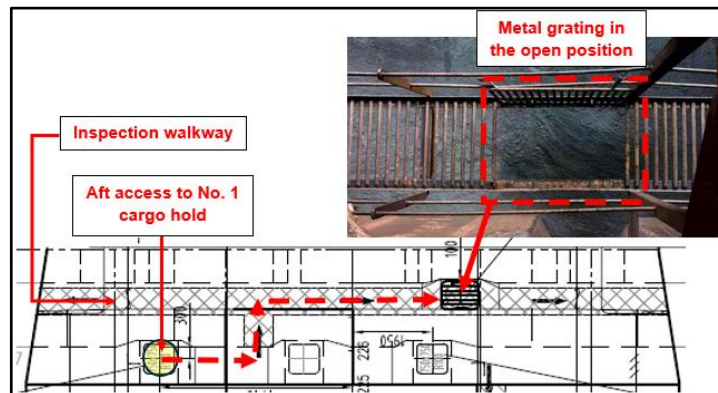
- 1.3.5 A metal grating, hinged at the side railing (see **Figure 7**) and located near the midway of the elevated inspection walkway at the aft access, can be lifted to form an opening to facilitate the disposal of residues from the cargo hold during washing and cleaning. The lifted metal grating can be hooked onto the side railing to form an opening in the inspection walkway.

Figure 7 – Walking route from the booby hatch to the opening (after metal grating being hooked to the side railing) on the inspection walkway
(Source: the Company, annotated by TSIB)

- 1.3.6 The metal grating was left open by the deck crew after completing painting works in the cargo hold on 26 October 2025.
- 1.4 SMS procedures
- 1.4.1 Cargo hold cleaning is a critical operation for bulk carriers, aimed at ensuring the quality of the next cargo, preventing contamination from the last cargo carried, minimising corrosion of the ship's structures and ensuring compliance with maritime safety regulations. The process involves sweeping, washing, rinsing, drying, and conducting an inspection to ensure that cargo holds are properly prepared for the safe carriage and transport of the next cargo. The cleaning requirements depend on the type of cargo being carried and the specific guidelines outlined in the International Maritime Solid Bulk Cargoes (IMSBC²⁰) Code.

- 2.3.2 It is further noted that the opening in the inspection walkway was not fitted with any guardrails, fencing, or other physical barriers as recommended by the COSWP, to prevent a person from inadvertently stepping and falling through the opening.
- 2.3.3 The occurrence serves as a reminder that opening that pose a hazard of falling from height should be closed after completion of the work or be guarded with physical barriers.

- 3.4 The metal grating on the inspection walkway in No. 1 cargo hold was not closed after completion of work, resulting in an unguarded opening that posed a fall hazard. Guarding arrangements for the opening were not implemented to prevent the fall hazard.

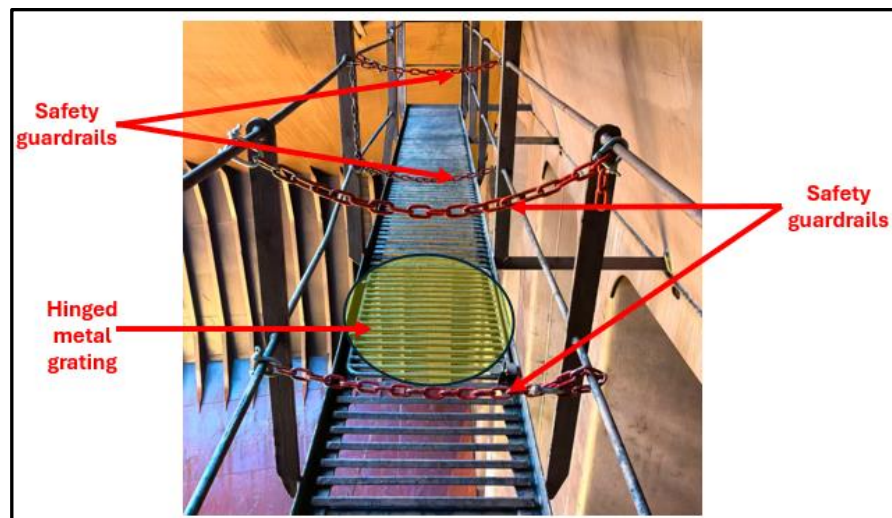
Figure 8 – Safety guardrails fitted on both sides of the hinged metal grating on the elevated inspection walkway
(Source: the Company, annotated by TSIB)

- 4.1 Sharing of information and highlighting the circumstances of the accident with all crew members of its fleet of vessels.
- 4.2 Issued a circular to its fleet of vessels to reinforce the need for ship's crew to carry out proper risk assessments and complete the relevant checklists and permits before commencing shipboard operations, including cargo hold cleaning, working aloft and entry into enclosed spaces. The circular also emphasised that such activities are to be conducted in accordance with the Company's SMS procedures and safety policies and highlighted the importance of maintaining safe working practices.
- 4.3 All bulk carriers under the Company's management have now been fitted with safety guardrails (see **Figure 8**) on both sides of the hinged metal grating on the elevated inspection walkway within cargo holds to mitigate the risk of a fall.
