# **Final Report**

## **GULFSTREAM G450, REGISTRATION T7-977 RUNWAY OVERRUN AT SELETAR AIRPORT**

**19 September 2025**

TIB/AAI/CAS.253

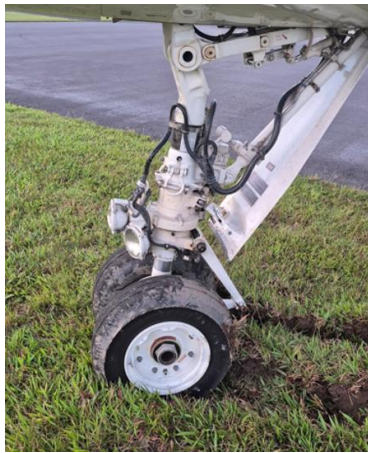
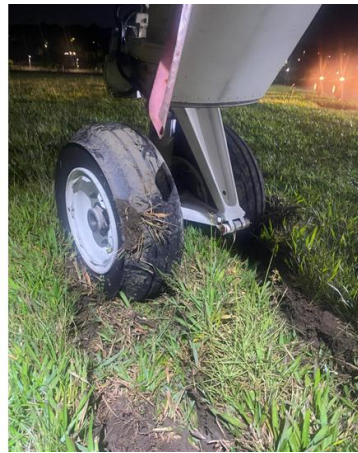
- 1.1.11 Upon noticing the abnormal fluctuation in airspeed indication, the SIC called for an aborted take-off. The PIC acknowledged the call and immediately reduced engine thrust, applied brakes and deployed thrust reversers. However, all these could not prevent the aircraft from overrunning the paved area of the runway and clearway (see paragraph 1.7.1).
- 1.1.12 The aircraft's nose landing gear (NLG) was immobilised in the grass area (see **Figure 1**) beyond the clearway while the main landing gear (MLG) was still on the clearway.

Figure 1: NLG immobilised in the grass area beyond the runway

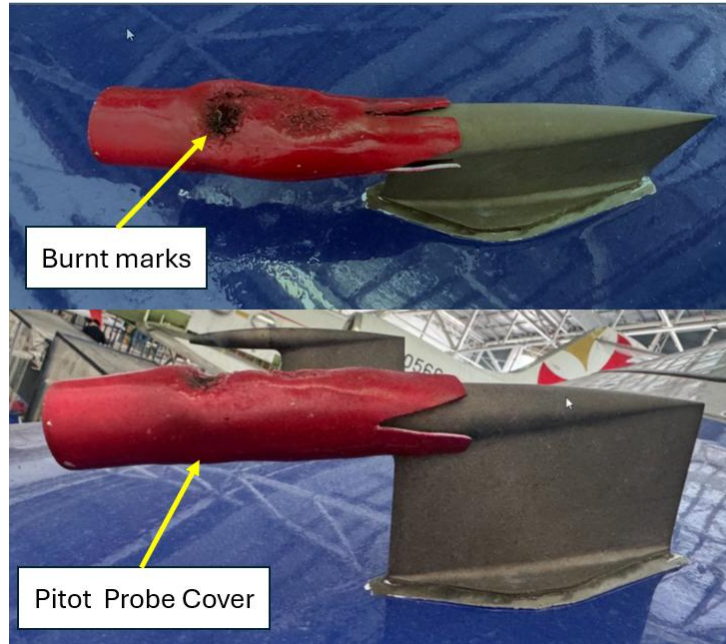
- 1.1.13 Post-occurrence inspection found that the left-hand side (LH) pitot probe cover was still installed (see **Figure 2**). The right-hand side (RH) pitot probe cover was found on the ground near the aircraft where it stopped. There were no streamers<sup>10</sup> attached to the covers for the LH and RH pitot probes.

Figure 2: Cover for the LH pitot probe

- (a) The pitot probe cover still installed on the LH pitot probe had a burnt mark and had melted (see Figure 2) and stuck onto the pitot probe<sup>11</sup>.
- (b) The RH pitot probe cover had melted (see **Figure 3**). Some residue from the melted pitot probe cover was stuck to the RH pitot probe (see **Figure 4**).

2.1.1 During the take-off roll, the flight crew observed an abnormal airspeed indication. Post-occurrence inspection found that the cover for the LH pitot probe was found on the pitot probe and had not been removed for the flight. The RH pitot probe cover was found on the ground near the aircraft where it stopped. The heat damage to the RH pitot probe cover and the melted residue observed on the RH pitot probe (see paragraph 1.3.2.1(b)) suggest that the cover for the RH pitot probe had also not been removed before the flight and had dislodged during the overrun.

2.4.1 The pitot probe covers installed on the aircraft were fabricated by the FE and did not conform to the aircraft manufacturer's standards. They were also not equipped with streamers, which would enhance their visibility.

- 5.1 The operator establish a systematic way to track and account for the installation of aircraft probe and static port covers and, prior to a flight, the removal of these covers. [TSIB Recommendation RA-2026-008]
- 5.2 The operator use only manufacturer-approved pitot probe covers, or equivalent devices fitted with prominent streamers or flags. [TSIB Recommendation RA-2026-009]

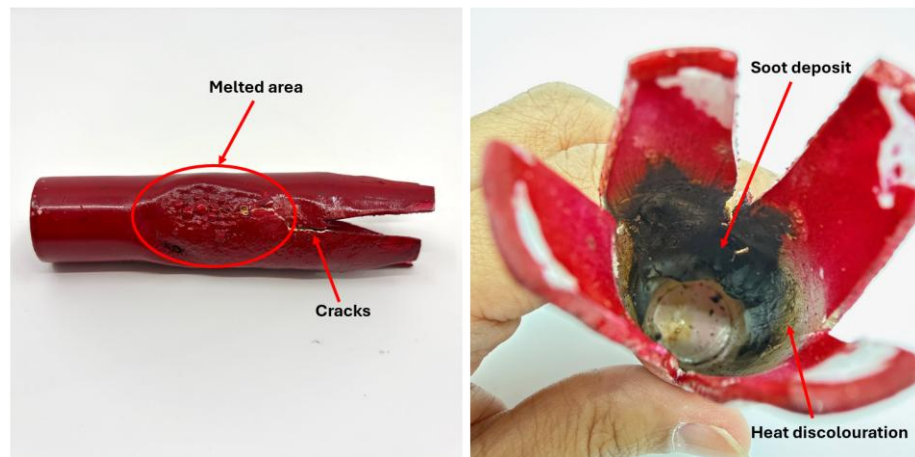
Figure 3: Melted RH pitot probe cover

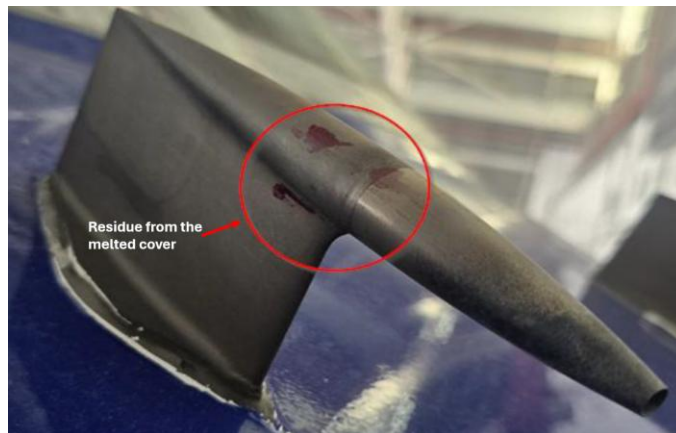
Figure 4: Residue from the pitot probe cover stuck on the RH pitot probe
