Final Report

A350-900, REGISTRATION 9V-SMB TURBULENCE EVENT

TIB/AAI/CAS.251

Transport Safety Investigation Bureau
Ministry of Transport
Singapore

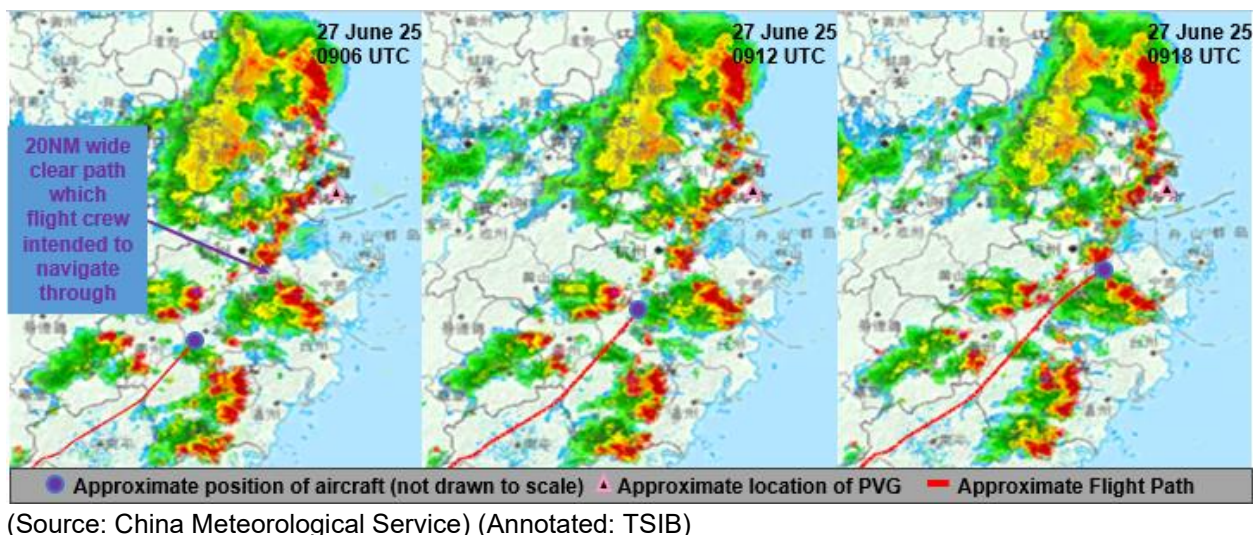
Figure 1: Ground weather radar images captured at 6-minute interval

- 1.6.2 Recorded Weather Data
 - 1.6.2.1 Figure 1 is a series of ground weather radar images, shared by the China Meteorological Service and taken at 0906hrs, 0912hrs and 0918hrs⁹. The images show weather cells to the left and right of the aircraft and also a path with clear weather in the vicinity of PVG.

weather cells. However, once the aircraft entered the layer cloud the flight crew could only rely on the WXR for navigation. The WXR limitations mentioned in paragraph 1.8.1.5, might have been what the flight crew experienced which did not allow them to accurately navigate between the two weather cells.
