Final Report

B787-8 REGISTRATION 9V-OFI TURBULENCE EVENT

9 JUNE 2025

TIB/AAI/CAS.249

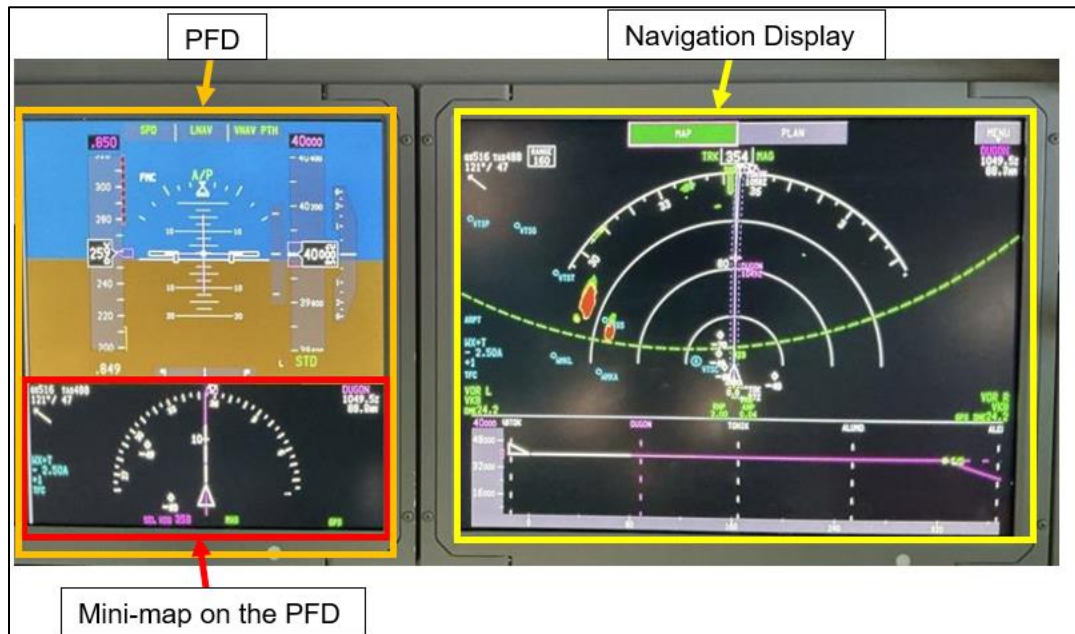
Figure 1. Mini-map on the PFD (for illustration purpose only)

1.1.4 At about 2306 hours, while the aircraft was approaching waypoint SUDUN, the FO observed green⁶ weather returns about 8 – 10nm ahead of the aircraft on the mini-map display on the FO's Primary Flight Display (PFD) (see **Figure 1**). These weather returns were not visible on the ND⁷ as the ND was set to a longer range at the time. As the aircraft was flying in IMC, the flight crew were unable to verify visually the weather suggested by the green weather returns. The flight crew then selected a shorter range of 20nm on their respective ND and now a green weather return was visible on the ND ahead of the aircraft track.

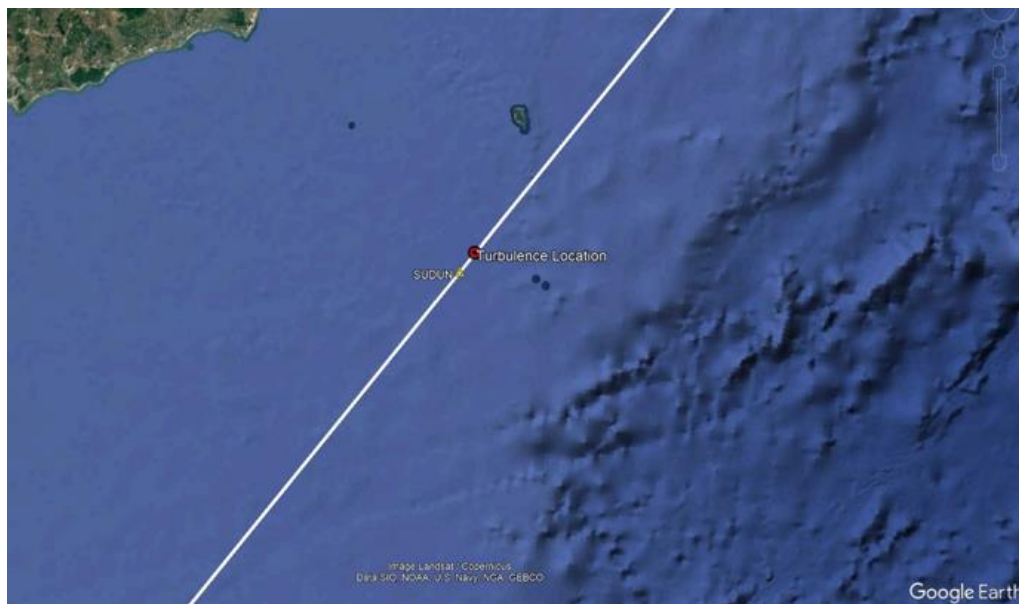
Figure 2. Turbulence location

1.1.7 At the time of the turbulence encounter, the flight crew saw an increase in aircraft speed, which prompted the FO to deploy the speed brakes briefly to slow down the aircraft. The aircraft deviated 200 feet from its assigned altitude. The aircraft stabilised and returned to the cruising altitude at 39,000 feet. **Figure 2** shows the approximate location of the turbulence encounter.

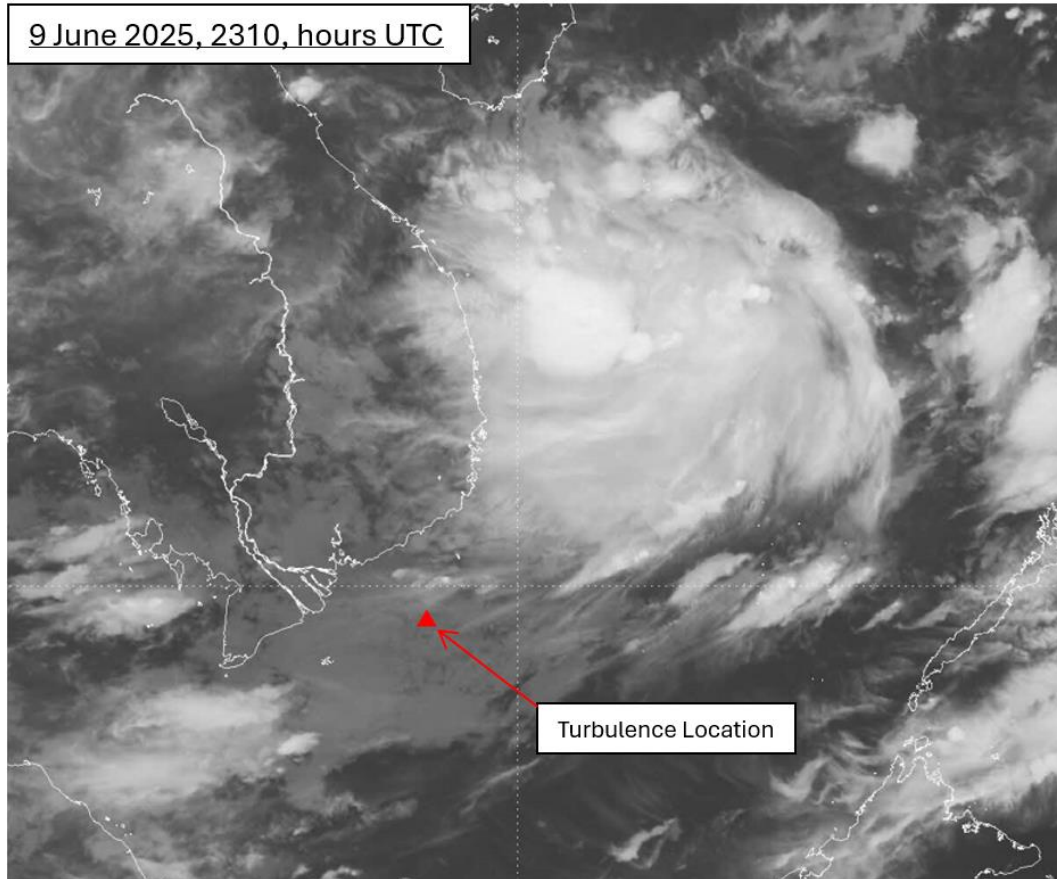
Figure 3: Satellite image of cloud types at location of turbulence encounter

1.6.1.2 According to the Meteorological Service Singapore, a tropical system that eventually evolved to become Severe Tropical Storm “Wutip¹¹” was about 850km northeast of the turbulence location. The aircraft flew through an area of middle to dense clouds as shown in satellite image (see **Figure 3**). However, the limited satellite image resolution is such that it is not possible to determine if the aircraft had encountered convective clouds or to discern the details of the weather system encountered¹².

- 2.2 At the time of the turbulence encounter, there was a developing tropical storm some 850km from the aircraft. The investigation team does not believe that this developing storm was a factor in the turbulence encounter. The investigation team opines that the turbulence encounter was more likely associated with the areas of middle to dense convective clouds in the vicinity of the aircraft location.
