# **Final Report**

## **Death of a crew member onboard the SRS offshore supply vessel ANAHITA on 14 May 2025 west of Soyo, Angola**

TIB/MAI/CAS.197

Transport Safety Investigation Bureau  
Ministry of Transport  
Singapore

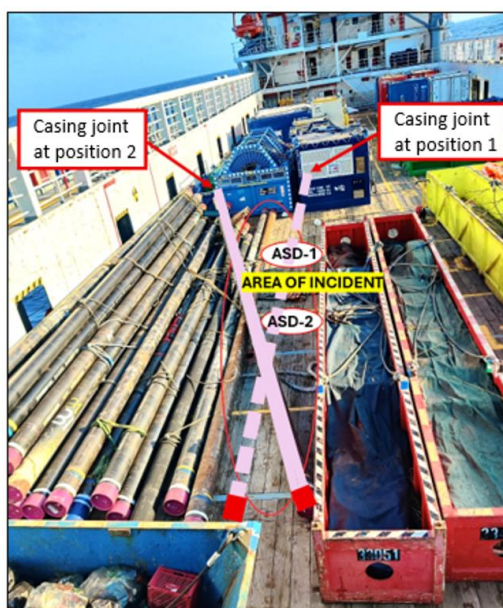
- 1.1.1.5 On arrival at the main deck, 2M-1 found that both ASDs were trapped underneath a casing joint (see **Figure 1**) and reported the incident to CM. 2M-1 then signalled and contacted SQ's crane operator via the portable VHF radio to draw attention to the situation. Subsequently, CM communicated with SQ via VHF radio, requesting assistance in lifting the casing joint to free the two ASDs.

Figure 1: ASD-1 and ASD-2 trapped beneath a casing joint at position 1, casing joint was subsequently shifted to position 2 as viewed from the stern.  
(Source: The Company of AN, annotated by TSIB)

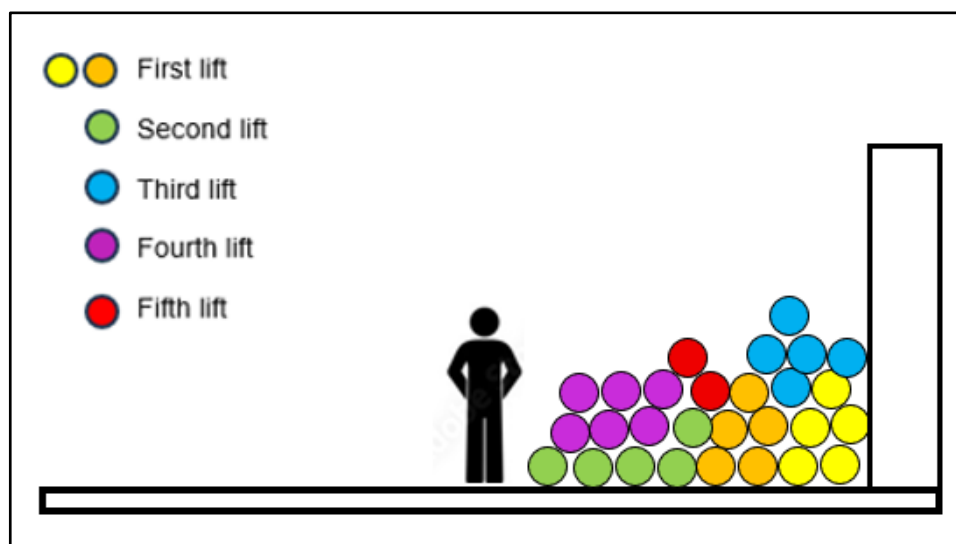
- 1.3.4 Between 0035H and 0134H on 14 May 2025, five lifts were conducted. The CCTV also showed that the casing joints were stacked in multiple layers on the port-side aft deck. For ease of understanding, a simplified illustration was prepared with information from CCTV footages to indicate the sequence and stacking arrangement (see **Figure 2** and **Table 4**).

Figure 2: Simplified illustration of the casing joints stacking arrangement and approximate positions of two ASDs, as observed from CCTV footage.

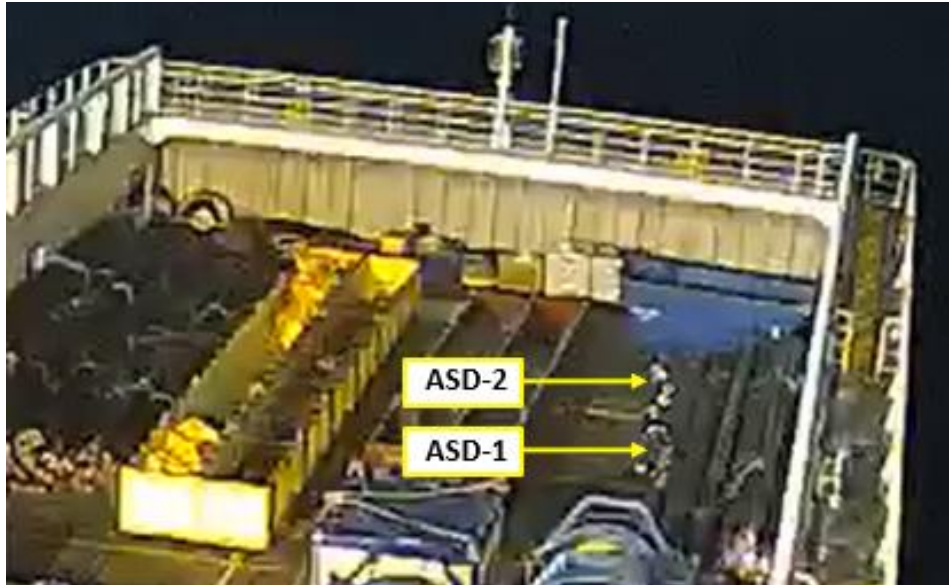
- 1.3.5 CCTV footage showed both ASDs standing clear of the final lift of two casing joints. After the final lift had landed, they approached the casing joints and unhooked the wire slings and began ensuring that the wire slings were clear of any obstruction in preparation for the next operation. The two casing joints (the fifth lift) from the final lift were stacked on top of, and added weight to, the existing stacks of casing joints. During the vessel's rolling motion caused by the deep swell, (see **Figure 3**), movement was observed on the casing joints from the second and fourth lifts (see **Figure 4**). Shortly after, both ASDs were seen trapped under a casing joint<sup>21</sup>.

Figure 3: CCTV frame showing the positions of ASD-1 and ASD-2 before the rolling down of the casing joint.

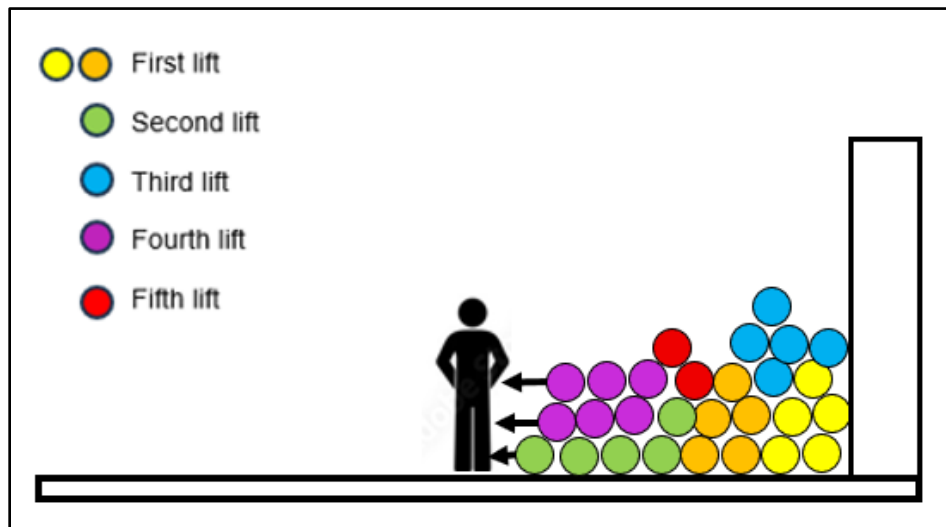
<sup>21</sup> The lower bundles that supported the final lift appeared to move during the vessel's motion, resulting in one of the casing joints rolling down and trapping the two ASDs.

Figure 4: Approximate direction and movement of the casing joints based on CCTV footage.

2.3.4 CCTV footage showed continuous rolling motion of AN's stern caused by the prevailing swell conditions. Although the vessel remained within approved stability limits and maintained position and heading under DP control, the rolling motion generated dynamic forces that affected the stability of the unrestrained casing joints, resulting in lateral movement of the lower layer.

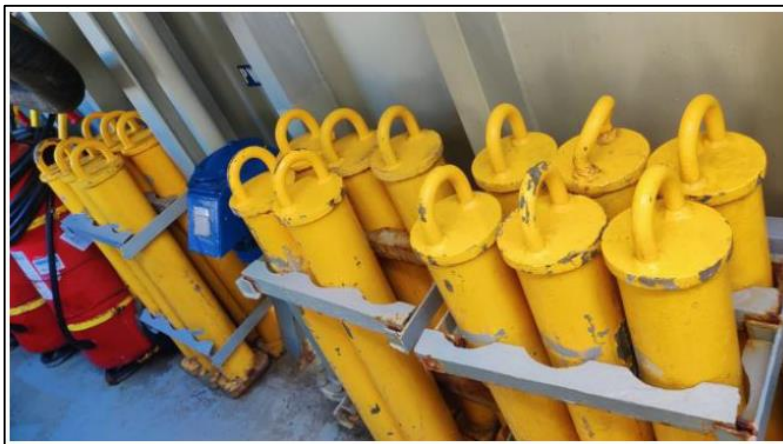
<sup>24</sup> These stanchion posts, each weighing about 39.1 kg each, are used to prevent the pipes from shifting and/ or rolling.

Figure 5: Stanchion posts onboard Anahita. (Source: The Company of AN)

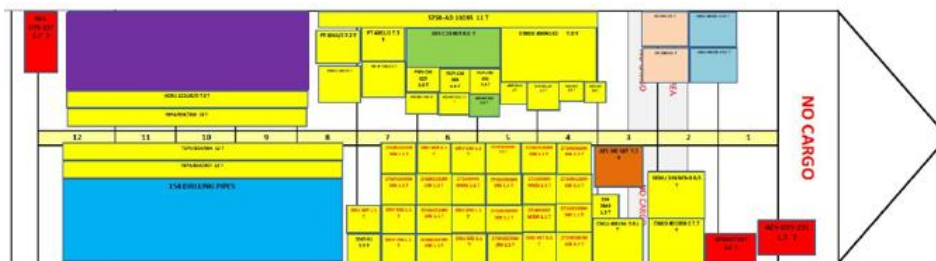
- 1.12.2 AN was operating in a loading condition in which casing joints were arranged in multiple stacks on the aft deck. At the time of the occurrence, the deck occupancy was recorded as about 85 per cent<sup>26</sup>. The deck stowage illustration is included to show the extent of cargo occupying the aft deck during the operation, as most of the usable deck area was taken up by various types of cargo, including the stacked casing joints. As shown in **Figure 6**, the area where the casing joints later shifted (colour-coded in purple) had limited open deck space around it.

Figure 6: Loading condition of Anahita. The purple-coloured box indicates the area occupied by casing joints before the occurrence. (Source: Company. Annotated by TSIB)
