# **Final Report**

## **MAN OVERBOARD AND MISSING BOSUN FROM KWK LEGACY AT SEA ON 10 DECEMBER 2025**

TIB/MAI/CAS.222

Transport Safety Investigation Bureau  
Ministry of Transport  
Singapore

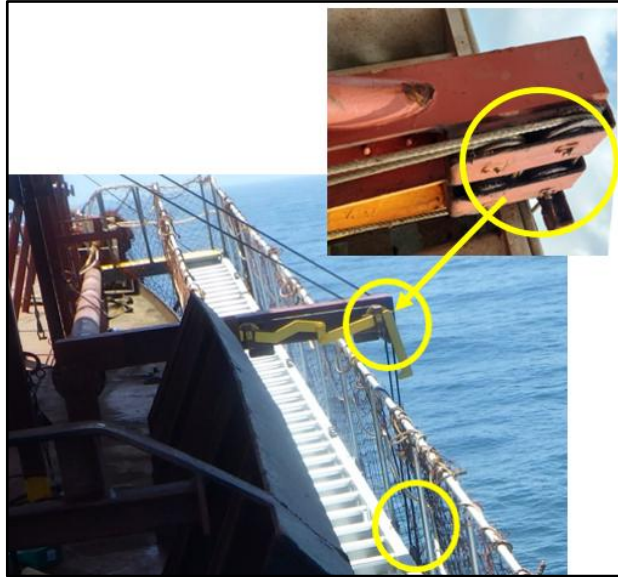
- 1.1.10 When BSN passed the middle section of the gangway, BSN appeared to lean towards the lower outer sheave<sup>12</sup> (see **Figure 3**) to apply lubricant grease.

**Figure 3** – View of upper and lower outer sheaves on starboard gangway for illustration.

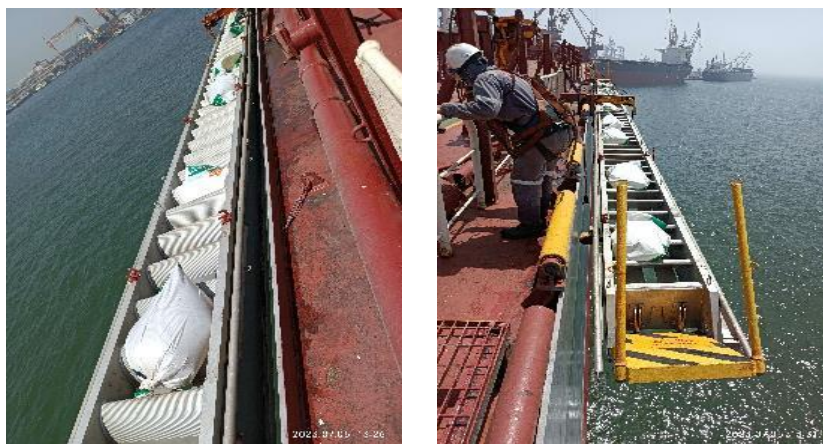
- 1.4.4 As required by IMO Circular MSC.1/Circ.1331<sup>23</sup>, a load test (see **Figure 6**) was reportedly performed by Legacy's crew on 5 July 2023 after the gangways were reinstalled onboard the vessel. The Company consulted ABS and confirmed that on-site attendance and supervision of the load test from its Class Surveyor was not required.

**Figure 6** – Load tests of the port and starboard gangways carried out by Legacy's crew (Source: the Company)

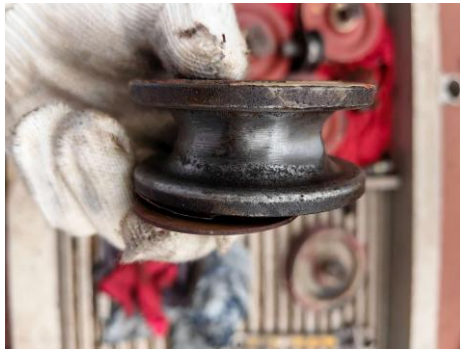
- 1.7.1 Following the incident, the upper outer sheave of the port gangway was removed from the vessel, and the Company found that the bearing of the sheave was seized and unable to rotate freely as designed (see **Figures 8a** and **8b**). This sheave was in a relatively inaccessible area, and the seizure was not detected by the ship crew. The repeated abrasive friction caused degradation of the wire rope due the seized sheave.

**Figure 8a** – Retrieved upper outer sheave (*Source: the Company*)

- 2.3 Condition of upper outer sheave
- 2.3.1 The Company found that the upper outer sheave located at the port gangway was seized and unable to rotate freely as designed. The seized sheave could have led to abrasive friction between the sheave and the passing wire rope. The location of this sheave was in a relatively inaccessible area of the gangway, making routine inspection of its operational condition challenging.

- 2.3.2 Under normal working conditions, the sheave was supposed to rotate and guide the wire rope to reduce friction between the wire rope and the sheave and evenly distribute loads during gangway hoisting or lowering movements. When seized, the wire rope slid over a stationary surface rather than over a freely rotating sheave. This caused abrasion of the wire rope on the stationary sheave. This abrasive action amplified each time the gangway was raised, lowered, or adjusted, weakening the wire rope load-bearing capacity.

- 3.1 BSN was tasked to test the gangway as part of the vessel's pre-arrival requirements. He was considered a hardworking and pro-active crew member.
- 3.2 The Company indicated that the upper outer sheave at of the port gangway was seized after the occurrence. It was likely the sheave had been seized for some time but was not detected by the crew as the sheave was in a relatively inaccessible area. The wire rope repeatedly slid over the seized sheave during gangway operations and the repeated abrasive friction degraded the wire rope, reducing its load-bearing capacity.

- 2.3.3 It would be desirable for crew members to report on challenges faced in maintaining shipboard machinery equipment, such as the inaccessible location of the upper outer sheave. This could have caused a review of options for inspecting and checking the sheave's condition. One option would be to conduct the inspection while the vessel is alongside berth, with the gangway lowered and resting on quay. Another option would be to reduce the interval for the wire rope turned end-for-end to an earlier time, instead of the 30-month interval. Such measures would provide better access to the upper outer sheave and prevent the wire rope to be under tension.

- (e) Any signs of wear, corrosion, or broken strands to be addressed immediately to ensure the integrity of the ladders and wire ropes.
- 4.2 Additionally, all ladder components, e.g., sheaves, securing points, etc., must be regularly checked, serviced, and repaired or replaced as necessary to ensure smooth operation when hoisting or lowering the ladders.

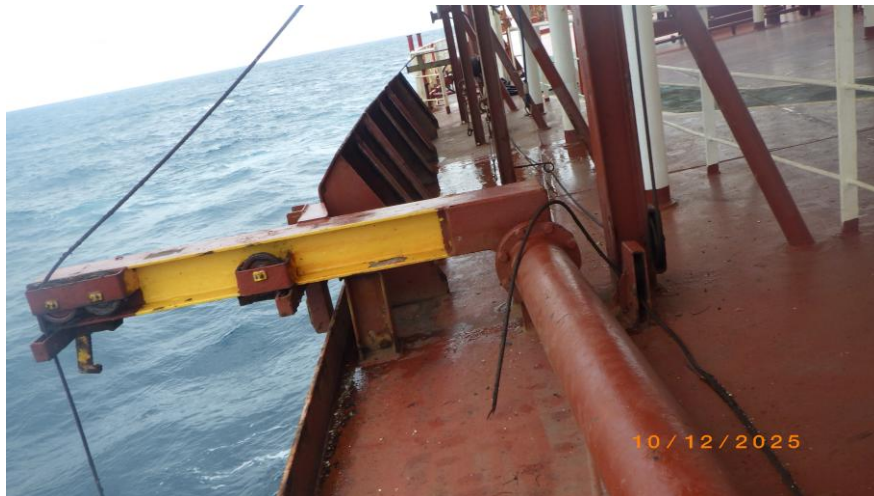
- 1.5.8 The wire rope that parted was at a point near the lower sheave fitted to the outboard side of the port gangway. According to CO, the portion of the wire rope passing the sheave was difficult to inspect when the gangway was fully secured at its stowage position, making damage less likely to be detected during regular checks.

**Figure 8b** – Parted wire rope (*Source: the Company*)

- 2.4 Failure of the port gangway wire rope
  - 2.4.1 The broken port gangway wire rope was forensically tested and failed to meet the specified minimum breaking tensile strength test, indicating that the wire rope had experienced a significant reduction in its load-bearing capacity.

- 2.4.3 Considering the inaccessibility of the upper outer sheave, it would have been desirable for the crew members to inspect the wire rope more regularly and pay more attention to the condition of the wire rope.
