Final Report

B777-300ER, 9V-SWM Turbulence Event over Myanmar

21 MAY 2024

TIB/AAI/CAS.231

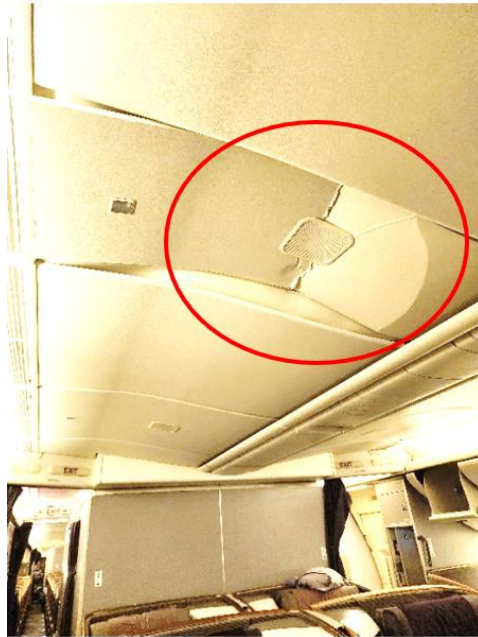
1.3.1 The damage in the cabin interior included broken ceiling panels, dislodged overhead passenger service units (PSUs³⁰), punctured overhead bins, damaged seat backrest reclining mechanism, cracked sidewall panels and broken sidewall lights (see **Figure 4** to **Figure 9**).

Figure 4: Broken ceiling panel

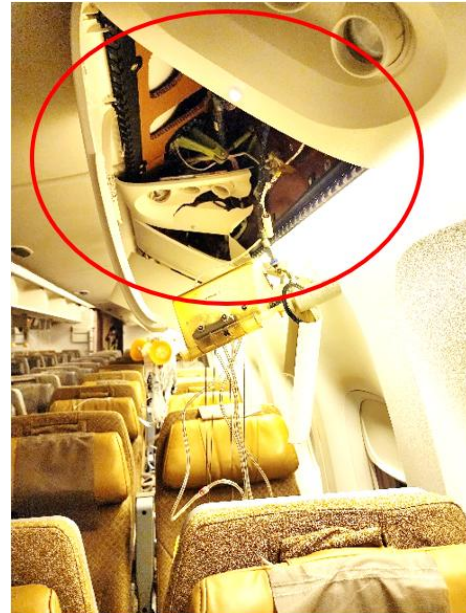
Figure 5: Broken PSUs with oxygen masks dislodged

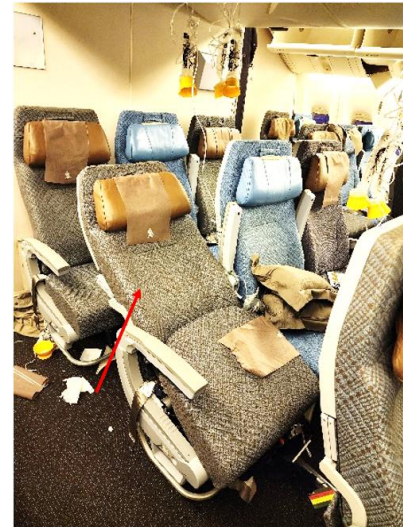
Figure 7: Damaged seat backrest reclining mechanism

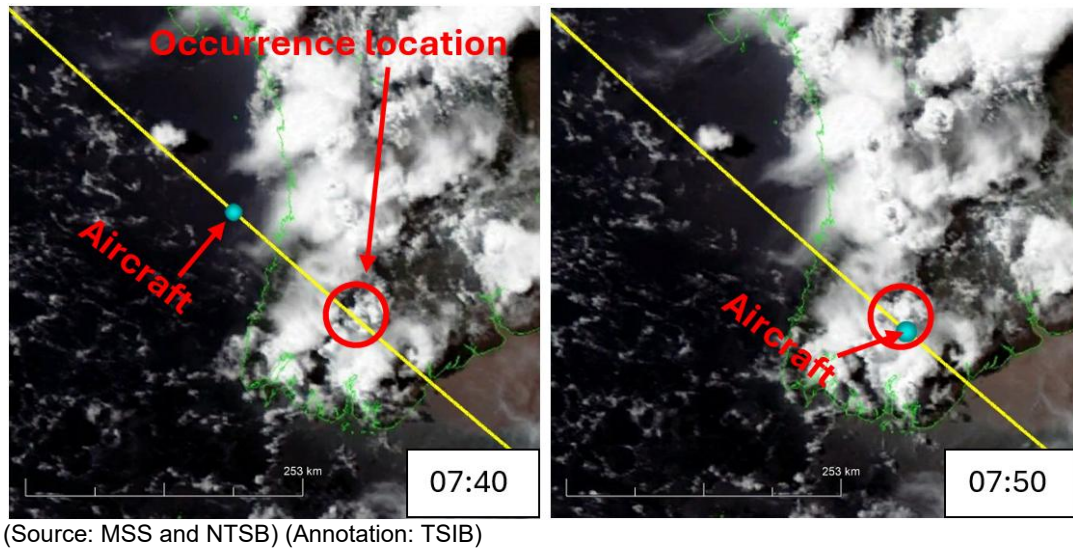
Figure 14: Occurrence aircraft location and cloud conditions

- (b) There were developing convective clouds at the occurrence location (hereinafter referred to as Cloud B.) According to MSS' analysis, the cloud-top height of Cloud B was about 27,500ft at 07:40. Cloud B then developed quickly over the next 10 minutes and the cloud-top height reached about 40,000ft at 07:50, i.e. the rate of increase of the cloud-top height was about 1,200ft/min.

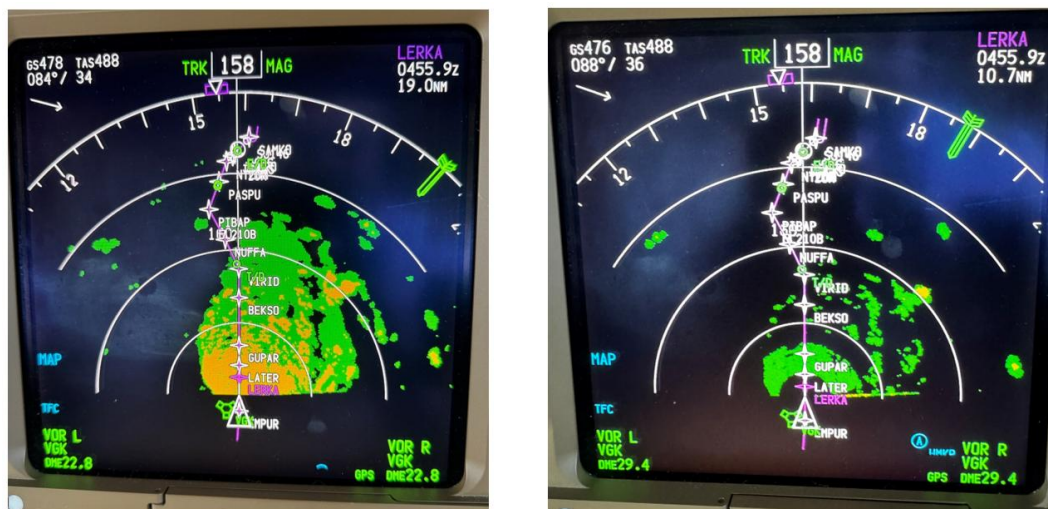
1.10.1.2 The photos taken by the flight crew indicated that the WXR-R was under-painting when compared with WXR-L (see **Figure 16**).

Figure 16: Comparison of WXR-L (left photo) and WXR-R (right photo) during in-flight WXR system check

2.4.1 The in-flight WXR system check carried out during the ferry flight from Bangkok to Singapore suggests that the WXR of the occurrence aircraft might have an under-painting issue, as observed by the flight crew operating the ferry flight.

2.4.2 The flight crew did not follow the WXR OEM's instruction to take a photo five minutes after switching from WXR-L to WXR-R to allow for a full scan cycle. The flight crew had taken a photo about one minute after switching WXR-L to WXR-R. They did not take another photo after five minutes as they noted that there was no difference in what was displayed on the ND five minutes after switching and therefore, they did not see the need to take another photo. The WXR OEM's view is that, since the ferry flight crew did not have photographic evidence taken in accordance with its instructions, the in-flight test result of the WXR systems was not valid and could not be used to infer on the performance of WXR-R versus WXR-L.

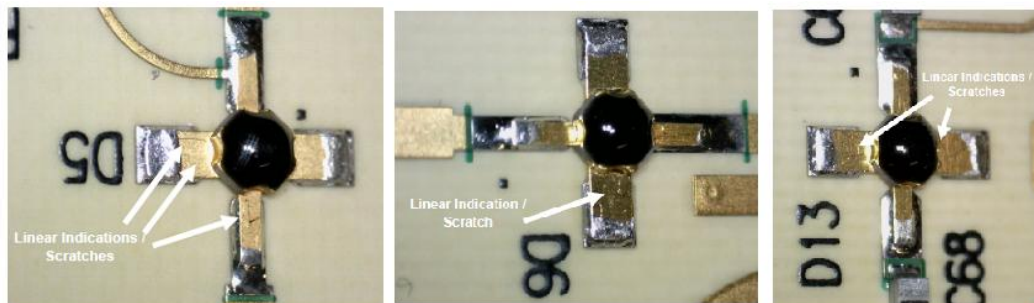
- (a) No assembly issue was identified.
 - (b) No defective diodes were found.
 - (c) The inspection of the diode identified superficial scratches on the surface but did not identify areas of concern.

A6.2 The diodes were visually inspected under a high-resolution microscope. It was observed that (see Figure 18 below):

- (a) the solder joints on the diodes' leads were intact and appeared undamaged.
- (b) there were some fine linear scratches on the leads of the diodes.

Figure 18: Visual inspection of TR-R diodes

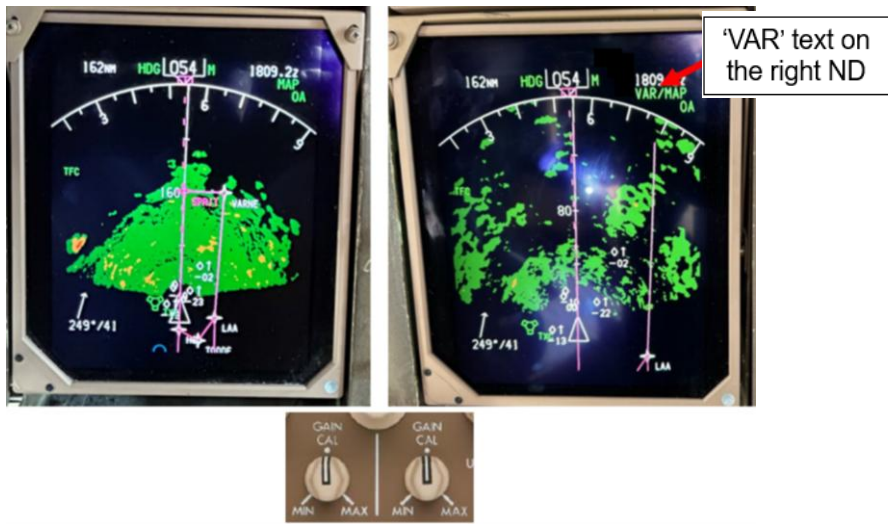
Figure 19: Comparison of left and right NDs when GAIN knobs were set to CAL position (red arrow showing VAR text on the right ND)

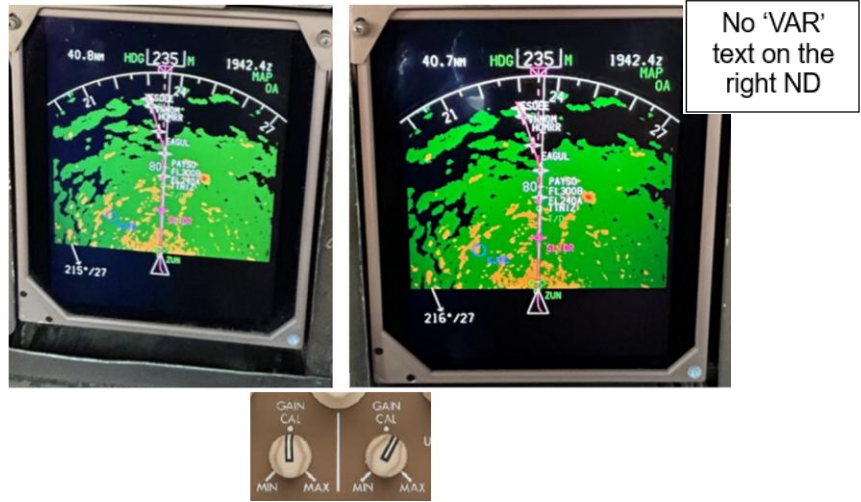
- (b) When the right GAIN knob was turned to the 2 o'clock position (corresponding to an increase in gain), the weather returns on both the NDs appeared similar and the VAR text, which should appear on the right ND at this GAIN knob position, did not appear (see **Figure 20**).

Figure 20: Comparison of left and right NDs when left GAIN knob was set to CAL position and right GAIN knob set at 2 o'clock position

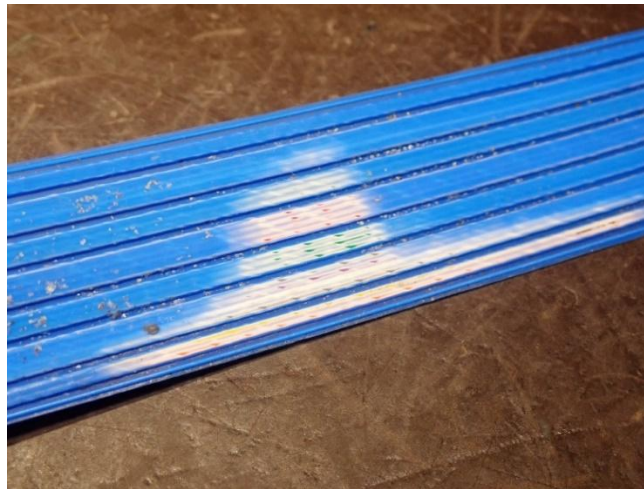
- A10.1 There are two ribbon cables (blue in colour), Ribbon 1 and Ribbon 2, in a DA that receive signals from the TRs to control the scanning pattern of the antenna. Ribbon 1 is associated with Side 1 of the DA and the left TR and left RP. Ribbon 2 is associated with Side 2 of the DA and the right TR and right RP.
- A10.2 The occurrence DA was disassembled to inspect Ribbon 1 and Ribbon 2. The inspection revealed scoring and debris. No exposed conductor was found on Ribbon 2, whereas about four inches (102mm) of exposed conductor was found on Ribbon 1 (see **Figure 21**).

Figure 21: Conductor found exposed on Ribbon 1
