# **Final Report**

## **BOEING B737, REGISTRATION 9M-MLL RUNWAY INCURSION AT CHANGI AIRPORT**

**19 May 2025**

TIB/AAI/CAS.246

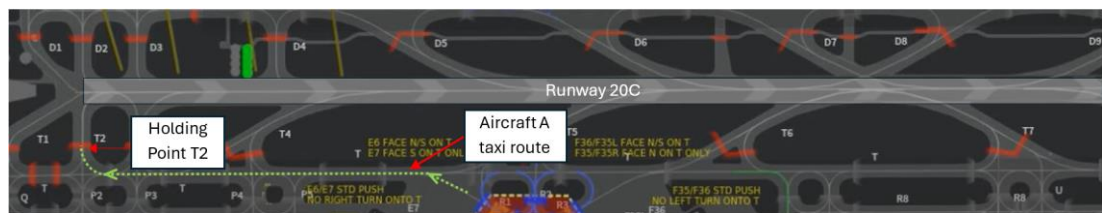
Figure 1: Taxi route of Aircraft A

1.1.2 At about 1649LT, the aircraft was cleared to taxi via Taxiway T and Taxiway T2 to the runway holding point on Taxiway T2 (hereinafter referred to as Holding Point T2) for departure on Runway 20C (see **Figure 1**).

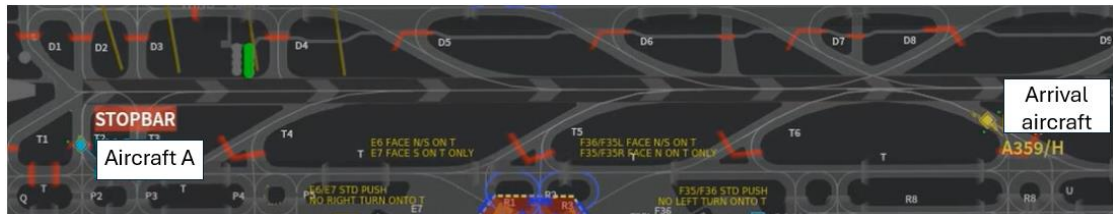
Figure 2: STOPBAR visual alert on ASMGCS.

- 1.1.9 At about the same time, the RWC noticed the “STOPBAR” visual alert appearing on the ASMGCS (see **Figure 2**) and understood the alert as an indication that Aircraft A had taxied across the red stop bar lights<sup>8</sup>.

<sup>8</sup> The “Runway Incursion” audio alert was also generated but the RWC did not notice the alert.
