# **Final Report**

## **FATAL INJURY OF CHIEF OFFICER ONBOARD THE CONTAINER VESSEL EVER WISH AT SEA ON 23 OCTOBER 2025**

TIB/MAI/CAS.213

Transport Safety Investigation Bureau of Singapore  
Ministry of Transport  
Singapore

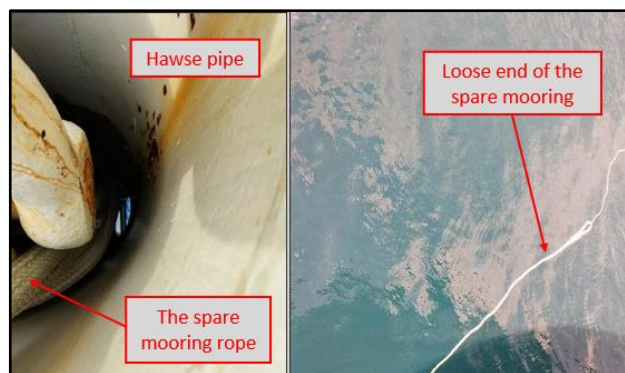
1.1.2 On the morning of 23 October 2025, the Bosun and an Able Seafarer Deck (ASD-1) went on deck for safety rounds and noticed the two coiled spare mooring ropes<sup>3</sup> placed on the wooden pallets at the forecastle deck had scattered on deck. One end of the spare mooring rope placed at the starboard side was found floating on the sea after passing through the starboard hawse pipe (see **Figure 1**). The duo attempted to pull up the spare mooring rope but was unsuccessful as it was stuck with the anchor and chain in the hawse pipe.

Figure 1 – View of the spare mooring rope inside the hawse pipe and the loose end floating on water surface (*Source: the Company*)

2.1.2 EW was sailing through rough sea with 3-4m swells against its starboard bow causing up and down pitching movements. This could have caused the unsecured coiled spare mooring rope (200m in length and 64mm in diameter), at the starboard side to scatter on the forecastle deck. One end of the spare mooring rope went into the nearby hawse pipe and slipped through the starboard hawse pipe and ended in the sea.

- 3.1 While EW was navigating through rough sea with 3-4m swells, the up and down pitch movements likely caused the unsecured coiled spare mooring rope placed at the starboard side to scatter on the forecastle deck. One end of the spare mooring rope ended up in the sea after slipping through the starboard hawse pipe.

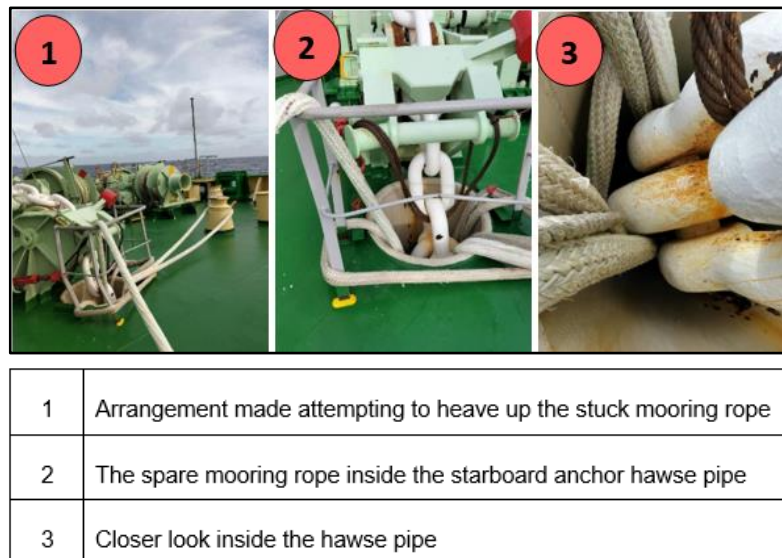
- 1.1.4 At about 0820H, CO-1, together with the Bosun and ASD-1 went to the forecastle deck to check on the fouled mooring rope. Two attempts<sup>5</sup> to clear the fouled mooring rope from the hawse pipe were unsuccessful. CO-1 then instructed the Bosun to walk back to the accommodation to request the officer of the watch, the Third Officer (3O) for additional manpower.
- 1.1.5 At about 0835H, two ASDs (ASD-2 and ASD-3) and an Ordinary Seaman (OS), who were cleaning the accommodation areas, were asked to assist in the clearing of the stuck mooring rope.
- 1.1.6 With six crew members available, CO-1 re-attempted to clear the fouled mooring rope (see **Figure 2**) by using the starboard side mooring winch. During the reattempting period, EW experienced heavy up and down pitch movements when navigating through the rough sea swells, which occasionally slammed the ship's bow.

Figure 2 – View of the incident site for clearing the stuck mooring rope  
(Source: the Company)

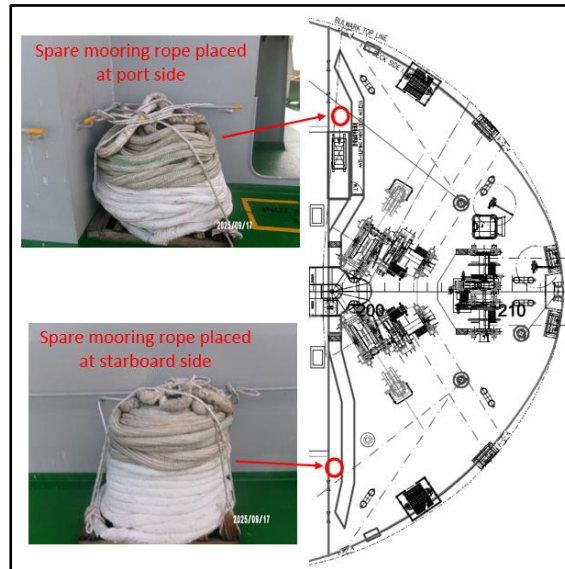
- 1.4.2 Both mooring ropes were placed on the forecastle deck, in front of the windbreaker (see **Figure 4**) since the delivery of EW from the shipyard on 13 May 2025. Depending on the circumstance and/or environmental condition, masters could deploy one or two spare mooring ropes in addition to normal mooring arrangement<sup>12</sup> to secure the ship alongside at berth.

Figure 4 – The original locations of the two spare mooring ropes  
(Source: the Company)

store, mooring rope locker, seats with storage crate or bracket on deck, or other place with secured means to strong points on deck, to prevent it from becoming loose on deck.

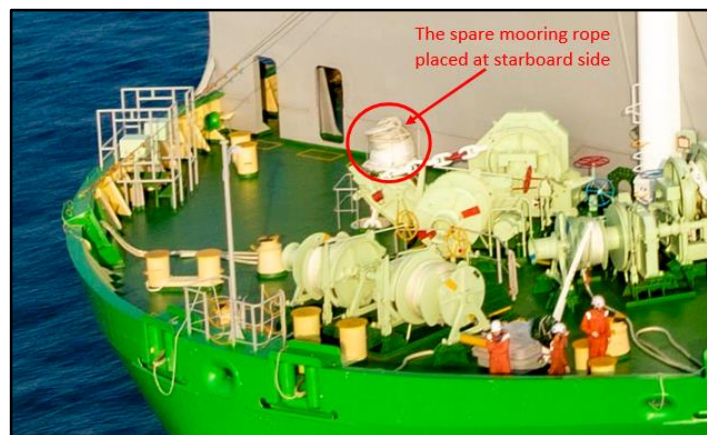
1.4.3 According to the Master, at the end of unberthing from the last port, Laem Chabang, while CO-1 was still at the forward station, he had instructed CO-1 via walkie-talkie to secure all equipment and mooring lines<sup>13</sup> at forward station before CO-1 stood down. The investigation team was informed that both spare mooring ropes were placed at the same location (see **Figure 5**) since the delivery of EW without any covers, on a wooden pallet secured to the handrail of the windbreaker by ropes.

Figure 5 – The spare mooring rope placed at starboard side  
(Source: the Company, red annotations by TSIB)

2.2.2 Though the Master had instructed CO-1 to secure all equipment and mooring lines at the forward station at the end of unberthing from Laem Chabang, this instruction was meant to be of general house-keeping practice for departing every port, rather than preparation for "Navigation in Heavy Weather Checklist". As such, the two spare mooring ropes were coiled on the wooden pallet at the forecastle deck without proper securing arrangements or covers to prevent them from getting loose and scattering on deck.

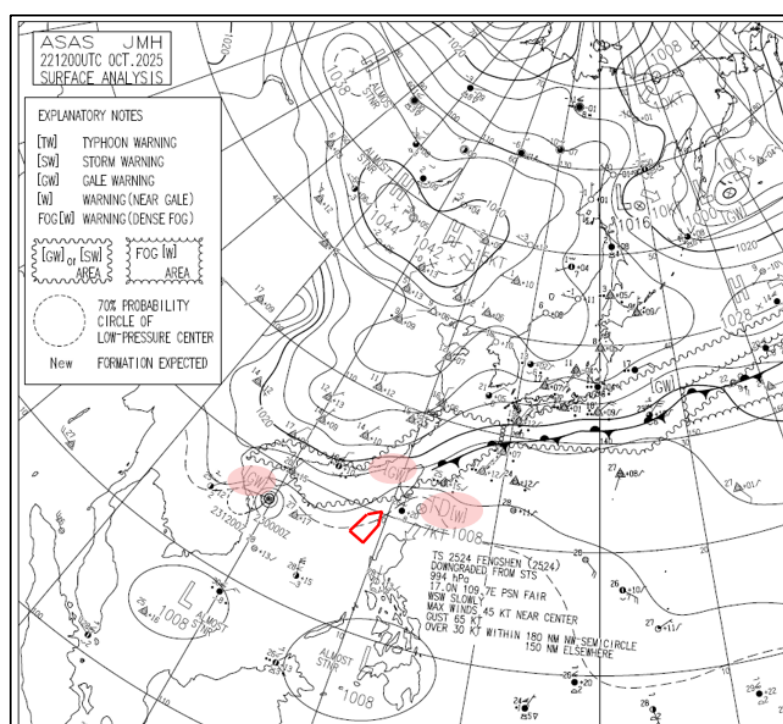
Figure 6 – JMH weather fax<sup>18</sup> - forecasted at 1200UTC, 22 October 2025, shown the gale warning and tropical depression (GW and TD, highlighted in rose colour) and EW's estimated position (Source: the Company, red symbol of ship added by TSIB)

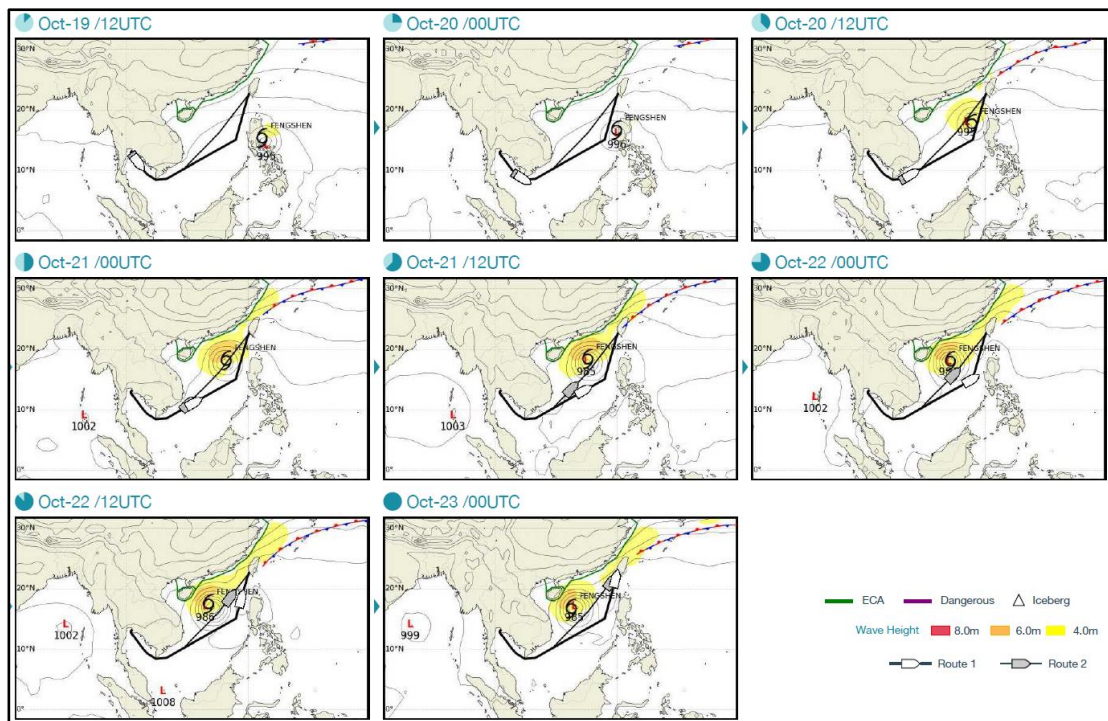
1.6.3 On 18 October 2025, the Master requested routing advice and weather forecast information for the intended passage from Laem Chabang to Kaohsiung, with dates and times of departure and arrival given to the routing service provider. The routing service provider responded on the same day with recommended routes for the Master to consider. A developing tropical storm, namely 'Fengshen' and its forecasted tracks over the following days were highlighted to the Master for attention in relation to the planned passage (see **Figure 7**) on each day during the passage. Route 1 (sailing further eastly to stay away from the tropical storm) was selected by the Master with an intention to reduce the weather impact from the passing tropical storm. The likely sea waves to be encountered were about 4m high (yellow highlighted).

Figure 7 – Initial voyage plan issued at 0635UTC, 18 October 2025  
(Source: WNI via the Company)

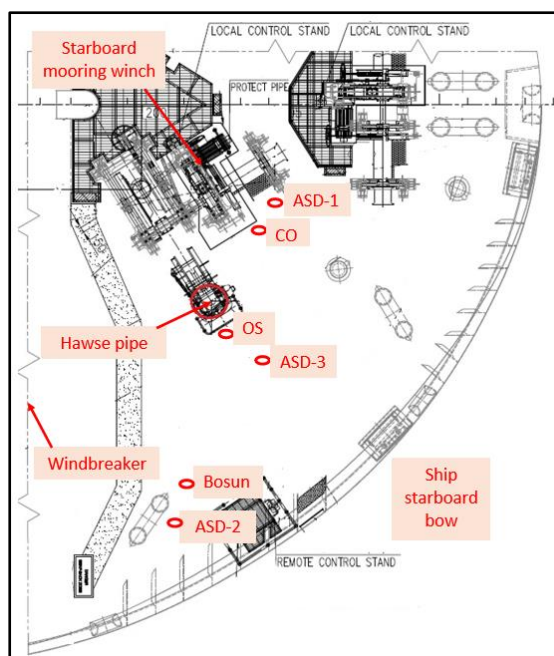
- 1.7.2 According to the recollection of the injured crew, prior to the occurrence, the estimated positions of CO-1 and the other five crew members at the forecastle deck were marked on the ship's drawing (see **Figure 8**).

Figure 8 – Positions of the six crew members at the forecastle deck prior to the occurrence (*Source: the Company, annotation by TSIB*)

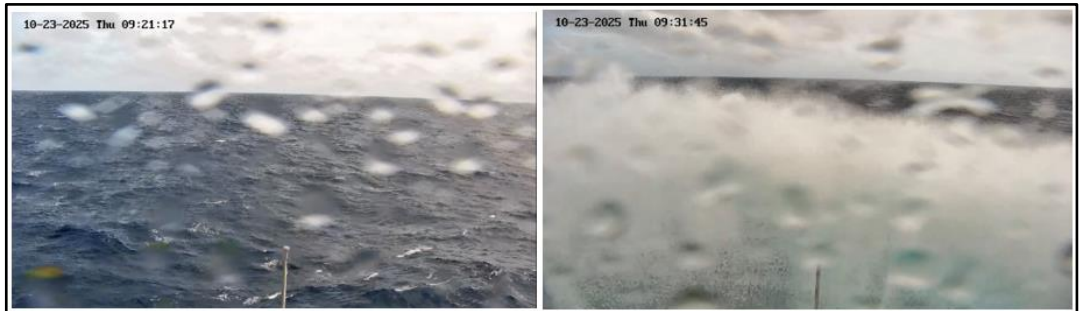
- 1.7.3 A CCTV camera installed on top of EW's foremast captured the moment where the wave splashed on to the forecastle deck (see **Figure 9 – right**). **Figure 9 left** shows the image of the sea about 10 minutes before the wave for comparison.

Figure 9 – (Left) Sea condition prior to the wave (0921H) and (Right) the wave splashing on the forecastle deck (0931H) on 23 October 2025  
(Source: the Company)

2.1.4 While CO-1 had suspended the operation due to the rough sea conditions, all six crew members suffered injuries after being struck by a huge wave which splashed onto the forecastle deck.

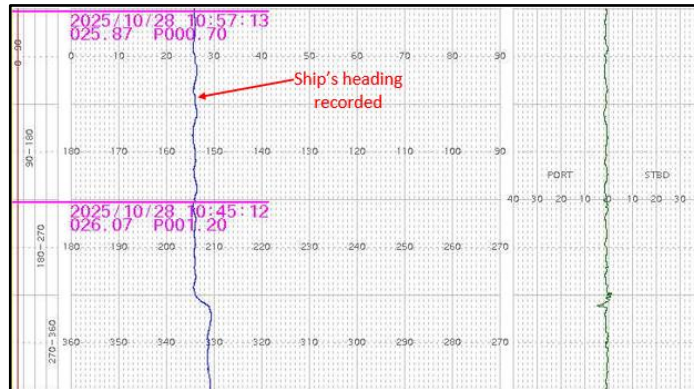
- 1.7.4 To understand if the OOW had been changing ship course (heading) during the rough sea conditions, the investigation team requested for the past ship course data to be retrieved from the ship course recorder<sup>19</sup> after the occurrence. However, when the ship crew tried to recover past ship course data, it was discovered that no past ship course data was saved in the ship course recorder since the vessel departed shipyard on 13 May 2025.

Figure 10 – Ship's heading recorded by the course recorder on 28 October 2025  
(Source: the Company, red annotation by TSIB)
