# **Final Report**

**B777-300ER PH-BVO**

**Runway Incursion at Changi Airport**

TIB/AAI/CAS.248

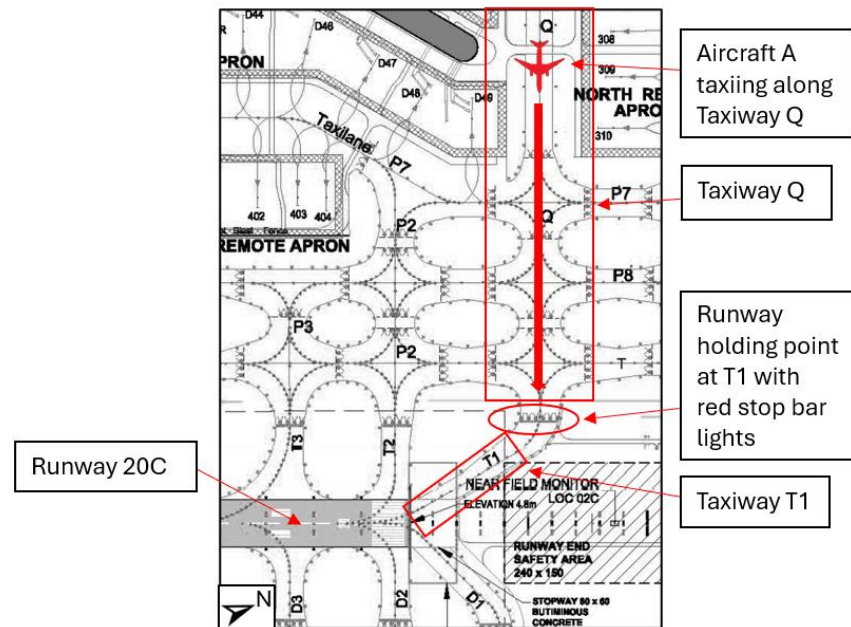
- 1.1.4 At 16:59:33 while Aircraft A was still taxiing on Taxiway Q (see **Figure 1**), PM contacted and informed RWC that they were ready for departure. Prior to this, RWC had issued to Aircraft B a clearance to continue approach. Aircraft A flight crew were not aware that Aircraft B was on the approach as they were not yet listening in on the Tower frequency.

Figure 1: Map showing Aircraft A taxiing along Taxiway Q

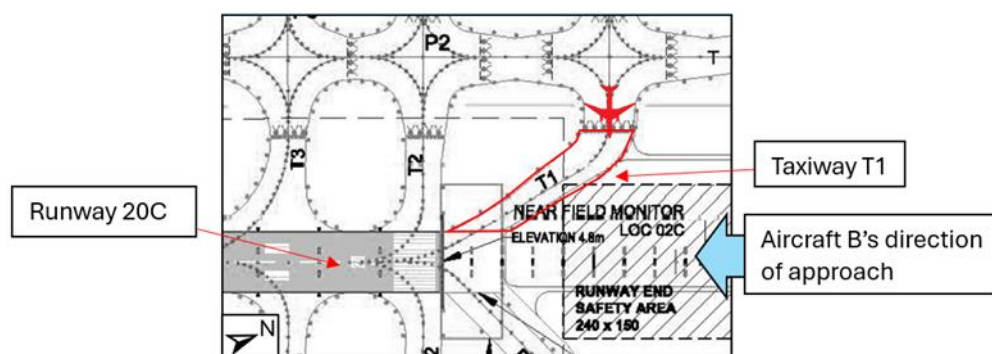
- 1.1.12 RWC did not reply to Aircraft B flight crew but instead transmitted “K-L-M Eight Three Five Hold Position” at 17:01:06. At 17:01:10, PM queried RWC if this transmission was for them while Aircraft A was approaching the SBL of RHP T1, by transmitting “Confirm K-L-M Eight Three Five”. Soon after this, Aircraft A crossed RHP T1 (see **Figure 2**). As aircraft A crossed the SBL onto Taxiway T1 (which forms the runway strip and is a protected area around the runway where clearance is needed before entry), the Advanced Surface Movement Guidance and Control System (ASMGCS) generated a runway incursion audio alarm. RWC heard a transmission but could not make out who the caller was or what was said as the ASMGCS audio alarm had interfered with the intelligibility of the transmission.

Figure 2: Aircraft A entered Taxiway T1 and triggered the runway incursion alarm

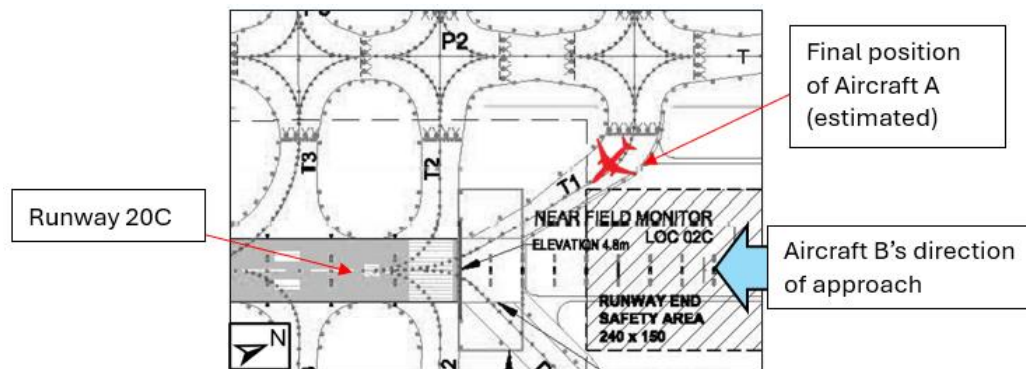
Eight Three Five Confirm Uh We Are Cleared for Take-off". At 17:01:31, RWC transmitted "Negative to Hold your Position Instructions were to hold at Holding Point Tango One". Aircraft A flight crew immediately brought Aircraft A to a stop on Taxiway T1 at 17:01:33 (see **Figure 3**) but did not reply to RWC. RWC not having received a readback from Aircraft A, called Aircraft A flight crew at 17:01:39. PM answered at 17:01:42 that Aircraft A was holding position.

Figure 3: Final position of Aircraft A

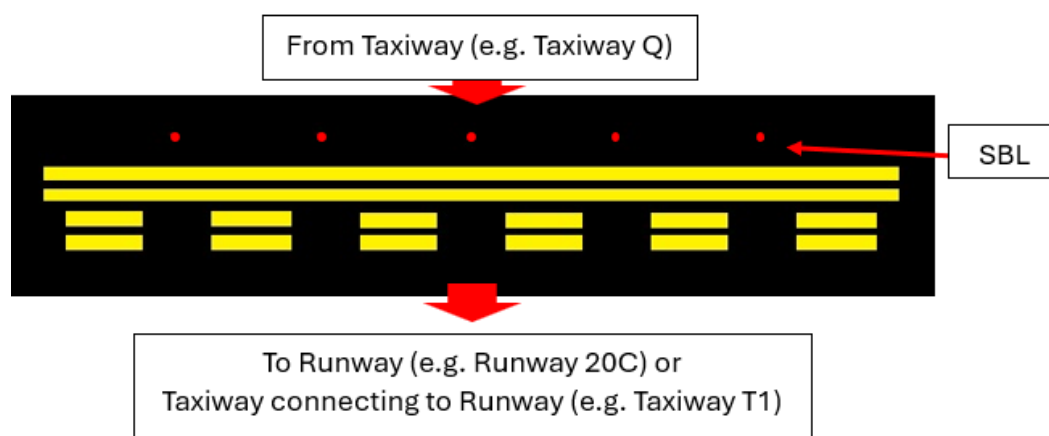
- 1.7.3 Runway holding positions (RHPs)
- 1.7.3.1 RHPs are demarcated with two solid yellow lines and two broken yellow lines painted across a taxiway. At Changi Airport, RHP markings are supplemented with a row of SBL (see paragraph 1.7.4) across the taxiway (see **Figure 4**) and these are always in operation.

Figure 4: RHP markings and SBL

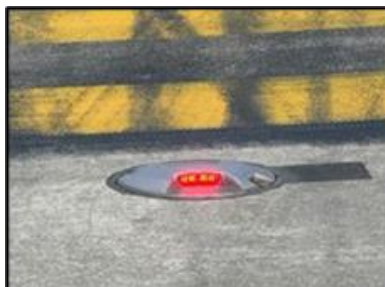
Figure 5: Stop bar light at RHP T1

- 1.7.4.2 There was no system fault logged for the SBL at RHP T1 at the time of the occurrence. No other flight crews operating around the time of the incident reported difficulty seeing the red illumination of the SBL at RHP T1. Initially when approaching RHP T1, Aircraft A flight crew saw the red illumination of the SBL.

2.2.1 There was no evidence that the SBL had been turned OFF during the occurrence. Aircraft A flight crew had seen the SBL illuminated while they were approaching RHP T1. However, as the aircraft came closer to RHP T1, the flight crew perceived the SBL to be OFF.

- 2.2.2 The investigation team understands from the Aircraft A flight crew after the occurrence that the strong reflection of the setting sun (which was behind the aircraft) might have masked the illumination of the SBL, making them believe that the SBL were OFF. The investigation team opines that this was possible. The occurrence highlights that flight crews should be mindful that the perception of SBL status can be influenced by environmental conditions, e.g. the sun. If in doubt, flight crews should ascertain the status of the SBL with the air traffic controllers.

- (d) Under no circumstances should aircraft operators allow their aircraft, while operating on the taxiways, to cross illuminated red stop bar lights at runway holding positions. Disregarding illuminated red stop bar lights on the taxiways poses an unacceptable safety risk and has been identified as a key precursor to runway incursions.
- 4.2 Safety actions by the Aircraft A operator
  - 4.2.1 The operator has completed a study of runway incursions in its operations.
  - 4.2.2 The operator is reviewing its procedures and practices by comparing its existing defences and the recommendations from the Industry Study titled Global Action Plan for the Prevention of Runway Incursions (2024).

- 5.1 Aircraft A operator remind its flight crews to seek clarification if air traffic control transmissions are unclear or difficult to understand. [TSIB Recommendation RA-2026-006]
- 5.2 Aircraft A operator remind its flight crews that environmental conditions may affect their perception of the stop bar lights and that, if the status of the lights is in doubt, they should verify with the air traffic controllers. [TSIB Recommendation RA-2026-007]
