# **Final Report**

**Missing Second Engineer (MOB)**

**SRS China Champion**

TIB/MAI/CAS.220

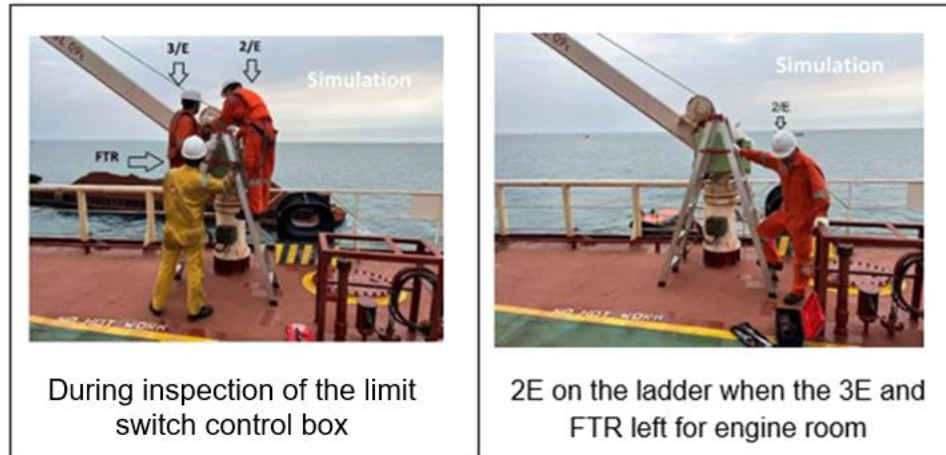
1.1.4 The A-frame ladder was positioned on the deck next to the port side bunkering davit to access the limit switch control box for inspection. See **Figure 2**, which shows a reenactment with FTR holding the A-frame ladder and two persons simulating 2E and 3E on the ladder during the inspection.

Figure 2: Reenacting the positions of 2E and 3E on the A-frame ladder during inspection of the limit switch control box. (Source: Company of CC)

- 1.1.5 At about 1505H, following the inspection, 2E observed that the screws on the limit switch control box were covered with paint. As a suitable screwdriver was not available at the worksite, 2E instructed FTR to retrieve a large striking screwdriver from the engine room and 3E to obtain silicone sealant. 3E and FTR then left the worksite to retrieve the required tools and materials, leaving 2E standing on the ladder.

2.1.2 When 2E and 3E were accessing the limit switch control box from an A-frame ladder, FTR was stabilising the ladder. Subsequently, FTR and 3E left the work area to retrieve additional tools and materials required for the task, leaving 2E alone on the ladder. Following the occurrence, the A-frame ladder was found resting against the port-side railing. As there were no eyewitnesses, the manner in which 2E fell overboard could not be determined. However, the work arrangement required 2E to work from an A-frame ladder near the ship's side while the vessel was underway, increasing his exposure to the risk of falling overboard.

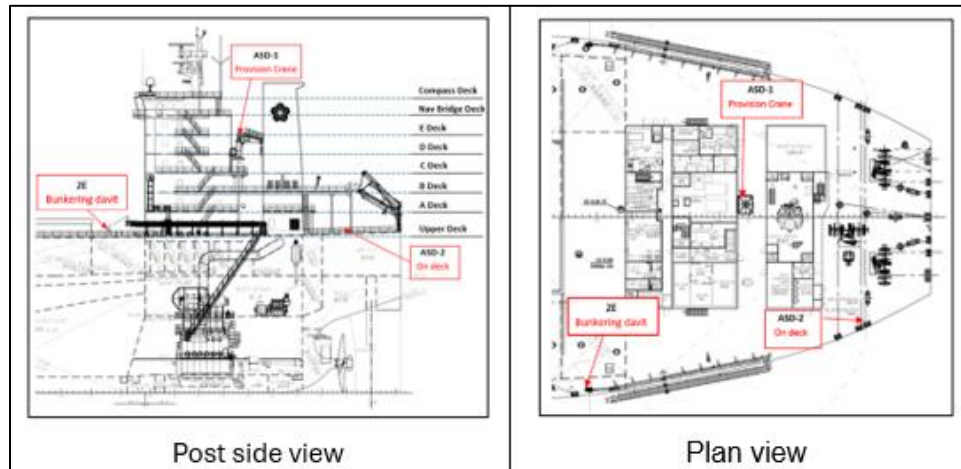
- 1.1.6 At about 1508H, Able Seafarer Deck-1 (ASD-1), who was carrying out painting work on the port side provision crane platform at C deck, observed a person wearing an orange boiler suit in the water astern of the ship. A safety helmet was also seen floating nearby. ASD-1 immediately shouted, “Man Overboard” (MOB) and alerted Able Seafarer Deck-2 (ASD-2), who was working at the stern and closest to the MOB location, see **Figure 3**. The person in water was subsequently identified as 2E. There were no eyewitnesses to 2E’s fall overboard.

Figure 3: Port side and plan view indicating the locations of crew at the time of the occurrence. (Source: The Company of CC and Annotated by TSIB)

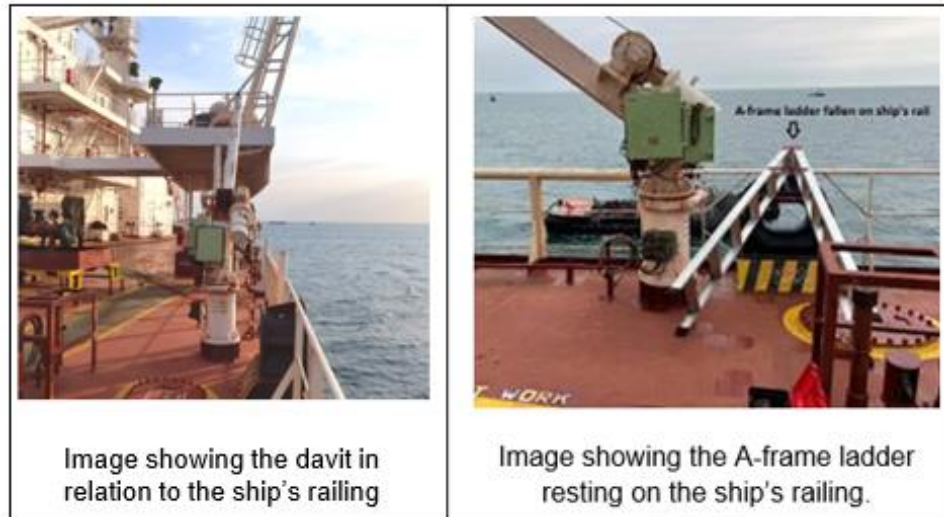
Figure 4: Images showing the bunkering davit and the A-frame ladder.  
(Source: Company)

2.1.1 The maintenance work of the port side bunkering davit was conducted on the upper deck using an A-frame ladder to access the limit switch control box. The work area was located near the ship's side and exposed to prevailing environmental conditions at sea.

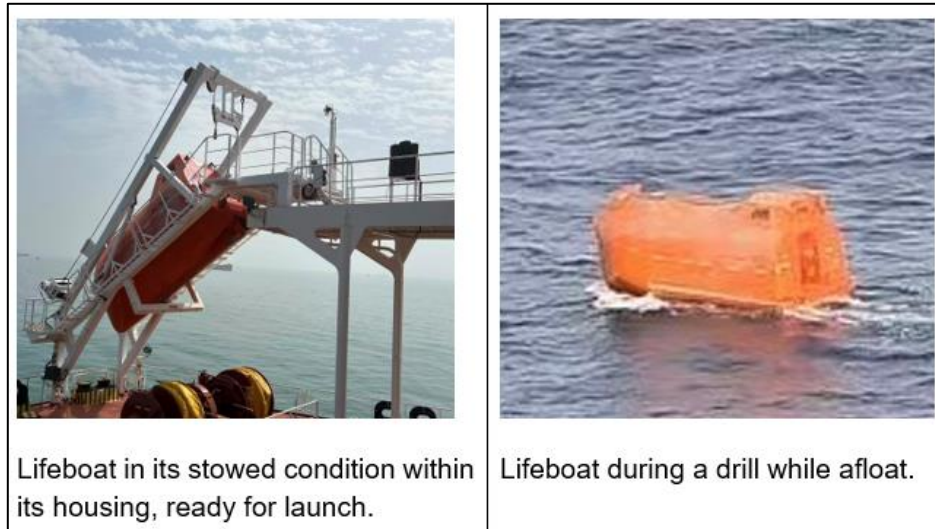
Figure 5: Photographs showing the LB in its stowed position and afloat in water after launching. (Source: The Company)

- 1.5.1.2 The LB was fully enclosed and fitted with two openings, comprising a forward hatch in the form of a window and an aft entrance door. It had an overall length of 6.7m, breadth of 2.75m, depth of 1m, and an overall height of 3.15m. It was certified to accommodate up to 28 persons.

2.4.4 While the free-fall LB could be launched more readily under the prevailing weather conditions, its fully enclosed design and limited access openings reduced accessibility and available working space during SAR operations. The enclosed operating environment also contributed to seasickness of the rescue team and restricted their external visibility, reducing the effectiveness of the

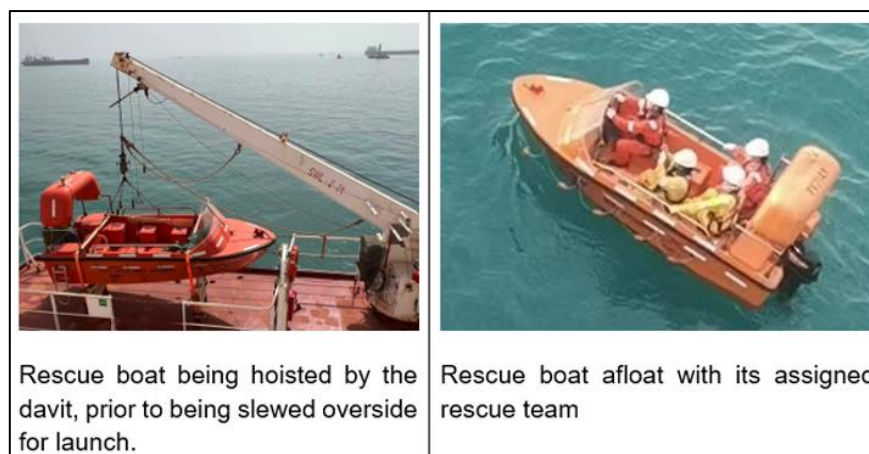
- 1.5.2.1 The ship was also equipped with an RB of type BH-R4. The RB was designed for the recovery of persons from the water, with open-sided arrangement to facilitate access during rescue operations, see **Figure 6**.

Figure 6: Photographs showing the rescue boat being hoisted and afloat in water after launching. (Source: The Company)

- 2.4.5 While the RB may have been better suited for recovering a person from the water, its deployment could also have exposed the rescue team to additional operational and safety risks under the prevailing environmental conditions. The Master therefore had to balance the safety of the rescue team against the effectiveness of the SAR operations when selecting the rescue craft.
