Final Report

COLLISION BETWEEN HAFNIA NILE AND CERES I AT SOUTH CHINA SEA ON 19 JULY 2024

TIB/MAI/CAS.173

Transport Safety Investigation Bureau
Ministry of Transport
Singapore

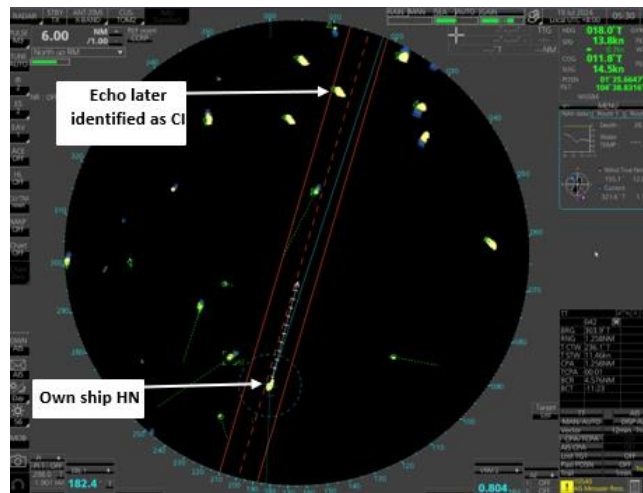
- 1.1.1.18 By about 0509H, HN-2M ordered a further course change to 014°. Once steadied, the autopilot was re-engaged. At about 0518H, HN-2M adjusted the course to the planned 017°.
- 1.1.1.19 At approximately 0520H, HN-2M altered course to 026°, to allow the ship on the starboard bow to cross ahead. The ship passed at 0531H at a distance of approximately 1.2nm. At about 0526²⁰H, HN-2M adjusted the course back to the planned track at 018°.
- 1.1.1.20 At around 0530H, HN-ASD2 reported several targets ahead. HN-2M consulted the X-band radar and visually identified a ship directly ahead, about 7.6nm away, with deck lights and without navigation lights, later identified as CI. Two additional ships on reciprocal courses were seen on the starboard bow. HN-2M decided to maintain the current course of 018° to allow them to pass safely. See **figure 1**.

Figure 1: X-band radar display at 0530H. (Source: HN-Company and annotation by TSIB)

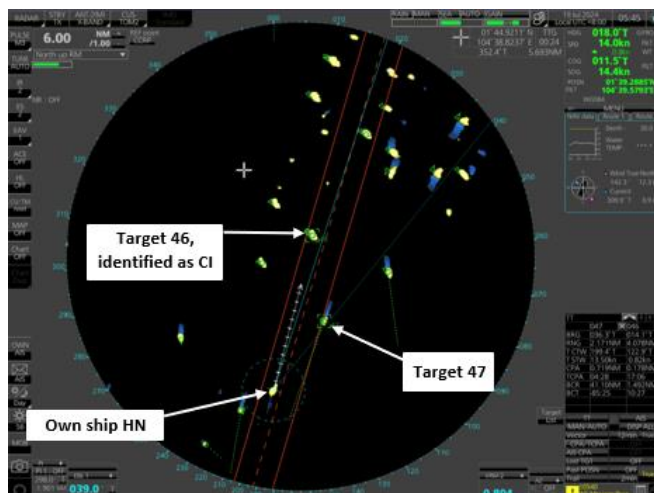
- 1.1.1.22 By about 0545H, CI was acquired on X-band ARPA, showing a CPA of 0.18nm in 17 minutes. HN-2M informed HN-ASD2 that after the ship, identified as Target 47 had passed on HN's starboard side, a course change would be made to increase CPA from CI ahead. At that time, several radar targets had already been acquired, including CI. However, according to HN-2M, he did not take note of the target data, including CPA and TCPA. HN-2M then entered the chartroom again, see **figure 2**.

Figure 2: X-band radar display at 0545H. (Source: HN-Company and Annotation by TSIB)

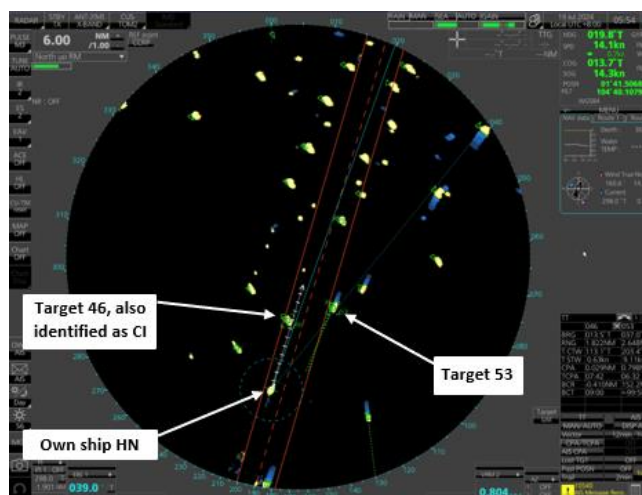
- 1.1.1.24 At about 0554H, after confirming that HN would pass ahead of CI by less than 200m, HN-2M observed another radar target, Target 53, about two points on the starboard bow, with CPA of eight cables in six minutes. At that time, HN-2M intended to have HN pass between CI and Target 53, which were approximately 0.7nm apart from each other. See **figure 3**. HN-2M then returned to the chartroom.

Figure 3: X-band radar display at 0555H. (Source: HN-Company and annotation by TSIB)

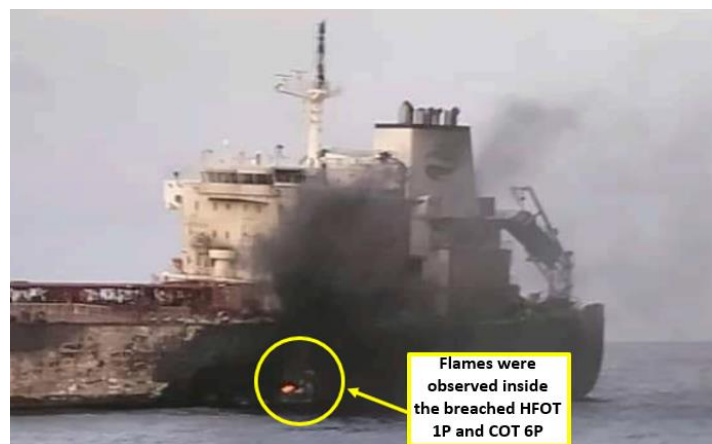
- 1.1.2.3 The fire, which broke out immediately after the collision, spread across both ships and the surrounding sea surface. See **figure 4**.

Figure 4: Photograph taken later in the day shows residual fire and smoke originating from HN's breached HFOT 1P and COT 6P. (*Source: CI-Company and annotation by TSIB*)

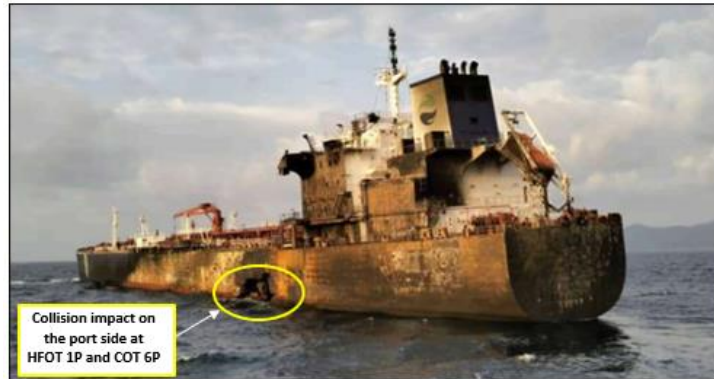
- 1.1.3 Damage assessment of HN
 - 1.1.3.1 Assessments indicated breaches to the hull in the area of COT 6P and HFOT 1P, contributing to post-collision fire and structural damage.

- 1.1.3.2 The hull breaches resulted in the loss of approximately 4065.44 MT of naphtha cargo from COT 6P and approximately 565 MT of Very Low Sulphur Fuel Oil (VLSFO) from HFOT 1P. **Figure 5** shows a portion of the VLSFO leaked into the sea. The contaminated oil-water mixture was later collected using a slop barge.

Figure 5: Image of the ship showing collision impact and subsequent fire damage. (Source: HN-Company and annotation by TSIB)

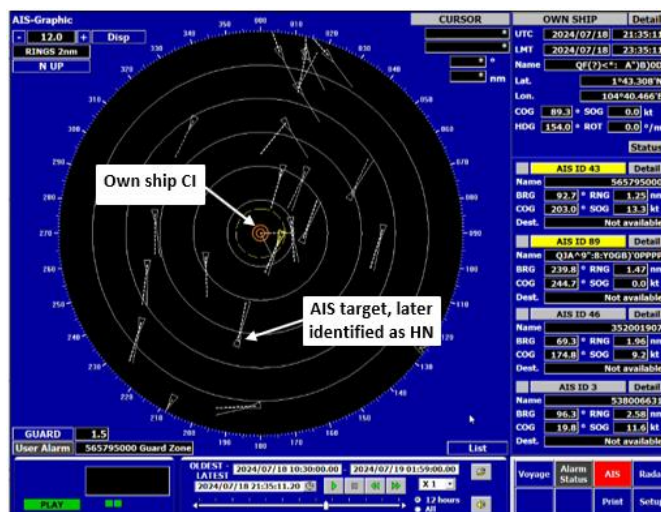
The bridge team continued to monitor HN's movement along with other nearby ships. See **figure 6**.

Figure 6: X-band radar screenshot with AIS overlay. (Source: MMD³⁵ and annotation by TSIB)

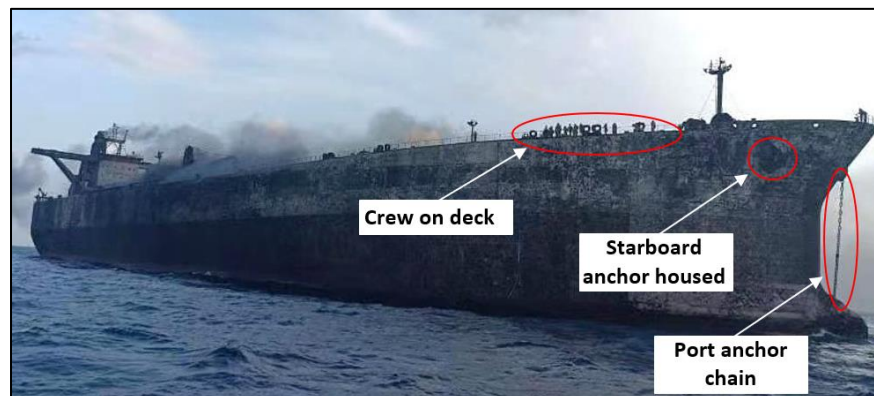
1.2.2.8 At approximately 0930H, after transferring all the shore workers, CI-Master ordered all crew to withdraw to the forecastle area as a safety measure against potential flare-ups. **Figure 7.**

Figure 7: CI with the port anchor chain parted, starboard anchor housed, crew on deck, residual smoke, and fire damage to the hull and superstructure.

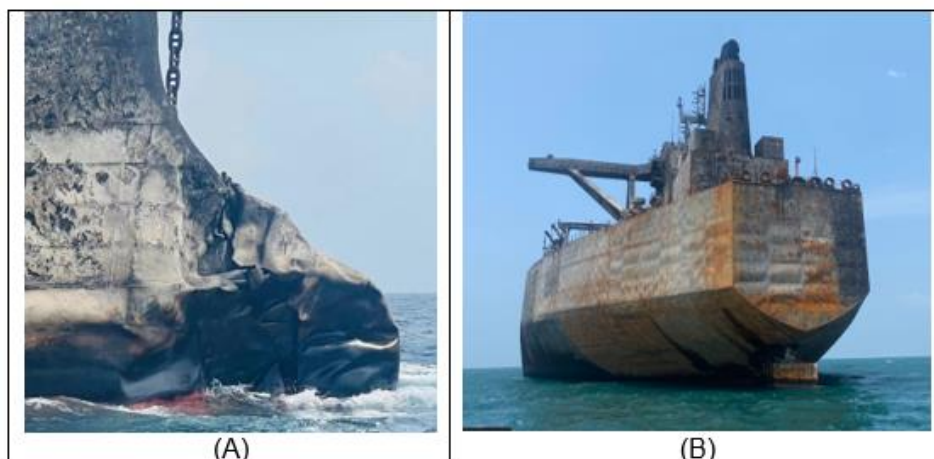
- 1.2.4 Damage assessment of CI
- 1.2.4.1 Initial assessments identified extensive fire damage to the ship's hull and superstructure. Notable losses included both the port and starboard cranes, the lifeboat, and the liferafts.

- 1.2.4.2 Additional damage included a completely burnt bosun store on the starboard side and partial fire damage on the port side. The port anchor and eleven shackles of chain were lost, and the port anchor chain stopper was damaged. Further damage included a burnt steering gear room, a damaged freshwater generator, and auxiliary engine No.2 generator. The main engine could not be turned, and its operational status remained uncertain (See **figure 8**). A complete damage assessment was not available at the time of publishing this report.

Figure 8: Images A and B of CI showing the damaged bow section (A) and fire damage of the hull and superstructure (B). (Source: CI-Company)
