# **Final Report**

## **FATAL INJURY OF SECOND ENGINEER ONBOARD VIYADA NAREE AT SEA ON 20 JANUARY 2026**

TIB/MAI/CAS.224

Transport Safety Investigation Bureau of Singapore  
Ministry of Transport  
Singapore

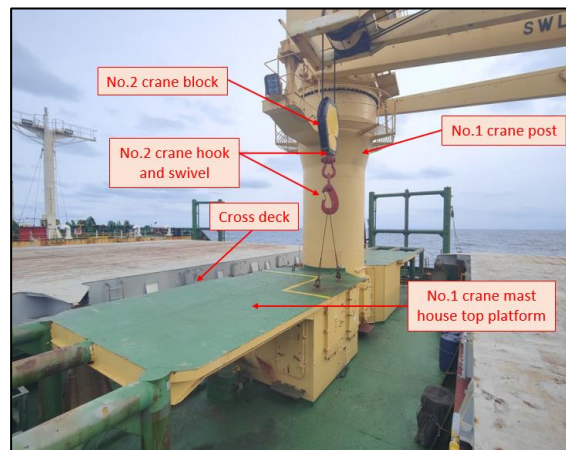
Figure 1 - View of No. 2 crane block and swivel hook and No. 1 crane mast house top platform (*Source: the Company, annotation by TSIB*)

- 1.1.9 Following the toolbox meeting and RA, the Able Seafarer Deck 1 (ASD-1) lowered the No.2 crane swivel hook and CO and BSN went onto the No. 1 crane platform (see **Figure 1**) and started to release the swivel hook by loosening two D-shackles from the crane block.

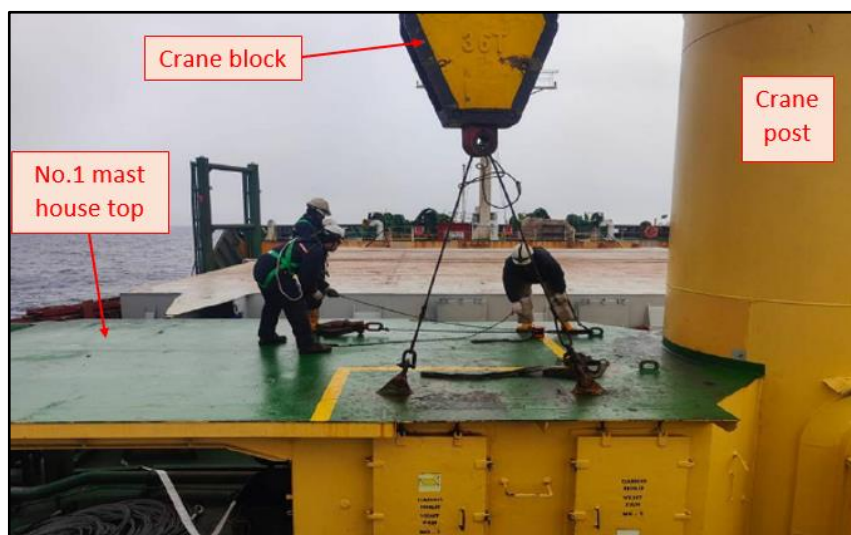
Figure 2 – Reenactment of securing No. 2 crane block to No. 1 crane platform after the occurrence (*Source: the Company, annotation by TSIB*)

<sup>18</sup> According to the Company, the three crew members worn safety harness for preventing falling from height (refer to **Figure 2** reenactment).

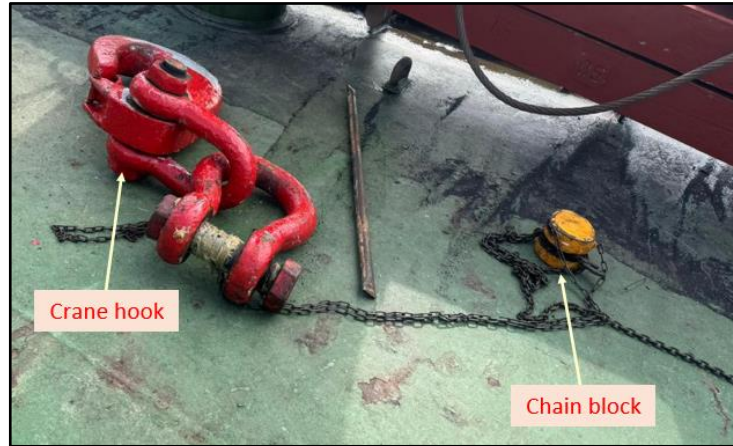
Figure 3 – The fallen No. 2 swivel hook with two D-shackles and chain block  
(Source: the Company, annotation by TSIB)

- 1.1.13 As the vessel's rolling motions increased, both the No. 2 swivel hook with two D-shackles and the chain block were sliding on the No. 1 crane platform. Similarly, the crane block was swinging between port and starboard.
- 1.1.14 During the rolling motion, the No. 2 swivel hook with two D-shackles and chain block (see **Figure 3**) slid from the No.1 crane platform and dropped onto the port side main deck. FTR sustained a minor injury and fell on the starboard outer cover of No. 1 crane mast house when No. 2 crane block swung towards him.

2.1.3 During a subsequent roll, the No. 2 swivel hook and the two D-shackles, weighing about 35kg together, and the chain block weighing about 10kg fell from the No. 1 crane platform onto the port-side main deck. The fallen equipment likely struck 2E who was walking pass the worksite and caused 2E to suffer serious injuries. 2E succumbed to the injuries later in the day.

- 3.1 The vessel's rolling motion due to moderate sea conditions had caused the disconnected No. 2 swivel hook and two D-shackles, together with a chain block, to slide and drop from the No. 1 mast house top platform and likely hit 2E, who was walking pass the worksite. 2E was seriously injured and succumbed to the injuries later in the day.

- 4.3 Further instructions were issued on crew briefing and awareness as follows:
  - a) a toolbox meeting shall be conducted prior to resumption of any similar work, emphasising the fallen object hazards, vessel motion risks and prohibition of entry into exclusion zones without authorisation.

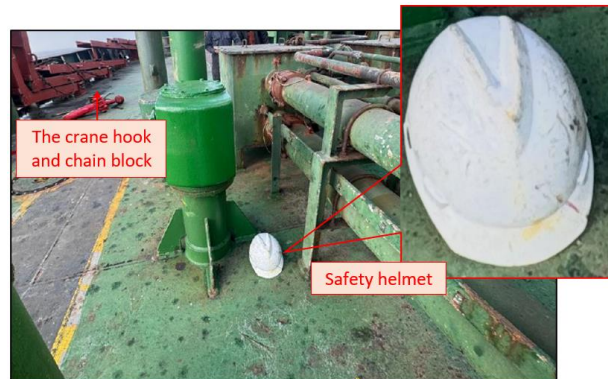
Figure 7 – The safety helmet worn by 2E (Source: the Company)

sustainable impact force of the safety helmet worn by 2E (see **Figure 7**) as the type/ model and safety compliance certificate were not available.

- 1.6.2 At the time of occurrence, 2E was wearing a safety helmet without a chinstrap. The safety helmet was reportedly found on the floor about three meters away from him, no visible damage was seen on the safety helmet.

2.4.2.1 2E was wearing a safety helmet without chinstrap at the time of occurrence. After the occurrence, the helmet was found at about three metres away from him. The primary purpose of a chinstrap is to keep the helmet securely fastened to the user's head during sudden movements, impacts, or falls.

2.4.2.2 It is important to emphasise that PPE must be worn properly to serve its intended safety purpose. Without a secured chinstrap, standard internal suspension systems cannot guarantee that a safety helmet will remain in place to protect the user's head if the user stumbles or experiences a severe impact.

- 5.1 It is recommended that the Company, Great Circle Shipping Agency Ltd. (the ISM Manager of Viyada Naree):
  - 5.11 ensure that functional test be carried out after a crane block has been overhauled or the crane components have been renewed and to notify the vessel classification society of such works in future. **[TSIB Recommendation RM-2026-003]**
  - 5.11 ensure safety helmet used by ship's crew has chinstrap and is properly worn. **[TSIB Recommendation RM-2026-004]**

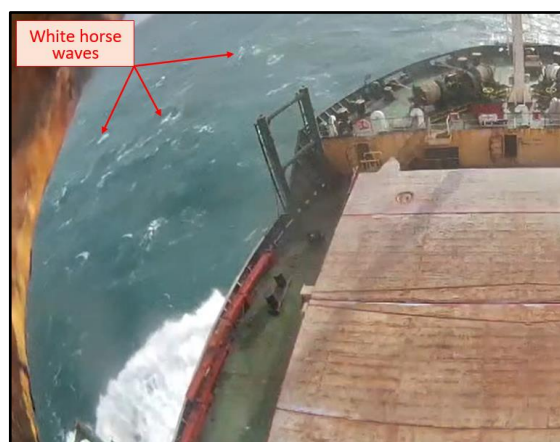
Figure 8 – VN's CCTV footage showing sea conditions at the time of occurrence  
(Source: the Company)

- 1.9.1 The weather conditions recorded in the ship's logbook indicated northerly fresh breeze between 17 and 21 knots (BF 5) at 0800H on 20 January 2026. The sky was overcast but visibility was more than 6nm. The sea state had been moderate<sup>20</sup> from the night of 19 January 2026 until the time of occurrence. The CCTV installed onboard VN captured the sea conditions which correlated the ship's logbook records (see **Figure 8**), many white horses were formed in the moderate sea state.

- 2.3.4 The deterioration of the sea conditions to "moderate" was not anticipated when the vessel sailed further out toward the open sea, thus the risk of moderate rolling of the vessel was not identified during the RA. Control measures, such as securing No. 2 swivel hook and two D-shackles before disconnecting them from the crane block, to prevent them from sliding or falling from No. 1 crane platform onto the main deck (equipment falling from a height), were not carried out. In addition, adjusting vessel's heading to reduce rolling motion was also not identified. This occurrence highlighted the importance of taking weather changes into consideration when performing an RA.
