Final Report

B777-300ER, 9V-SWM Turbulence Event over Myanmar

21 MAY 2024

TIB/AAI/CAS.231

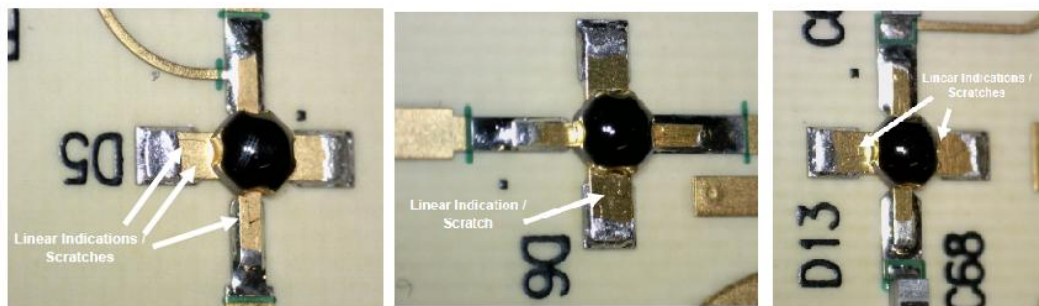
A6.2 The diodes were visually inspected under a high-resolution microscope. It was observed that (see Figure 18 below):

- (a) the solder joints on the diodes' leads were intact and appeared undamaged.
- (b) there were some fine linear scratches on the leads of the diodes.

Figure 18: Visual inspection of TR-R diodes

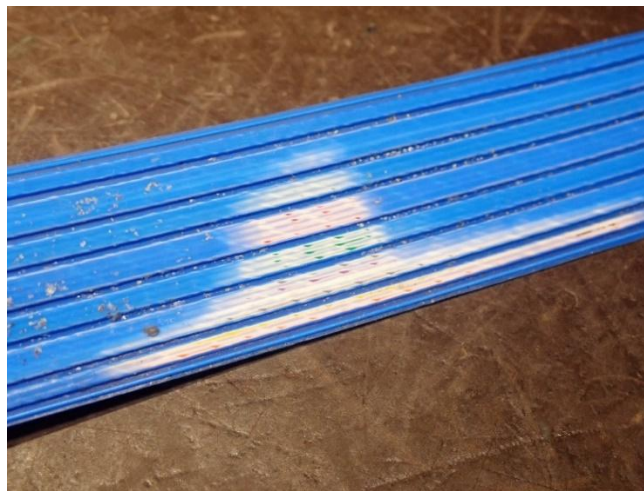
- A10.1 There are two ribbon cables (blue in colour), Ribbon 1 and Ribbon 2, in a DA that receive signals from the TRs to control the scanning pattern of the antenna. Ribbon 1 is associated with Side 1 of the DA and the left TR and left RP. Ribbon 2 is associated with Side 2 of the DA and the right TR and right RP.
- A10.2 The occurrence DA was disassembled to inspect Ribbon 1 and Ribbon 2. The inspection revealed scoring and debris. No exposed conductor was found on Ribbon 2, whereas about four inches (102mm) of exposed conductor was found on Ribbon 1 (see **Figure 21**).

Figure 21: Conductor found exposed on Ribbon 1
