# **Final Report**

## **CROSS-PASSAGE DOOR INCIDENT ON CHANGI AIRPORT LINE**

**10 SEPTEMBER 2025**

TIB/RAI/CAS.017

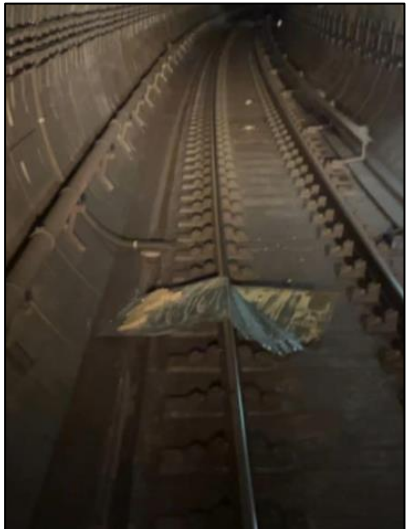
| 1826 to 1827 | When T101 was approaching TDM+8, TNM SM reported to CC that he saw an object on the track. T101 stopped at TDM+8 before the object. Upon further viewing and discussion with T101 TC, TNM SM thought that the object looked like a metallic object. TNM SM reported to CC that there was a metallic-looking object lying on one of the running rails and that it was not safe for T101 to proceed. |
| 1829 | <p>TNM SM sent a photo of the object to CC (see <b>Figure 2</b>).</p> <p>Figure 2: Photo of the object taken by TNM SM from T101</p> |

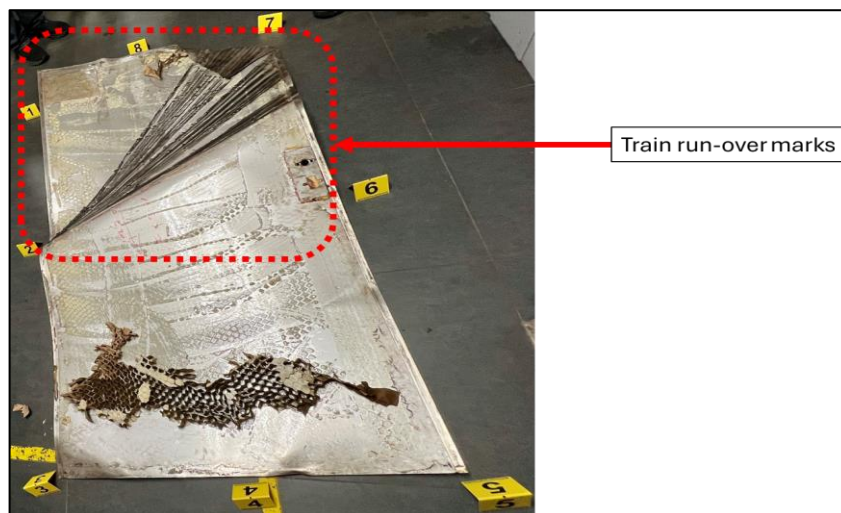
- 1.3.1 There were multiple train run-over marks on the metal cladding retrieved from the track (see **Figure 3**).

Figure 3: Train run-over marks on the metal cladding retrieved from the track

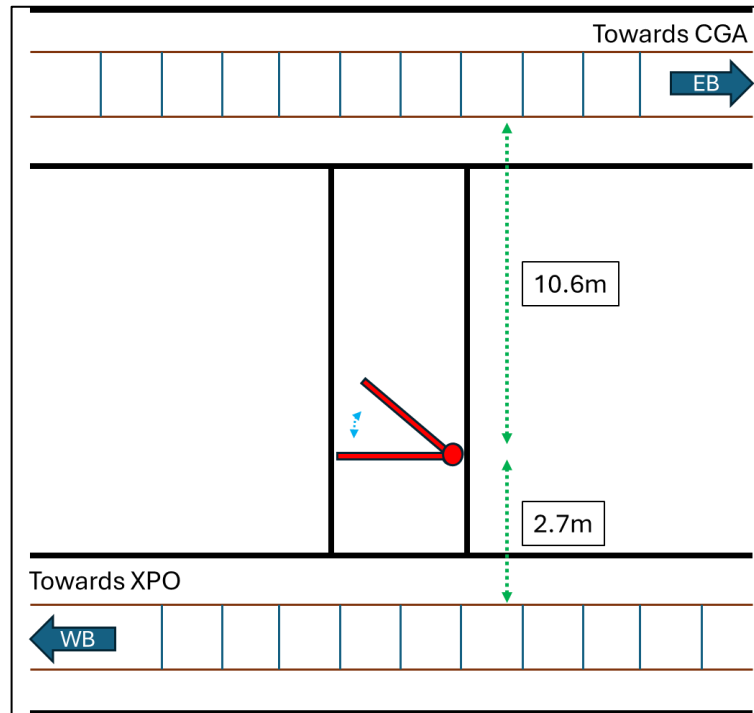
replacement door is the subject of the incident in this report and is hereinafter referred to as CP10.) CP10 was a single-swing door which opened towards the EB track (see **Figure 4**).

Figure 4: CP10 opening towards the EB track

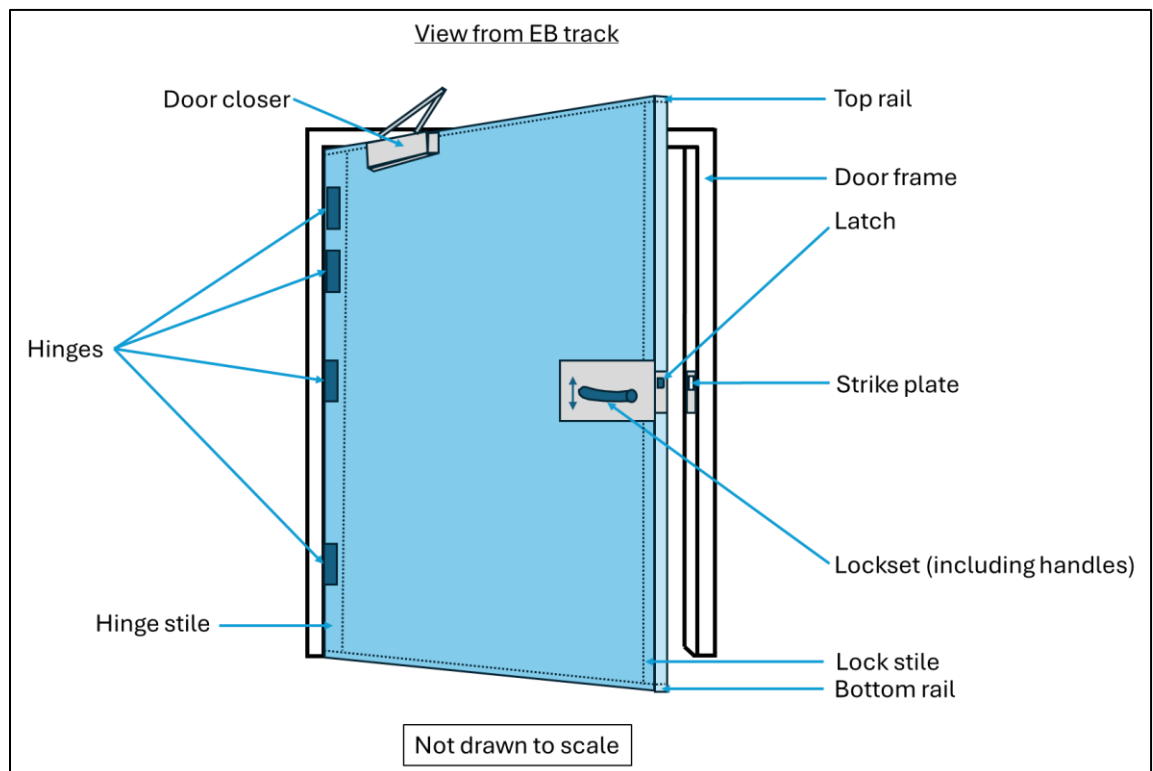
- 1.5.2.4 The construction of CP10 is shown in **Figure 5**. CP10 had a metallic frame structure of top rail, bottom rail<sup>8</sup>, hinge stile and lock stile<sup>9</sup>. This frame structure was filled with paper honeycomb. The frame structure and honeycomb core were glued between two metallic skin claddings. There is no evidence that the metallic skin claddings were fastened or welded onto the metallic frame structure. The door is hinged to the door frame in the cross passage. CP10 had a lockset and a door closer for self-closing. CP10 had a sticker stating that it had a two-hour fire rating. The metal cladding found on the CAL EB track was from the side of CP10 facing the WB track.

Figure 5: Construction of CP10

- 2.2.1 As mentioned in paragraph 1.5.2.4, CP10 had a paper honeycomb core within a metallic frame structure of top and bottom rails and hinge and lock stiles, all of this being glued between two metallic skin claddings. The investigation team noted that the metallic claddings were not secured onto the metallic door frame structure through such means as mechanical fasteners or tag welding.

- 2.2.2 The investigation team doubts that metal-to-metal glueing would provide the necessary structural strength for CP10 to withstand the wind loads experienced by the door. The glue that bonded the claddings to the door frame structure and honeycomb core had most likely deteriorated. This resulted in delamination of the door cladding in this incident. It is unlikely that the delamination occurred suddenly as it would take time for the glue to deteriorate. The inspection checklist developed by the rail operator did not include checks specifically addressing cladding delamination as the rail operator at that time did not yet understand the potential risks associated with cladding delamination. As such, there was no information in the maintenance database pertaining to any delamination of the CP door cladding.

- (a) Inspected all the CP doors and reinforced the claddings of those CP doors found with cladding delamination issue using bolts to mitigate the risk of further delamination.
- (b) Included in the checklist for CP doors a check specifically for CP door delamination.
- (c) Required the recording of all defects identified during inspections, whether or not they are rectified on-site.
- (d) Required managers involved in CP door maintenance to conduct monthly sampling checks of CP doors work records and checklists to ensure proper endorsement and compliance.

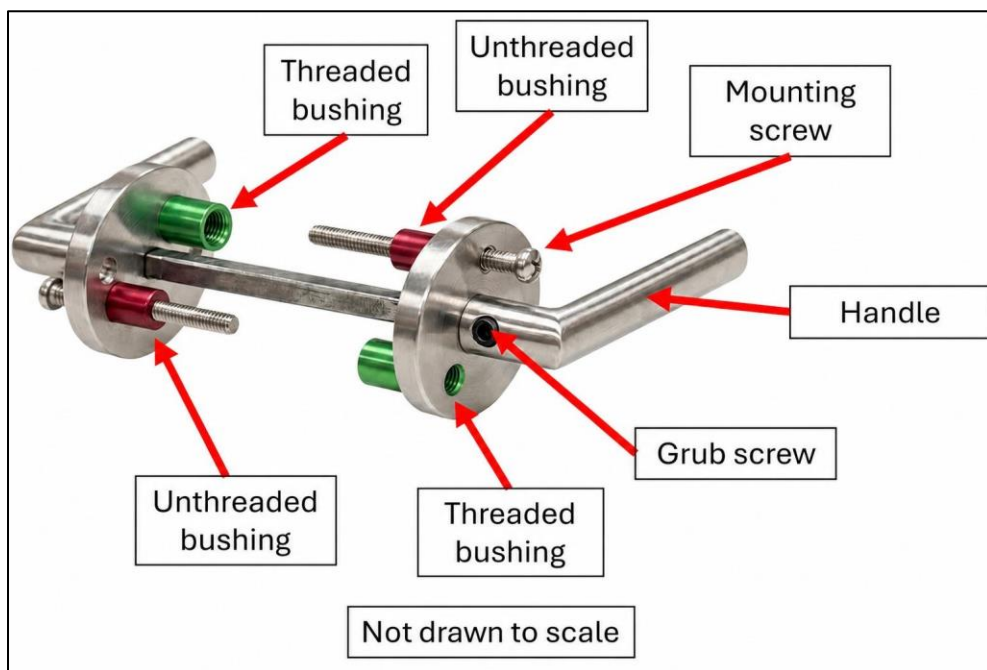
1.5.3.1 CP10 was fitted with a lockset whose latch would engage a strike plate installed on the door frame. The construction of the lockset is shown in **Figure 6**.

- (a) A spindle connected the two door handles.
- (b) The handles were secured onto the spindle by two grub screws which would prevent the handles from slipping off the spindle.
- (c) The spindle and handles assembly were secured onto the CP door with two mounting screws, one on each side of the door.
- (d) The mounting screws should be inserted through the unthreaded bushings of one handle assembly to engage the threaded bushings on the other handle assembly.

Figure 6: Lockset of CP10

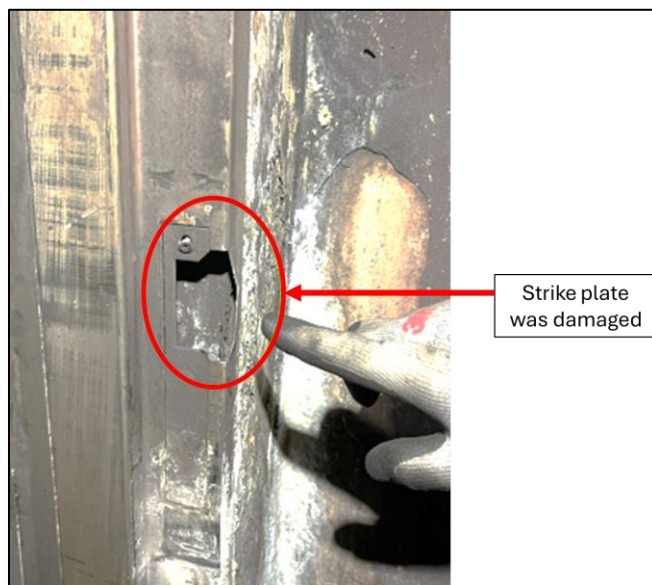
1.5.3.2 The strike plate installed on the door frame of CP10 was found after the incident to have been damaged (see **Figure 7**).

Figure 7: Damaged strike plate

- (a) As mentioned in paragraph 1.5.9.2, the strike plate on the CP10 door frame structure was found after the incident to have been damaged. The damage was such that the latch of the lockset could not be retained by the strike plate on the CP10 door frame structure and CP10 was thus not effectively closed. However, it could not be established whether the damage to the strike plate pre-dated the incident or happened at the time of the incident.

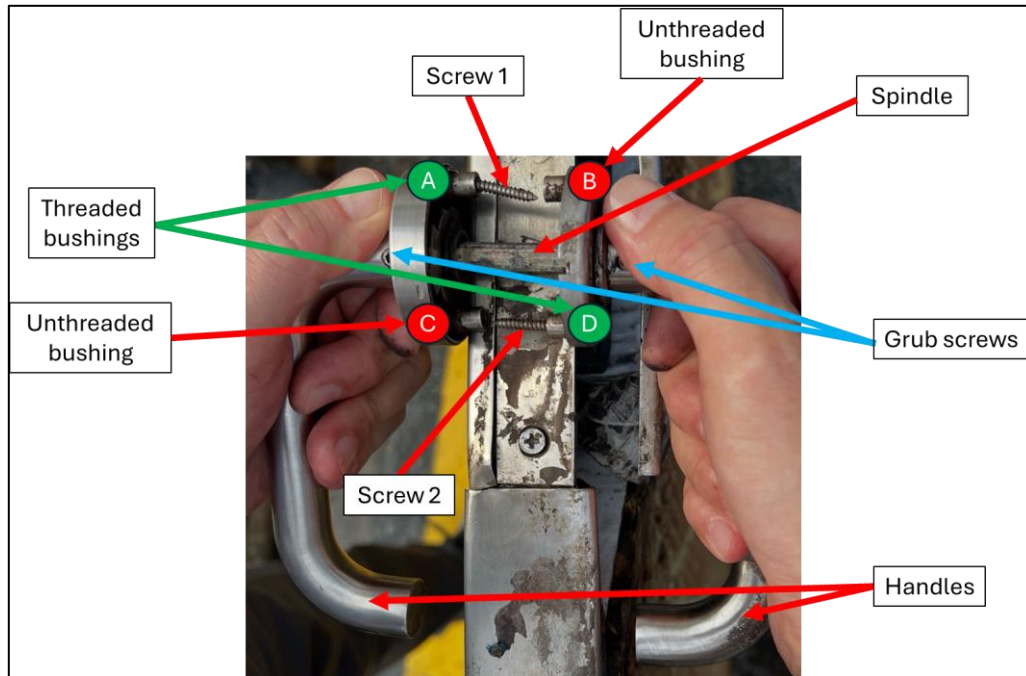
1.5.3.3 The investigation team also noted the following as regards the mounting screws on CP10's lockset (see **Figure 8**):

- (a) The mounting screws were inserted through the threaded bushings instead of being inserted through the unthreaded bushings to engage the threaded bushings in order to secure both handles together.
- (b) The length of the mounting screws was of an incorrect length. Even if the mounting screws were installed correctly through the unthreaded bushings, the mounting screws were not long enough to engage the threaded bushings completely to secure the handles together.
- (c) The mounting screws were self-tapping screws<sup>10</sup>, which were not of the correct type of screw for the purpose of securing the handles. According to DM, who manufactured CP10, the mounting screws should be of the machine screw type<sup>11</sup> (see **Figure 9**).

Figure 8: Lockset of CP10

- (b) CP10's lockset was loose and the latch of the lockset was not engaging the strike plate and CP10 was thus not closed. The lockset appeared to have been repaired or reinstalled in an incorrect manner during maintenance inspections of CP10 in the past (i.e. mounting screws having been inserted through the threaded bushings, use of mounting screws of incorrect length, and use of self-tapping screws instead of machine screws). The lockset managed to stay integral probably thanks to the two grub screws that secured the handles onto the spindle, but

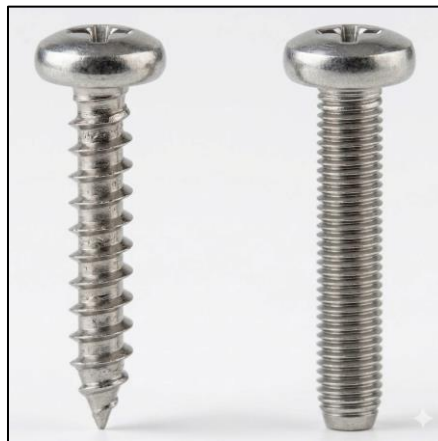
Figure 9: Self-tapping screw (left) and machine screw (right)
