# **Final Report**

## **AIRBUS A350-900, REGISTRATION 9V-SHJ TURBULENCE ENCOUNTER**

**14 NOVEMBER 2025**

TIB/AAI/CAS.255

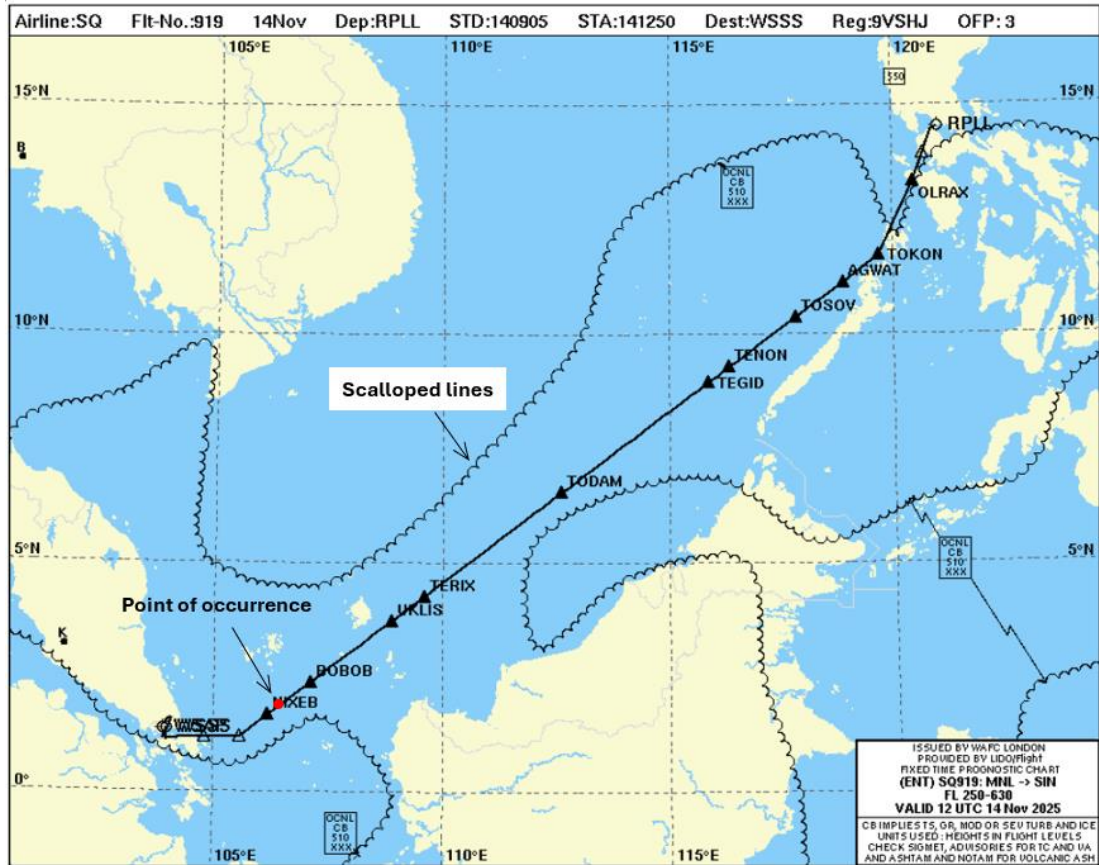
Figure 1: Weather prognostic chart extracted from pre-flight briefing package

1.1.2 Prior to the flight, the flight crew reviewed the pre-flight briefing package. The weather prognostic chart (see Figure 1) forecasted occasional cumulonimbus clouds (OCNL CB)<sup>1</sup> for the area from the Philippines to Singapore, with cloud tops height of up to 51,000 feet (more on weather prognostic chart in paragraph 1.5.2.1). The Electronic Weather Awareness System (eWAS), an application on the flight crew's mobile tablets, highlighted that they could expect to encounter some weather during the second half of the flight, i.e. from about 1120hrs<sup>2</sup> onwards. The flight crew shared this assessment with the Cabin Crew-in-Charge during the pre-flight briefing.

1.5.2.1 As mentioned in paragraph 1.1.2, the weather prognostic chart forecasted OCNL CB clouds along the flight path from the Philippines to Singapore, with the top of the clouds extending up to 51,000 feet. The area of forecast was the area outlined by the scalloped lines (see **Figure 1**). This forecast suggested that the CB clouds could cover between 50% and 75% of this entire area but did not indicate where the clouds would be exactly. The forecast would alert flight crews that they might encounter CB clouds within this area and they should use the aircraft WXR or other methods to avoid areas of CB clouds, or decide on the appropriate actions to take if they need to fly through such weather.

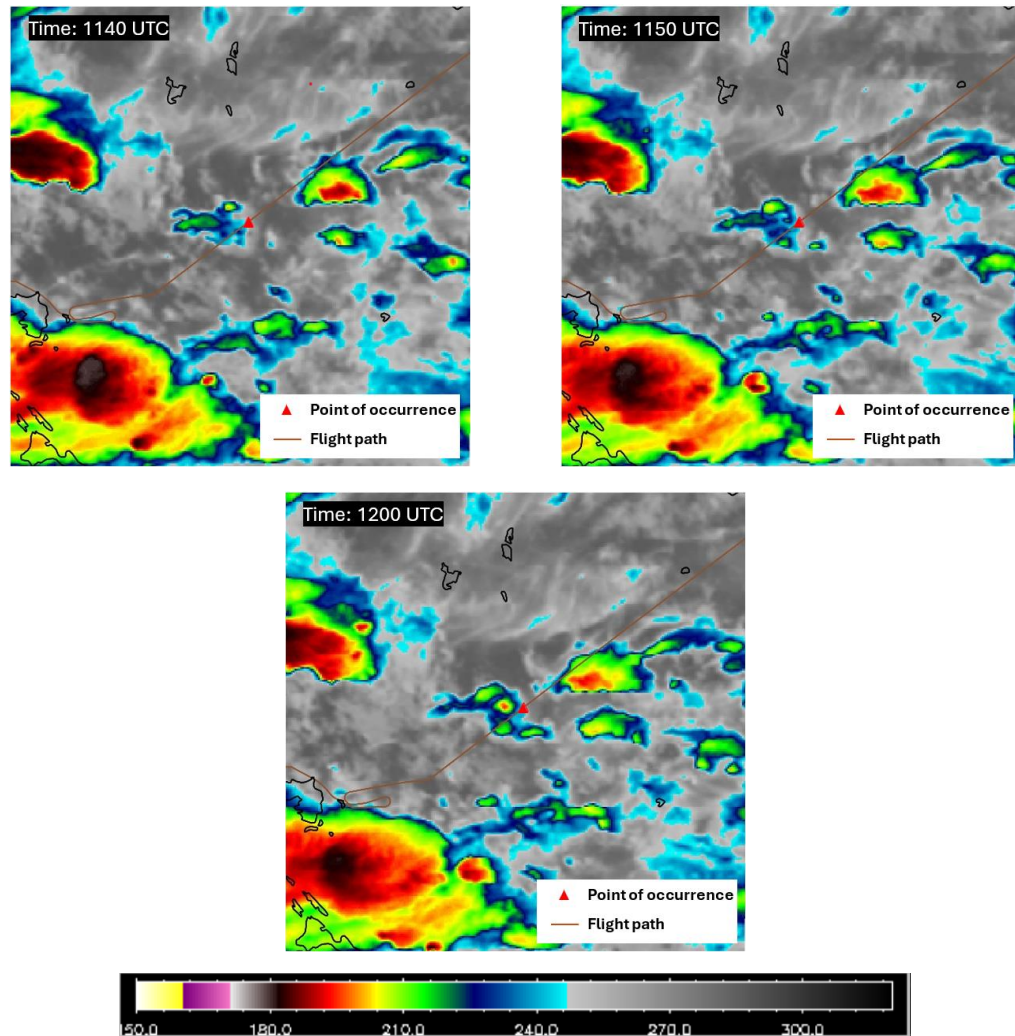
Figure 2: Infrared (temperature) images from geostationary weather satellite at 1140 UTC, 1150 UTC and 1200 UTC

- 1.5.1 According to the Meteorological Service Singapore (MSS), the satellite images<sup>6</sup> (see **Figure 2**) and ground WXR image<sup>7</sup> (see **Figure 3**) indicated that the aircraft was in the vicinity of convective activity at the time the turbulence occurred.

- 2.1 The data from the satellite images and the ground WXR corroborated with the flight crew account that the aircraft had overflowed an area of convective activity.
