Final Report

**Death of a crew member
onboard the SRS
offshore supply vessel
ANAHITA
on 14 May 2025
west of Soyo, Angola**

TIB/MAI/CAS.197

Transport Safety Investigation Bureau
Ministry of Transport
Singapore

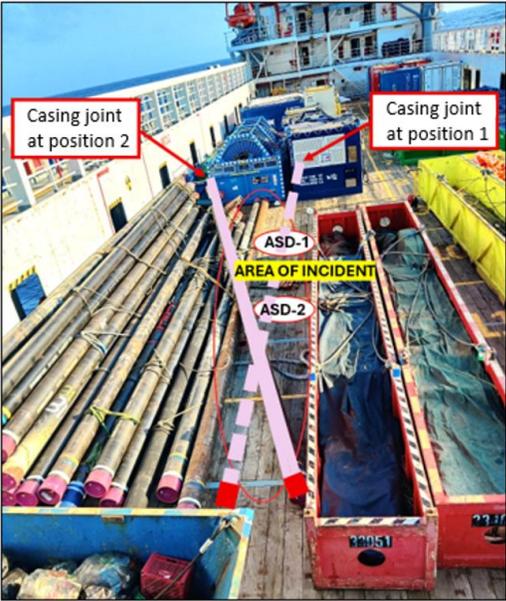
- 1.1.1.5 On arrival at the main deck, 2M-1 found that both ASDs were trapped underneath a casing joint (see **Figure 1**) and reported the incident to CM. 2M-1 then signalled and contacted SQ’s crane operator via the portable VHF radio to draw attention to the situation. Subsequently, CM communicated with SQ via VHF radio, requesting assistance in lifting the casing joint to free the two ASDs.

Figure 1: ASD-1 and ASD-2 trapped beneath a casing joint at position 1, casing joint was subsequently shifted to position 2 as viewed from the stern. (Source: The Company of AN, annotated by TSIB)

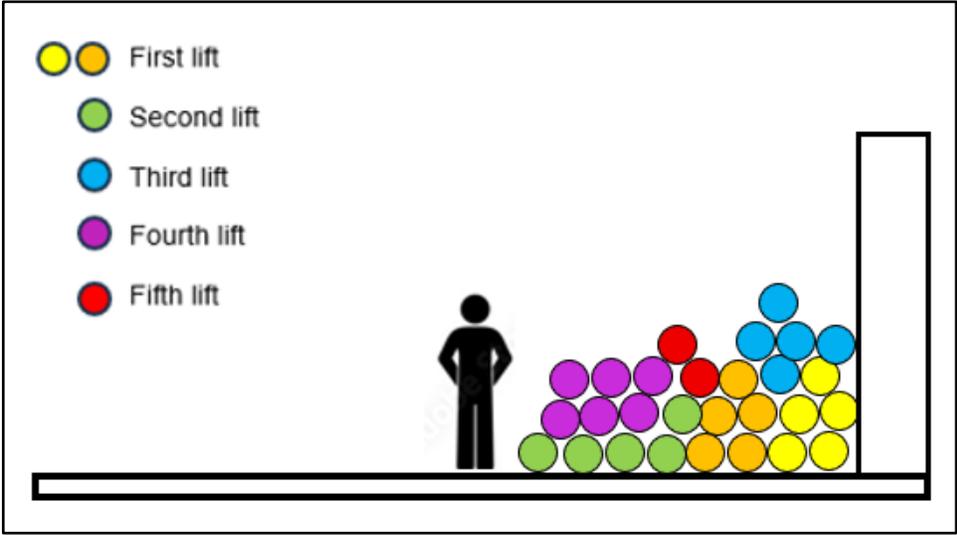
- 1.3.4 Between 0035H and 0134H on 14 May 2025, five lifts were conducted. The CCTV also showed that the casing joints were stacked in multiple layers on the port-side aft deck. For ease of understanding, a simplified illustration was prepared with information from CCTV footages to indicate the sequence and stacking arrangement (see **Figure 2** and **Table 4**).

Figure 2: Simplified illustration of the casing joints stacking arrangement and approximate positions of two ASDs, as observed from CCTV footage.

2.2.2 Cylindrical-shaped items, such as casing joints, are susceptible to rolling movement when not restrained. As additional loads were landed during the backloading operation, the lower stacks of casing joints were susceptible to lateral movement due to the additional weight placed on them or due to vessel rolling caused by deep sea swells. The effect of vessel rolling on the stability of the casing joints is discussed in paragraph 2.3.

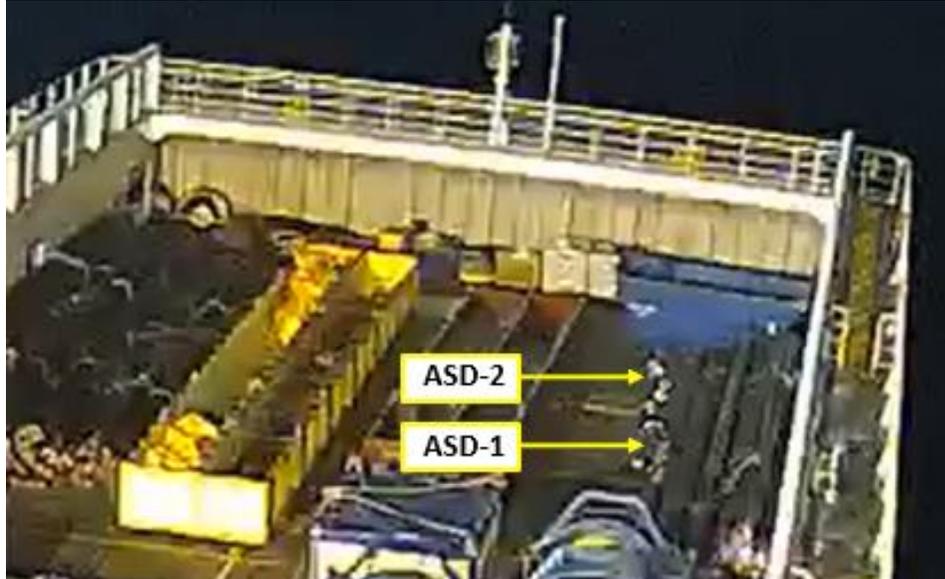
1.3.5 CCTV footage showed both ASDs standing clear of the final lift of two casing joints. After the final lift had landed, they approached the casing joints and unhooked the wire slings and began ensuring that the wire slings were clear of any obstruction in preparation for the next operation. The two casing joints (the fifth lift) from the final lift were stacked on top of, and added weight to, the existing stacks of casing joints. During the vessel's rolling motion caused by the deep swell, (see **Figure 3**), movement was observed on the casing joints from the second and fourth lifts (see **Figure 4**). Shortly after, both ASDs were seen trapped under a casing joint²¹.

Figure 3: CCTV frame showing the positions of ASD-1 and ASD-2 before the rolling down of the casing joint.

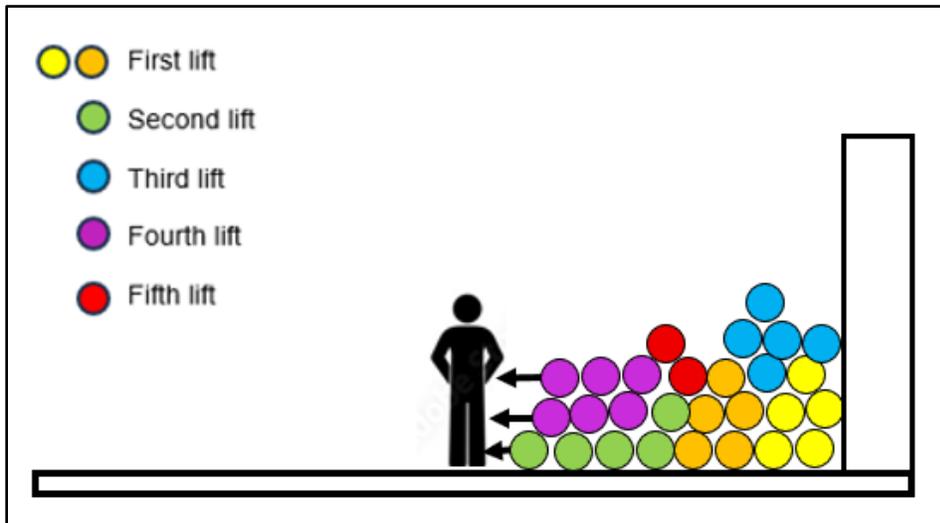
²¹ The lower bundles that supported the final lift appeared to move during the vessel's motion, resulting in one of the casing joints rolling down and trapping the two ASDs.

Figure 4: Approximate direction and movement of the casing joints based on CCTV footage.

2.3.4 CCTV footage showed continuous rolling motion of AN's stern caused by the prevailing swell conditions. Although the vessel remained within approved stability limits and maintained position and heading under DP control, the rolling motion generated dynamic forces that affected the stability of the unrestrained casing joints, resulting in lateral movement of the lower layer.

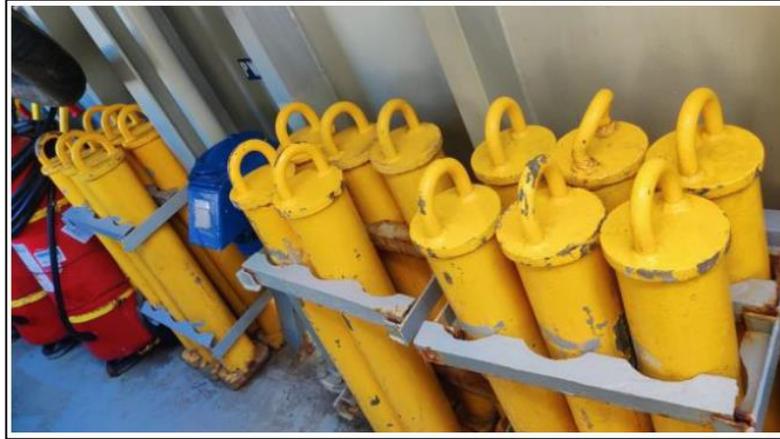
- 1.7.4 The risk of casing joints rolling on deck between lifts was not identified, i.e. each stack of casing joints landed on deck could have rolled due to vessel movement caused by sea swells. Hence, there were no control measures in place to restrain movement of the casing joints after each lift.

1.10.2 The Company's record confirmed that these securing items formed part of AN's standard deck-cargo equipment. The vessel's loading procedure listed the stanchion posts and chocks as equipment to be used when handling casing joints cargo. CCTV footage showed the stanchion posts stowed at the aft area of the main deck throughout the lifting sequence. They were not used during the stacking of the casing joints during backloading operation. See **Figure 5**.

Figure 5: Stanchion posts onboard Anahita. (Source: The Company of AN)

- 4.1 The Company disseminated safety information to its fleet to reinforce awareness of line-of-fire hazards during deck cargo operations, particularly when handling cylindrical cargo that has not yet been secured.

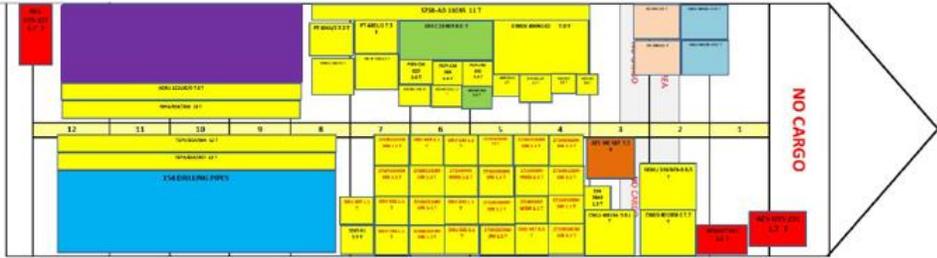
1.12.2 AN was operating in a loading condition in which casing joints were arranged in multiple stacks on the aft deck. At the time of the occurrence, the deck occupancy was recorded as about 85 per cent²⁶. The deck stowage illustration is included to show the extent of cargo occupying the aft deck during the operation, as most of the usable deck area was taken up by various types of cargo, including the stacked casing joints. As shown in **Figure 6**, the area where the casing joints later shifted (colour-coded in purple) had limited open deck space around it.

Figure 6: Loading condition of Anahita. The purple-coloured box indicates the area occupied by casing joints before the occurrence. (Source: Company. Annotated by TSIB)

2.3.1 At the time of the occurrence, AN was in a loading condition that met the applicable stability and strength requirements. The vessel had a positive trim by the stern and a slight list to port, both within the acceptable limits for deck cargo operations. Cargo occupancy on deck was high, with most of the available aft deck space occupied by stacked casing joints.
