Urgent Medical Device Safety Notification

Important information regarding extension handling during implant procedure
Medtronic DBS Extensions Models 37085 and 37086

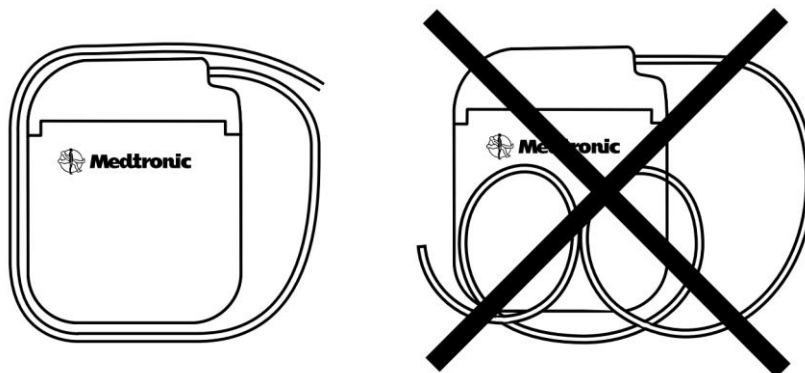
Figure 3. Wrap excess extension around the perimeter of the neurostimulator.

- Ensure that the neurostimulator is placed no deeper than 4 cm (1.5 in) below the skin and is parallel to the skin. If the neurostimulator is too deep or is not parallel to the skin, telemetry may be unsuccessful.
- Do not coil excess extension in front of the neurostimulator. Wrap excess extension around the perimeter (Figure 3) of the neurostimulator to minimize subcutaneous pocket depth, help minimize potential damage during neurostimulator replacement surgery, help minimize potential kinking of the extension, and minimize interference with telemetry. Excess extension should not exceed two wraps around the perimeter of the neurostimulator. Extension lengths requiring more than two wraps can interfere with telemetry.
