FIELD CORRECTIVE ACTION NOTICE

Leica M525 F20 Microscope System

FCA Identifier: CAPA-HER-MD-18-001

Enhancement of instructions for use and additional markings to prevent inadvertent tipping

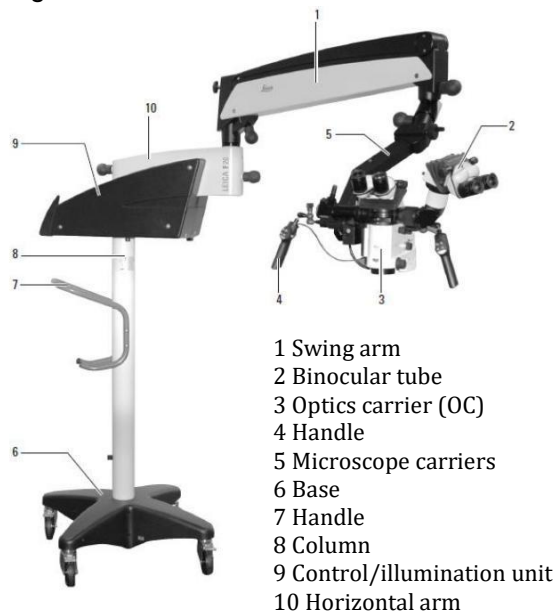
Figure 1: Overall view of Leica M525 F20 Microscope

This letter is to inform you about a field corrective action involving all Leica M525 F20 Microscope Systems (see Figure 1) to replace the instructions for use with an enhanced revision and to fix additional markings onto the device.

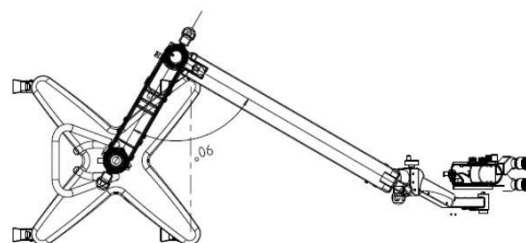
Figure 2: Top view of Leica M525 F20 Microscope

Intended correct positioning:

~ 90° between horizontal arm and swing arm

- Ensure that your Leica M525 F20 is positioned and handled with an angle of approximately 90° between horizontal arm and swing arm during surgery as well as during set-up and preparation (see Figure 2 and Attachment 1).

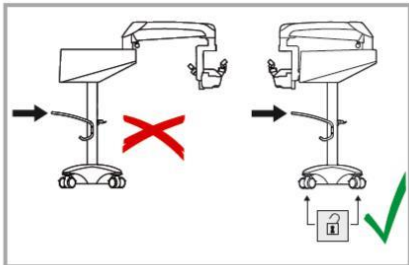
<p>Never move stand in the extended position.</p>

- Ensure adherence to the current instructions for use, in particular for transportation: ○
 - For transportation always move the Leica M525 F20 into the transport position. ○
 - Never move the stand while the unit is extended.

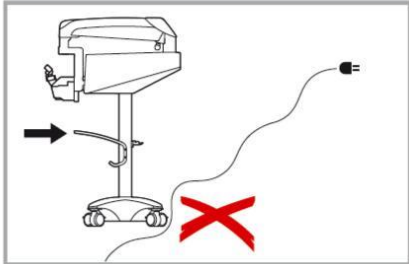
<p>Never roll over cables lying on the floor.</p>

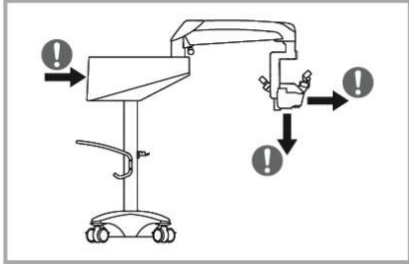
<p>Do not allow vertical and horizontal forces to the stand in the extended position.</p>

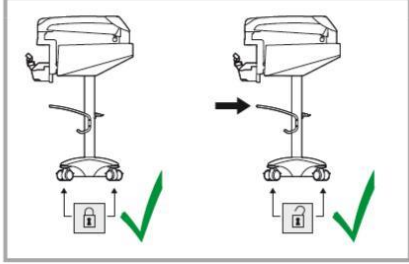
<p>Always lock the foot brake when you are not moving the system. Always open the foot brake when you are moving the system.</p>

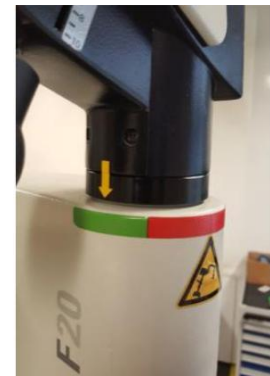
Figure C: Scale Indicator

The yellow arrow pointing to the green area shows that the device is set up as intended. The yellow arrow pointing to the red area shows that the device is not set up as intended and special care is needed to prevent inadvertent tipping when handling the device.

An additional marking with a scale indicator and arrow as shown above in Figure C will assist Leica M525 F20 users to position the horizontal arm and swing arm with as intended with an angle of approximately 90°:
