Attached is a Field Safety Notice/Field Change Order pertaining to the Efficia 3/5 ECG Trunk Cable, AAMI/IEC due to FCO 86400024. Please note that the serial number of the units affected are stated below:

URGENT - Medical Device Correction Efficia 3/5 ECG Trunk Cable, AAMI/IEC

Possible Reduction of Defibrillation Energy Delivered or Failure to Deliver Defibrillation Energy

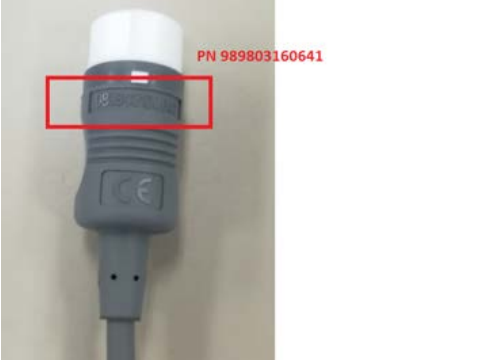
HOW TO IDENTIFY AFFECTED PRODUCTS	Step	Action	Supporting Picture
	1	Locate all Efficia ECG Trunk Cables (part number 989803160641) in your facility. The picture to the right depicts the location of the part number on the product.

ACTION TO BE TAKEN BY CUSTOMER / USER	<ol style="list-style-type: none"> 1. Identify all affected Efficia ECG Trunk Cables in your facility using the instructions provided in the HOW TO IDENTIFY AFFECTED PRODUCTS section above. 2. Discontinue use of all affected Efficia ECG Trunk Cables. 3. Fill out and sign the reply form provided on the last page of this letter. 4. Send the completed and signed reply form to Philips via the contact information located on the form. 5. Dispose of all affected Efficia ECG Trunk Cables in your inventory in accordance with your local regulations. Please do not return any affected product to Philips. <p><i>Please return the reply form, even if you do not have any inventory of the affected Efficia ECG Trunk Cables.</i></p>
ACTIONS PLANNED BY PHILIPS	<p>Philips will replace all affected Efficia ECG Trunk Cables free of charge. Upon receipt of the completed and signed reply form, an order for replacement product will be entered and shipped to the address provided on the reply form.</p>

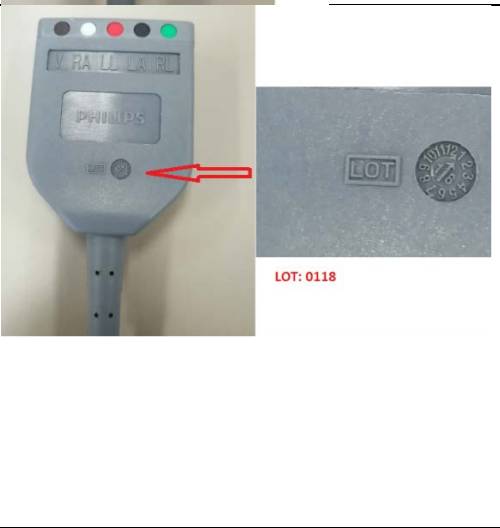
2	Review the lot number dial of each cable. The picture to the right depicts the location of lot number dial on the cable. The twelve numbers around the outside of the dial represent the twelve months of the year. The number located in the middle of the dial represents the last two digits of the year. The dial's arrow points to the month in which the cable was produced. The lot number of the cable in the picture to the right is 0118 (January 2018). Cables produced from February 2014 through September 2018 are potentially affected. Lot numbers outside of this range are NOT affected.

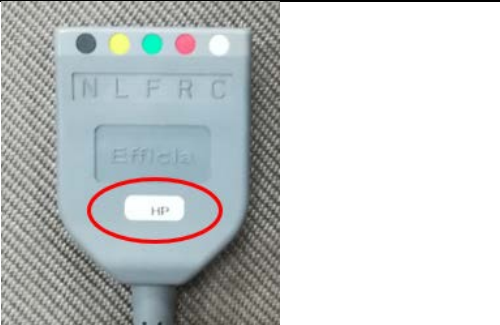
3	For Efficia ECG Trunk Cables in your facility produced from February 2014 through September 2018, look for the presence of an "HP" label applied to the cable. Cables bearing the "HP" label are NOT affected (see picture to the right). Cables not bearing the "HP" label that were produced from February 2014 through September 2018 ARE affected.
