Urgent Field Action Notice for Instrument ASP6025

ASP6025 Tissue Processor

Serial Numbers: 163, 169, 200-821, 823-895, 897-899, 901-1123 (all odd - serial numbers)

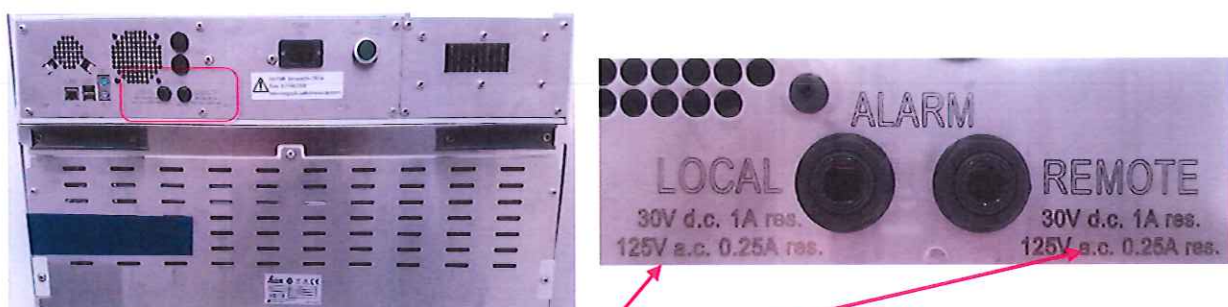
Alarm Connectors labelling

The affected devices mentioned above have incorrect labelling with regard to the specified voltage for the Alarm Connectors on the rear side of the instrument (please refer to the pictures below).

The current incorrect labels specify 125Va.c. as maximum voltage. It has been identified, that if somebody connects such 125Va.c. to the 6.3mm stereo jack, there would be hazardous voltage accessible on the plug which could lead in the worst case to a serious electrical incident.

As an immediate action, we ask that you to first clean the surface around the Alarm Connectors (grease free). Then remove the provided adhesive label (1) from the foil and place it at the Alarm Connectors as shown in the pictures below. The engraved specification must not be readable anymore!

As outlined on the new label, the maximum voltage that can be applied to the Alarm Connector is 30V DC/AC. In case you do not use the External Alarms no further immediate action is necessary. For ASP 6025 Tissue Processors where the external Alarm is used, please ensure that the maximum voltage is not exceeded by the connected external device.

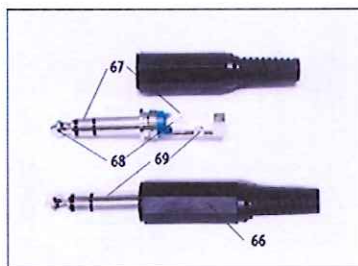
Fig. 63

In addition, the current specification in the Instruction for Use (IFU) has an incorrect labelling with regard to the specified voltage for the Alarm Connectors (please refer to the pictures below).

The maximum values of the alarm system connected to the instrument must not exceed the following:

For 30 V DC, max. 1 A
For 120 V AC, max. 0.25 A
