FIELD SAFETY NOTICE

HeartMate 3™ Left Ventricular Assist System Catalog # 106524INT – LVAS KIT, HM 3 105581INT – Packaged assembly Outflow, HM3(INT)

18 May 2017

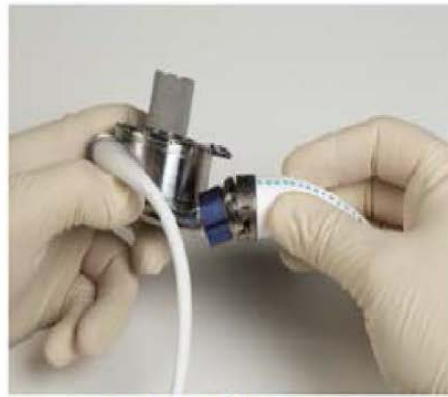
There may be no symptoms associated with an OGBR that is not fully and evenly connected; however, there is potential: (1) for kinking of the outflow graft leading to a low flow state that may result in heart failure symptoms and reoperation; or (2) for mechanical wear and tear of the outflow graft leading to intra-pericardial bleeding potentially causing hemodynamic compromise that may require emergency surgery.

Incorrect: Not Fully Connected

- For patients already implanted with the HM3 LVAS, please review a current x-ray to ensure the OGBR is fully and evenly secured to the outflow graft. Where images of the outflow graft and bend relief are not available, please take images at the patient's next visit and review to ensure the OGBR is properly secured.

- For newly implanted patients, please take an x-ray one day post-implant and review it to ensure the OGBR is fully and evenly secured.

- If a disconnected OGBR is identified during x-ray review, physicians should determine patient care recommendations based on each unique clinical case. Additionally, review with your Abbott clinical specialist to file a complaint through the normal complaint process.
