ADVIA Centaur®
ADVIA Centaur® XP

Potential Vacuum Leaks at the Glass Rod Sensor on the Waste Reservoir

This response form is to confirm receipt of the enclosed Siemens Healthcare Diagnostics Urgent Field Corrective Action CI-16-01.A.OUS dated November 2015 regarding Potential Vacuum Leaks at the Glass Rod Sensor on the Waste Reservoir. Please read each question and indicate the appropriate answer. Fax this completed form to Siemens Healthcare Diagnostics at the fax number provided at the bottom of this page.

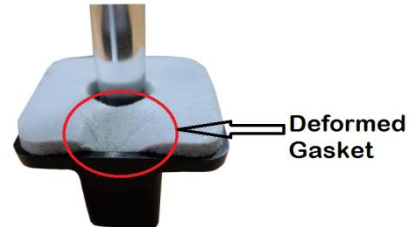
A potential vacuum leak may occur around the Glass Rod Sensor in the Waste Reservoir, caused by the gasket on the housing of the Glass Rod Sensor sliding out of position.

- If your system stops running due to a low vacuum error - Error code 600 13 24, verify that the gasket under the Glass Rod Sensor housing on the Waste Reservoir is positioned properly.

The illustrations below shows the bottom view of the gasket properly seated and not properly seated.

View of Gasket Properly Seated

View of Gasket Not Properly Seated

1. If the gasket is positioned correctly, please follow the troubleshooting steps outlined in the On-line Help on the system for - Error code 600 13 24 - to troubleshoot other possible causes of Vacuum Low Errors.
 2. If the gasket is not positioned correctly, call your Siemens Technical support center to schedule a replacement.
- Service engineers will inspect the Glass Rod Sensor on the next service visit and replace the Glass Rod Sensor if necessary.
 - Complete and return the Field Correction Effectiveness Check attached to this letter within 30 days.
