URGENT - Field Safety Notice
SENSE Body Coil 1.5T used with ACS NT, Intera 1.5T and Achieva 1.5T MR Systems

Elevated temperature of the SENSE Body Coil 1.5T cables.

Field Safety Notice

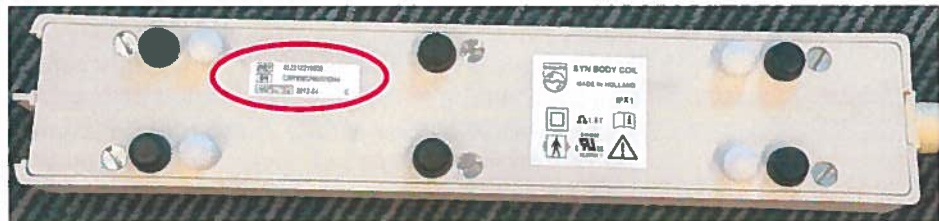
The identification number (12nc) can be found on the coil interface/driver box as indicated in below example. The 12nc is listed behind 'REF':
