MEDICAL DEVICE CORRECTION

RE: Prismaflex Control Unit software upgrade

November 19, 2019

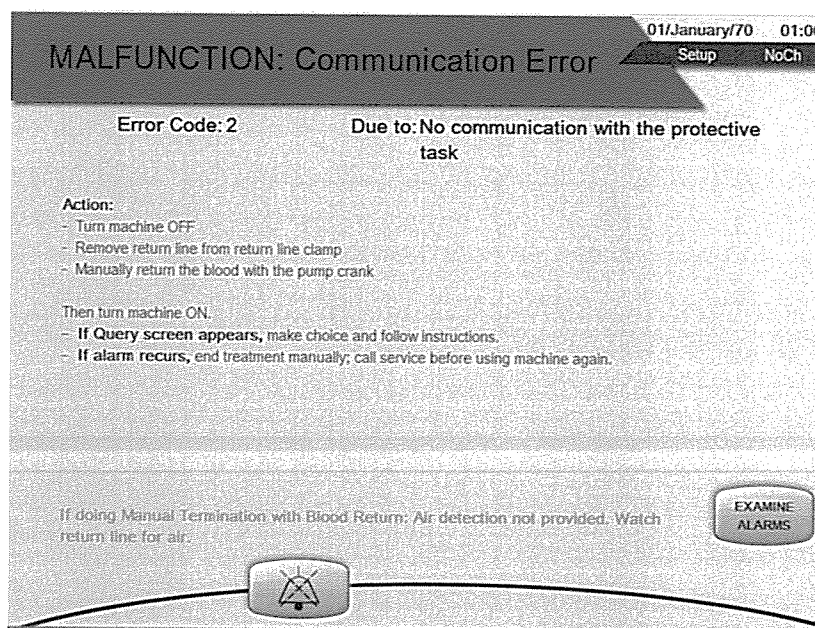
The following actions occur during a communication error alarm:

- The Prismaflex control unit enters a “safe state” by stopping all pumps and closing the return line clamp. Treatment is suspended. The patient’s blood does not circulate through the blood flow path.
- Red flashing light
- Recurring high-pitched sound of 10 sound pulses repeated approximately every 8 seconds until muted.
- Malfunction screen appears on the display as pictured below. The instructions to the user are the same for all error codes.

1. Operators may continue to safely use the Prismaflex control units until the upgrade is performed. If a communication error alarm does occur, follow the instructions presented on the graphical user interface and/or in the operator's manual. Please reinforce the importance to manually return the extracorporeal blood to the patient, and re-train users on this process, outlined on page 10:57 of the operator's manual, if necessary.
