Retention of Medical Device Fragments

Examples of recent FSCAs addressing medical device fragmentation and retention

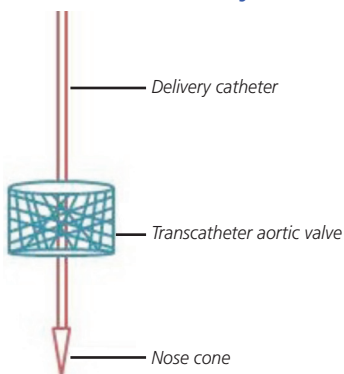
Case #1: FSCA for Medtronic CoreValve AccuTrak Delivery Catheter System (DCS)

Schematic diagram of a transcatheter aortic valve and delivery catheter

Medtronic had initiated this IFU update, as it had received 38 global reports of the DCS nose cone separating from the catheter, potentially remaining in patients and leading to risks such as embolism and additional surgical interventions to retrieve the nose cone. There have been no local complaints or incidents of AEs related to this issue.

Based on their investigations, Medtronic had attributed most of the incidents of nose cone separation to the way the device was used. In some incidents, the device was used in ways cautioned against in the IFU. As such, Medtronic initiated the IFU update to reinforce that (1) the guidewire should not be removed from the catheter while the catheter is inserted in the patient, (2) the retrieval or removal of the Aortic Valve bioprosthesis from the patient is not recommended once deployment is initiated, (3) the capsule should be closed before removal of the DCS, and (4) the DCS should not be manipulated forcefully during removal from the introducer sheath when resistance is encountered.

The relevant physicians using this device locally were informed of this safety issue by Medtronic via a Dear Healthcare Professional Letter (DHCPL)² issued in December 2013.

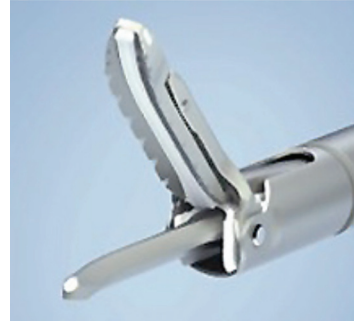
Case #2: FSCA for Olympus ThunderBeat Series of Hand Instruments

Olympus Thunderbeat Hand Instrument's probe tip and PTFE pad

Olympus had initiated this label and IFU update, as it had received from the US and Canada, 35 reports of breakage of the probe tips. These may result in device fragments falling into and being retained in the patient's body cavity. In Singapore, one event of probe tip breakage and four events of separation of the PTFE (also known as Teflon) pads were reported to HSA. None of the events resulted in user or patient adverse effects.

Olympus had attributed such reports to the use of the device in a manner not in accordance to the IFU. As such, Olympus initiated the label and IFU update to reinforce that (1) users should not grasp metal or hard objects or tissue (e.g., bone or calcified tissue) with the probe tips, (2) there should not be body fluids present around the probe tips, (3) ultrasonic energy should not be activated when tissue is not present in the grasping section, (4) device should not be activated while grasping thick tissue or twisting the device shaft, and (5) sharp devices (e.g., scalpels) should not be used to clean the grasping section of probe tips.

All affected healthcare facilities were informed of this safety issue and the IFU and label update, through the dissemination of a field safety notice in December 2013.
