## **URGENT: MEDICAL DEVICE CORRECTION**

### **Software Distribution Network & Associated Programmers**

<b>Product Name</b>	<b>Model Number</b>
CareLink™ 2090 Programmer	2090; All Serial Numbers
CareLink Encore™ 29901 Programmer	29901; All Serial Numbers

10 October 2018

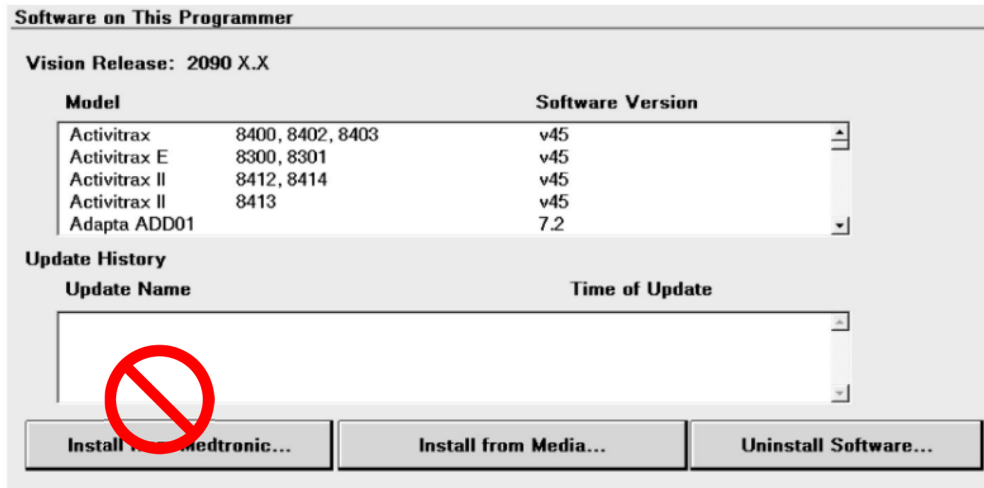
## Appendix A: Programmer Software Screen

**Do not attempt to update the programmer via the SDN.** If you select the "Install from Medtronic" button, it will result in an unsuccessful installation of software because access to the external SDN is no longer available.

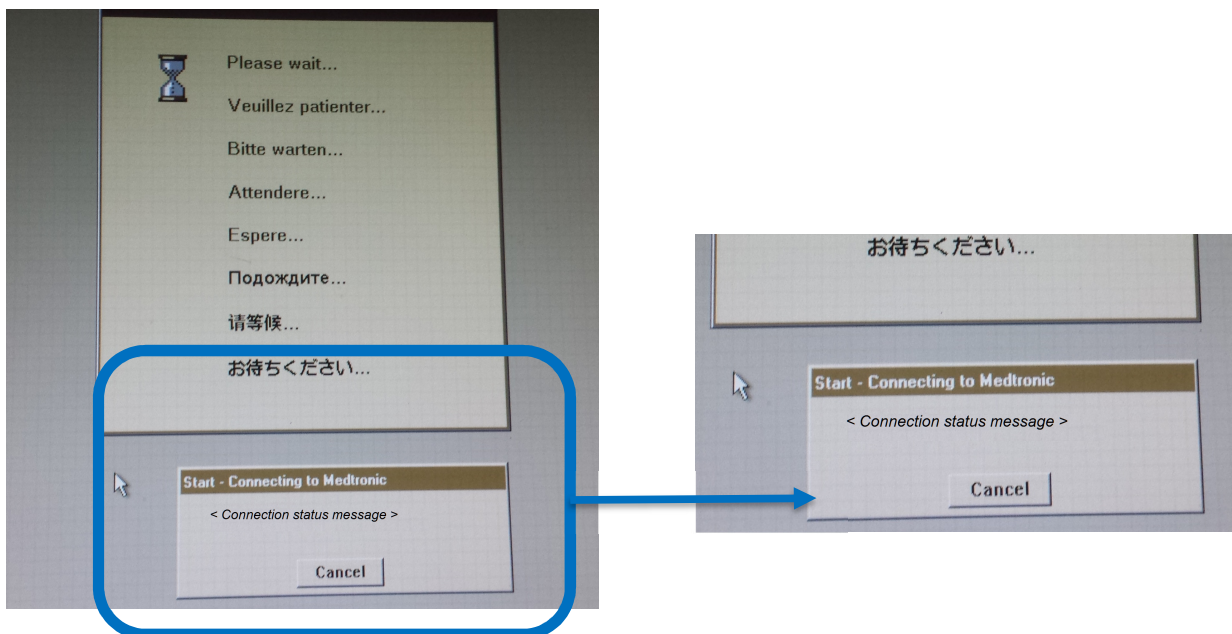
Several messages may be observed if installation of software from the SDN is attempted (e.g. "Install from Medtronic..."). See images below for example as to what will appear on the programmer display during the installation attempt. Below the larger "Please Wait" message will be a smaller window with a <connection status message> displayed; refer to highlighted area below. The connection status messages may alternate *between* "Connecting...", "Searching for Network...", "Logging in...", "Unable to connect to local network", and "Unable to connect to Medtronic". Since the SDN is no longer available, **the user should select "Cancel" to terminate the installation attempt.**

If the user cycles power on the programmer without first cancelling the installation attempt, upon power-up a count-down window will appear on the screen for approximately 30 seconds with "Yes" and "No" buttons. The user should select "No" to terminate the installation attempt and return to the Model Select screen. If the user selects "Yes" or does not respond prior to the 30-second time out, the programmer will attempt the installation again, and the process described above will repeat until the user either selects "Cancel" or selects "No" during the count-down window.
