April 2017

## **Battery Performance of the Model 8637 SynchroMed® II Implantable Drug Infusion Pump**

**Update to 2011 Notification, for Pumps Manufactured through June 2011**

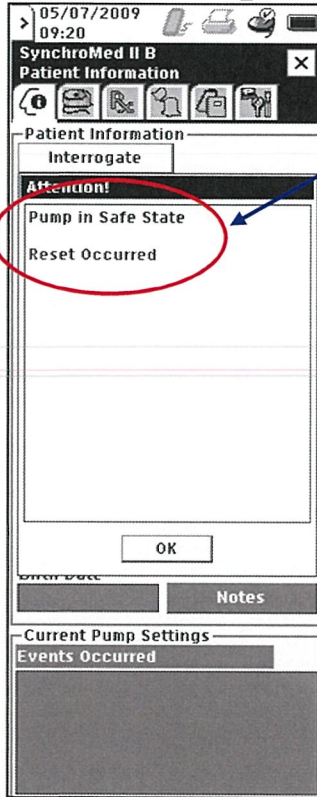
#### [Attention Dialog Box]

#### 8840 Dialog Box –

Notification for reset to safe state

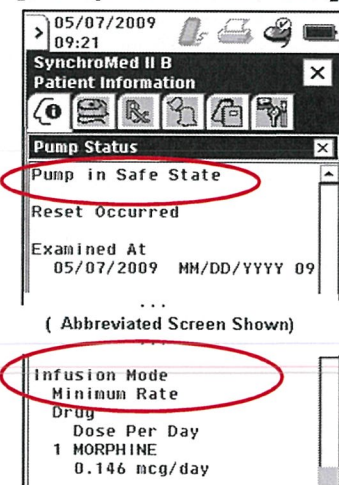
#### [Pump Status Screen]

#### 8840 Pump Status –

Shows pump in safe state, and Infusion mode at “Minimum Rate”

Safe state does not mean a clinically safe rate of infusion. The minimum rate mode in effect during a pump safe state is non-therapeutic and can result in loss of drug effect and/or drug withdrawal.

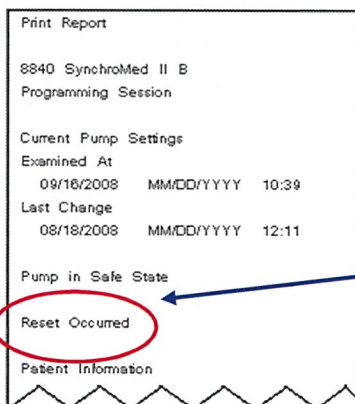
#### [Print Report]

**Print Report --**  
 Shows “Reset Occurred”

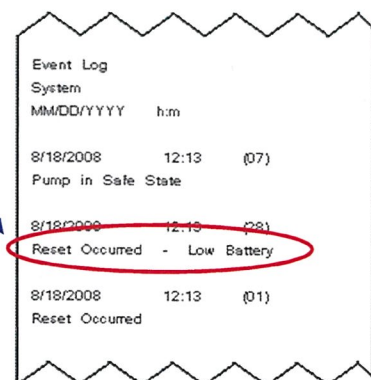
#### [Event Log]

**Event Log --**  
 Specifies it was a Low Battery Reset

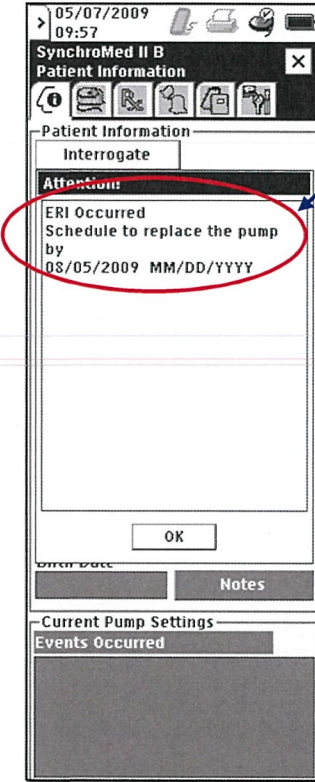
[Attention Dialog Box]

8840 Dialog Box –

Notification of ERI with calculated 90 day replacement date

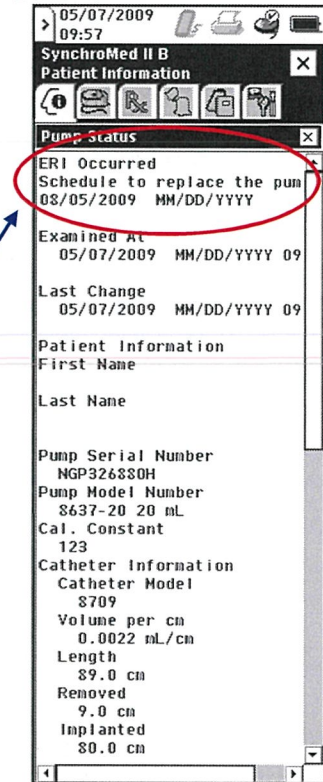
[Pump Status Screen]

8840 Pump Status –

Shows ERI Occurred, and calculated 90 day window to EOS

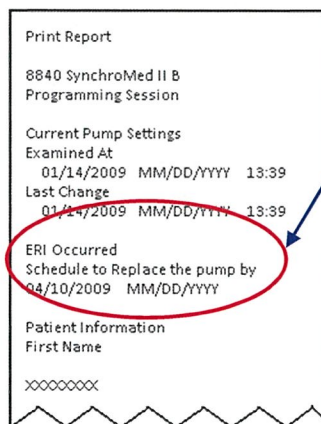
[Print Report]

Print Report --

Shows ERI Occurred, and calculated 90 day window to EOS

The minimum timeframe of 90 days between ERI and EOS may be reduced in an affected pump; therefore the scheduled replacement date displayed on the *Print Report* may not be accurate.

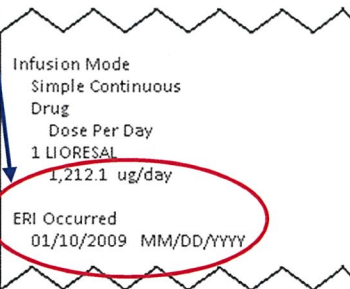
[Event Log]

Event Log -- Specifies ERI Occurred

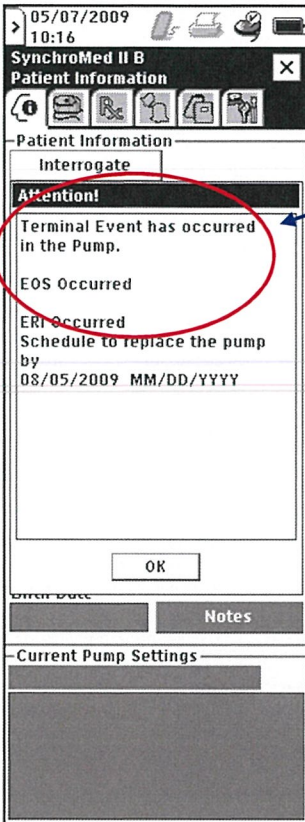
#### [Attention Dialog Box]

**8840 Dialog Box –**  
 Notification for *Terminal Event* and *EOS Occurred*

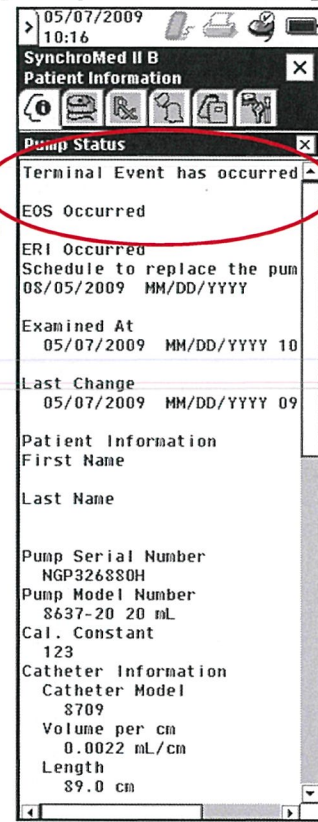
#### [Pump Status Screen]

**8840 Pump Status –**  
 Notification for *Terminal Event* and *EOS Occurred*

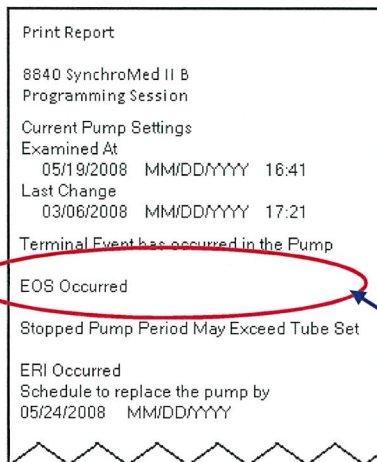
#### [Print Report]

**Print Report --**  
 Shows EOS Occurred

At EOS, the pump stops infusing drug. This will result in loss of drug effect and/or potentially drug withdrawal. Telemetry is available until the pump battery is depleted.

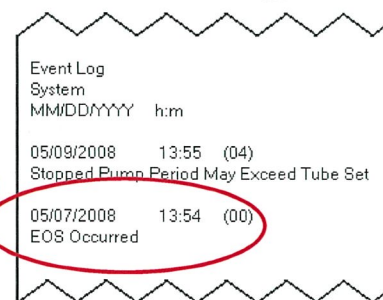
#### [Event Log]

**Event Log --**  
 Shows Date that the EOS event was triggered
