Field Safety Notice

Battery packs for deltastream MDC console and iLA active console

Manufacturer: MEDOS Medizintechnik AG
Obere Steinfurt 8-10
52222 Stolberg
Germany

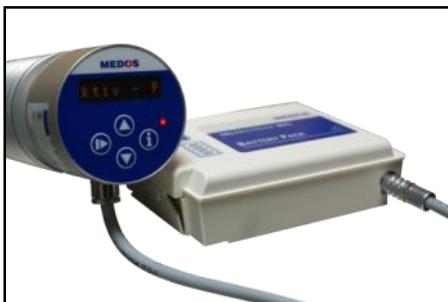
Picture 1:

The backup drive directly connected to the battery.

- The backup drive has to be directly connected to the battery pack.

- Start the backup drive
- Adjust speed to 3000 rpm

The battery is functional when the backup drive is working properly and the set speed is reached.
