**To the customers and users of the  
emergency breathing devices  
Oxylog 3000 and Oxylog 3000 plus**

**Important safety information!!!**

**Oxylog 3000, Oxylog 3000 plus  
Failure of ventilation function with "Control knob faulty" error message**

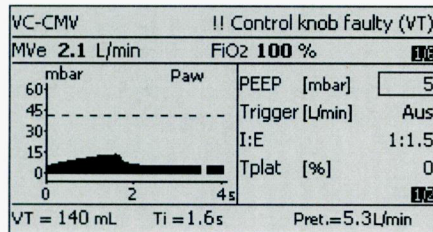
Our investigations indicate that the error condition is caused by an oxide layer in the potentiometer. These oxide layers may accumulate over a longer period of time if various factor collude i.e. if the knobs are moved rarely or never. A verified remedy is repeated twisting of the knobs that removes the oxide layer. This recommendation was described in the previous Safety Notice.

Whenever a “Control knob faulty” condition will occur with a device being equipped **with the new software the device will continue to ventilate with the last valid settings**, display for example the values for tidal volume in case of a defective potentiometer for VT and post the corresponding alarm (see Picture below)

Software version 1.06 will now be introduced for Oxylog 3000plus, version 1.23 for Oxylog 3000, respectively.

**As reflected in the amended IfU you are advised to check patient's condition and the ventilation.**
