Dako reference number: CAPA00475

Urgent Medical Device Field Safety Notice

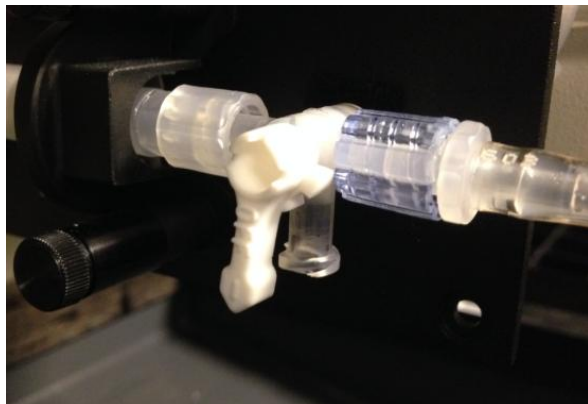
Dako has determined that a defect in the stopcock component of the syringe assembly (see figure 1) in some Autostainer instruments may, under some circumstances, cause leakage of excess buffer onto slide position 35 and 36 (for AS480 slide position 34) due to the stopcock's standby location over these position(s).

- When staining using the HercepTest™ protocols, excess leakage from the syringe assembly may dilute the antibody and reduce IHC staining quality and potentially affect the score.
- If the compromised HercepTest™ staining is not detected by the operator or pathologist, it could potentially be misinterpreted as a negative test result, which could contribute to an incorrect diagnosis. Positive test results will not be affected by this defect.

Figure 1. Picture of stopcock spare part to Autostainer

- Discontinue the use of HercepTest™ on the affected slide position(s).
- As set forth in Dako's staining protocol, use on-slide positive controls.
- Watch for any indication of buffer leakage from the syringe assembly. This can be done easily when the tubes are checked for air bubbles in connection with exchange of the buffer bottle.
- Check for weak staining in regards to HercepTest™ in the affected slide position(s). As advised in the IFU for HercepTest™ please contact Dako Technical Support Department to report unusual staining.

Dako has identified a longer term corrective action to install a drip tray under the stopcock. Your local Dako representative will contact you when the drip tray is available.
