URGENT - Field Safety Notice
FCO72200279

Allura systems. Actuator Monitor Ceiling Suspension (MCS)

Monitor suspension failure

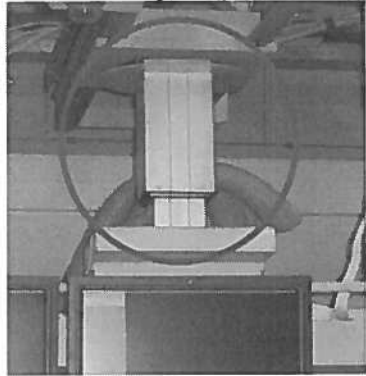
<p>PROBLEM DESCRIPTION</p>	<p>A call was registered at our service department with respect to an issue with a failing Monitor Ceiling Suspension (MCS) Actuator of an Allura Xper system. The actuator assembly had become detached and the monitor carriage with a flexvision monitor dropped to its lowest position. The Monitor Ceiling Suspension is designed to allow flexible positioning near the patient table when in use, and away from the patient when not in use. (park position)</p>

<p>HAZARD INVOLVED</p>	<p>When the Monitor Ceiling Suspension falls to its lowest position there is a possibility it might collide with patient or personnel in the room. There is also the possibility that the monitor ceiling suspension collides with other equipment in close proximity of the MCS.</p>
<p>HOW TO IDENTIFY AFFECTED PRODUCTS</p>	<p>All Allura Systems as mentioned above. The potential affected systems will be clearly identified by the local Philips Organization.</p>

<p>ACTION TO BE TAKEN BY CUSTOMER / USER</p>	<p>In order to avoid any risk for patients, users or bystanders we recommend the following until the containment action FCO has been implemented. We recommend that you do not:</p> <ul style="list-style-type: none"> - Position or move the Monitor Ceiling Suspension above the patient. - Allow staff to stand under or close to the Monitor Ceiling Suspension. <p>Additionally avoid any unnecessary movement of the Monitor Ceiling Suspension and inform all possible System users.</p>
<p>ACTIONS PLANNED BY PHILIPS</p>	<p>Two mandatory Field Safety Corrective Actions will be issued. Mandatory FCO72200279 as a containment action and will be free of charge. This FCO involves a check if the actuator serial number is on the affected product list. If the actuator is on the affected product list the containment action is to secure the MCS with straps to prevent the monitors to fall down in case the actuator fails. The expected date of this FCO will be June 2015. Actuators on the affected product list will be replaced with Mandatory FCO72200280 (corrective action)</p>
