Urgent: Medical Device Correction

Update to Model 8870 Software Application Card used in the 8840 N'Vision® Clinician Programmer and SynchroMed® II Infusion System Labeling for Priming Bolus

November 2016

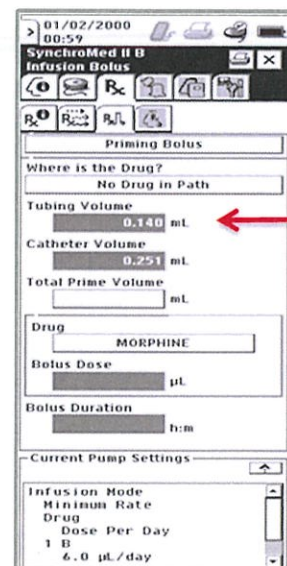
The software update will change the value displayed on the 8840 programmer for the SynchroMed II pump tubing volume from 0.199 mL to **0.140 mL** (see picture). The tubing volume is used to calculate the total volume of a full system priming bolus. This volume change does not alter the procedural steps or the other calculations required to program a priming bolus.

New tubing volume value of **0.140 mL**, replaces previous value of 0.199 mL

- Continue to use the current software card and its displayed tubing volume until your Medtronic Representative has exchanged the current card with the new software card (new version is BBU01).
