**FIELD SAFETY CORRECTIVE ACTION FSCA # 2018-04
MANDATORY HARDWARE UPDATE - PLEX ELITE 9000**

The purpose of this letter is to advise you that Carl Zeiss Meditec, Inc. (CZMI) is voluntarily performing a Field Safety Corrective Action on the PLEX® Elite 9000. This action involves a mandatory hardware update that applies to all PLEX Elite 9000 devices.

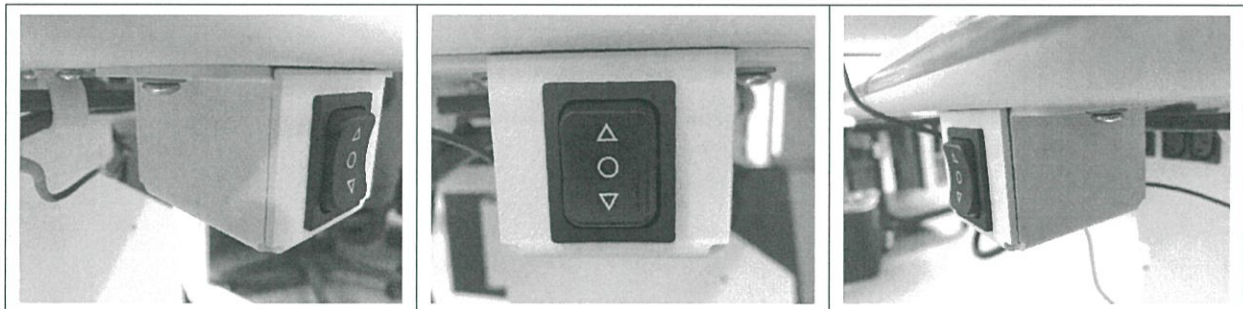
PLEX ELITE 9000 POWER TABLE UP/DOWN SWITCH: Under certain fault conditions, the existing design may expose the operator to a hazardous voltage when contacting the metal enclosure (including mounting screws) around the PLEX Elite 9000 Power Table Up/Down switch. Refer to Figure 1. A hazardous voltage from an electrical short circuit could occur as a result of damaged insulation on one of the wires inside the enclosure for the Power Table Up/Down switch.

Figure 1. PLEX Elite 9000 Power Table Up/Down Switch. Avoid any contact with the metal enclosure (including mounting screws) surrounding the black plastic Up/Down switch.

To correct the issue, our service staff will contact you to schedule a Field Service Engineer to perform a mandatory hardware update for your PLEX Elite 9000, s/n: XXX

- When adjusting the height of the Power Table, touch only the black plastic portion of the Up/Down switch. Avoid any contact with the entire metal enclosure (including mounting screws) surrounding the black plastic Up/Down switch. **Refer to Figure 1.**
