## Shimano (Singapore) Pte. Ltd. Recalls Cranksets for Bicycles Due to Crash Hazard

Shimano has launched a voluntary inspection and replacement program for some bonded 11-speed HOLLOWTECH II road cranksets produced before July 2019 for a possible bonding separation issue, posing a crash hazard to consumers.

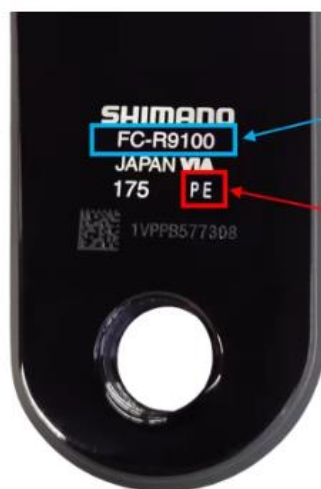
This recall involves models Ultegra FC-6800, Dura-Ace FC-9000, Ultegra FC-R8000, Dura-Ace FC-R9100 and FC-R9100P 11-Speed Bonded Hollowtech Road Cranksets manufactured prior to July 2019 sold individually and on bicycles sold by other manufacturers such as Trek and Specialized. A crankset is the component of the bicycle that the chain and pedals attach to for pedalling. The model numbers are stamped on the inside of the crank arm near the bottom of the arm. The affected models are pre-July 2019 production and have the following two-letter production code on the crank arm where the pedals are attached (red box on the image below): KF, KG, KH, KI, KJ, KK, KL, LA, LB, LC, LD, LE, LF, LG, LH, LI, LJ, LK, LL, MA, MB, MC, MD, ME, MF, MG, MH, MI, MJ, MK, ML, NA, NB, NC, ND, NE, NF, NG, NH, NI, NJ, NK, NL, OA, OB, OC, OD, OE, OF, OG, OH, OI, OJ, OK, OL, PA, PB, PC, PD, PE, PF, PG, PH, PI, PJ, PK, PL, QA, QB, QC, QD, QE, QF, QG, QH, QI, QJ, QK, QL, RA, RB, RC, RD, RE, and RF.

Model Number

Production Code

Consumers who owned the affected models of cranksets should immediately stop using them, and contact Shimano at +65 98305212 to schedule a free crankset inspection. Consumers whose cranksets show signs of bonding separation or delamination during the inspection will be provided a free replacement crankset and installation.
