Lift and Escalator Safety: Key Audit Findings and Case Studies (Oct 23 – Sep 24)

Electrical and Mechanical Engineering Group -
Investigation and Enforcement Department

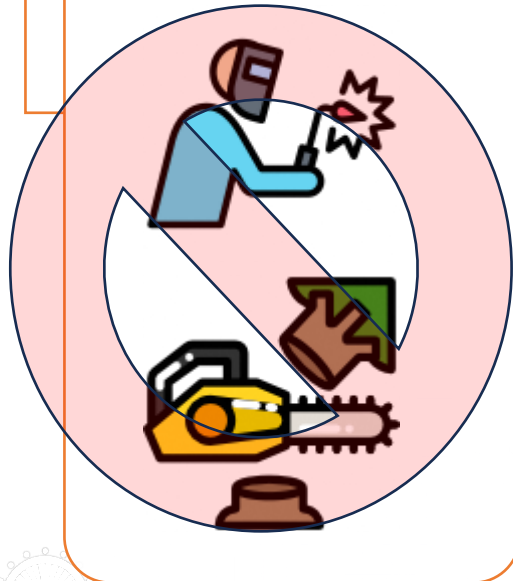
Cutting or welding are not proper ways to replace bearings. These methods can damage the shaft and make it unsafe.

1. Always use proper tools for bearing removal and installation.
2. Do not chisel or hit the shaft with hard objects, as this can cause dents and surface damage to the shaft.
3. No welding repair on the shaft.
4. Before deviating from SOPs, consult with the manufacturer or a certified expert.
5. Regular training, supervision are essential.

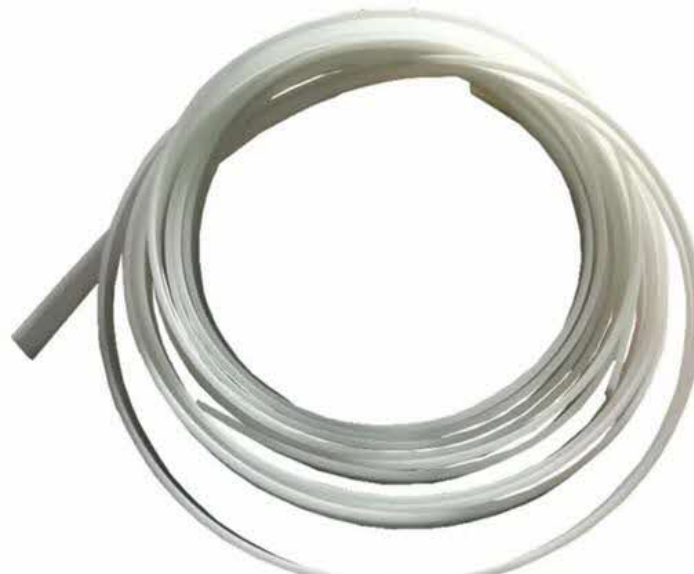
Case Study ② - Handrail Insert

- The handrail guide insert sits between the stationary guide rail and the moving handrail, reducing friction between them. It's clipped to the handrail guide with/ without a holding bracket at one end.
- Due to frequent movement causing wear and tear, the insert may occasionally fall into the escalator system, potentially causing jams or creating sharp edges on the handrail.
