# Guidelines on Periodic Facade Inspection

Version 1.3

Sep 2026

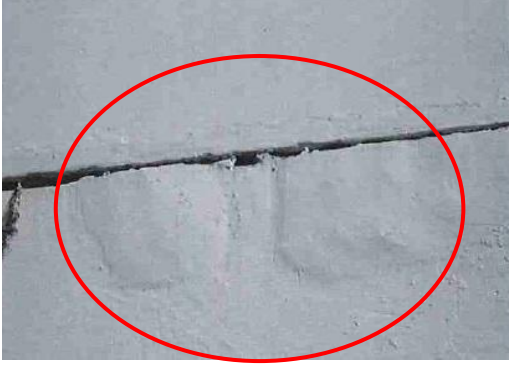
| <p>Bulging plaster<br/>[Source: BCA file]</p> | <p>Spalling concrete<br/>[Source: BCA file]</p> |

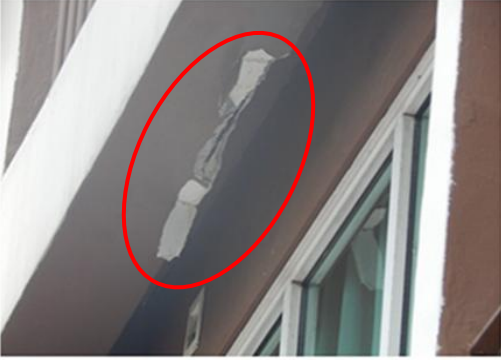
| <p>Spalling concrete<br/>[Source: BCA file]</p> | <p>Loose wall tiles<br/>[Source: BCA file]</p> |

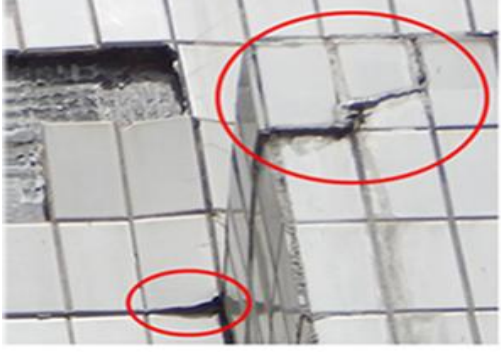
| <p>Cracked wall tiles<br/>[Source: BCA file]</p> | <p>Loose wall tiles<br/>[Source: BCA file]</p> |

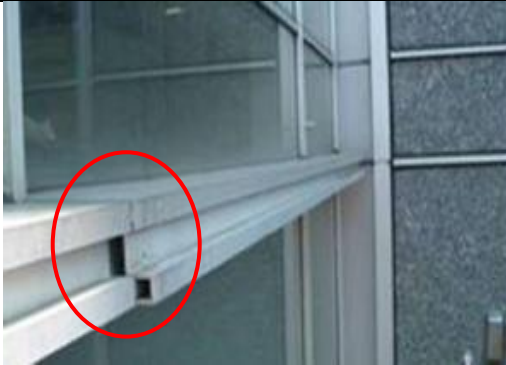
| <p>Misaligned transom<br/>[Source: BCA file]</p> | <p>Broken glass infill panel<br/>[Source: BCA file]</p> |

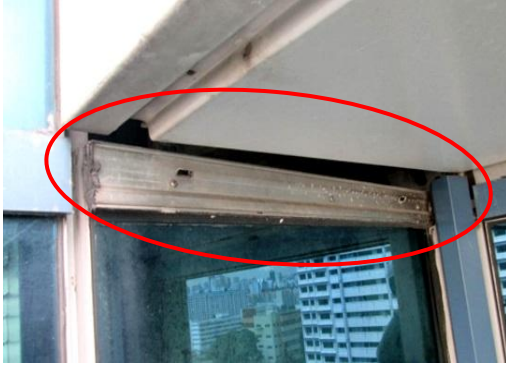
| <p>Detached aluminium capping<br/>[Source: local consultant]</p> | <p>Corroded floor bracket of curtain wall<br/>[Source: <a href="http://www.building-enclosure.com/building-enclosure-commissioning/">www.building-enclosure.com/building-enclosure-commissioning/</a>]</p> |

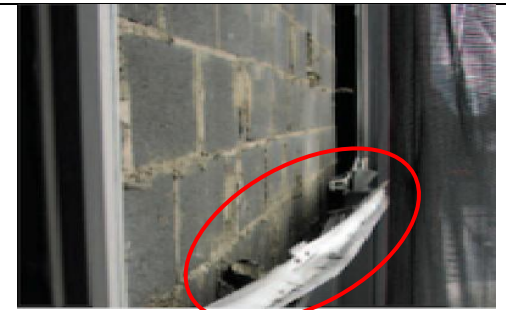
| <p>Dislodged frame joints<br/>[Source: <a href="http://www.bdcnetwork.com/">www.bdcnetwork.com/</a>]</p> | <p>Dislodged panel<br/>[Source: BCA file]</p> |

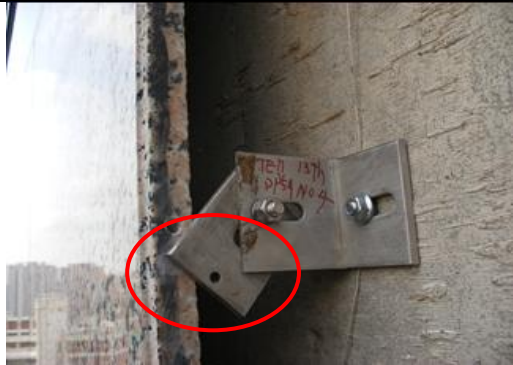
| Missing pin in stone cladding connection<br>[Source: BCAA course notes] | Corroded bracket in cladding system<br>[Source: BCAA course notes] |

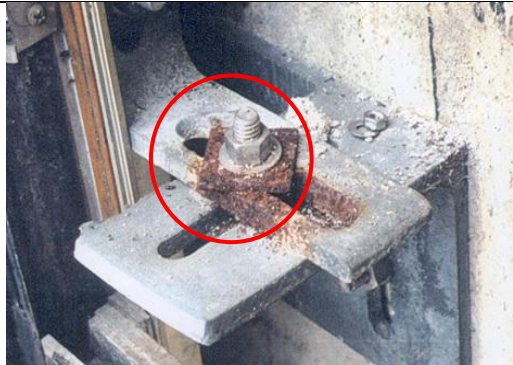
| Corroded bracket in cladding system<br>[Source: BCAA course notes] | Deformed or warped of cladding panels<br>[Source: BCAA course notes] |

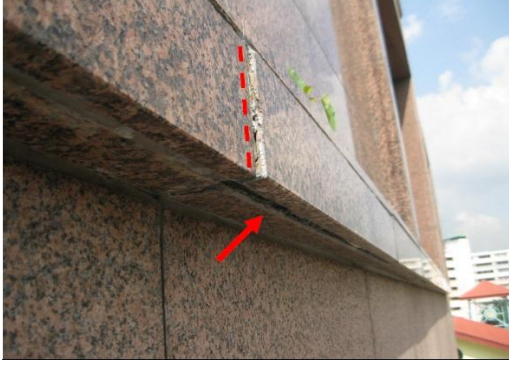
| <p>Dislodged / loose stone cladding<br/>[Source: BCAA course notes]</p> | <p>Cracked stone cladding panel<br/>[Source: BCAA course notes]</p> |

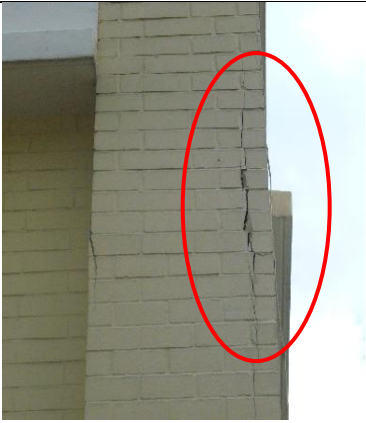
| <p>Cracked and de-bonded brick cladding<br/>[Source: BCA file]</p> | <p>Bulging brick cladding<br/>[Source: BCA file]</p> |

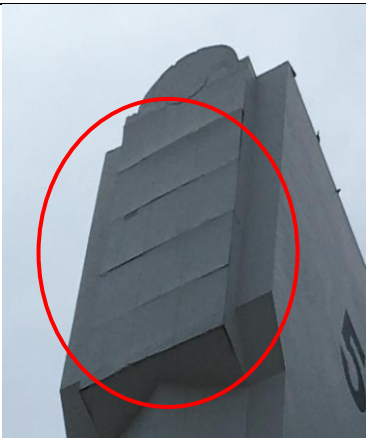
| <p>Bulging board cladding<br/>[Source: BCA file]</p> | <p>Fallen building board<br/>[Source: BCA file]</p> |

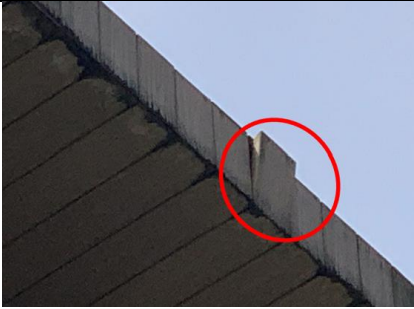
| <p>Warping timber cladding<br/>[Source: BCA file]</p> | <p>Loose timber ceiling<br/>[Source: BCA file]</p> |

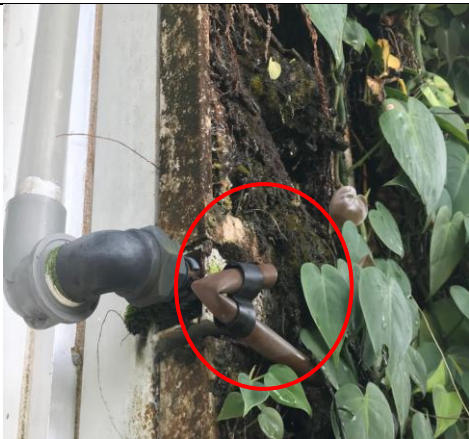
| <p>Corroded Element<br/>[Source: BCA file]</p> | <p>Rusty connection on screen wall<br/>[Source: BCA file]</p> |

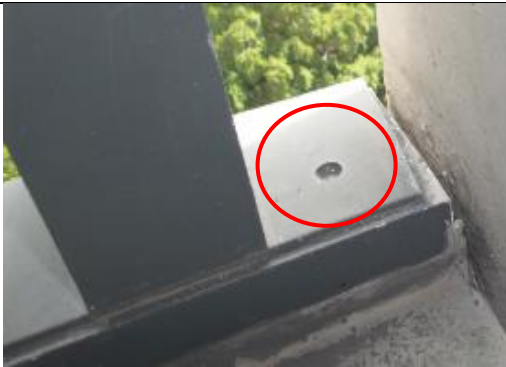
| <p>Missing connection on screen wall<br/>[Source: BCA file]</p> | <p>Loose connection between screen wall and support<br/>[Source: BCA file]</p> |

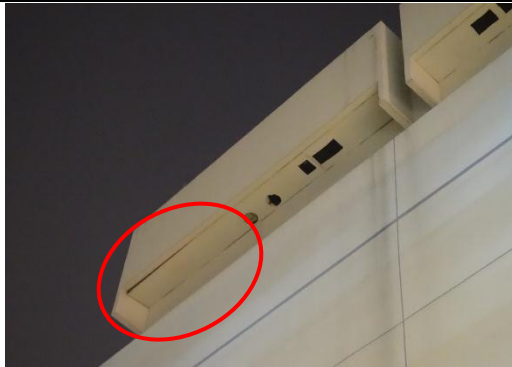
| Loose ceiling boards<br>[Source: BCA file] | Water stain on ceiling boards<br>[Source: BCA file] |

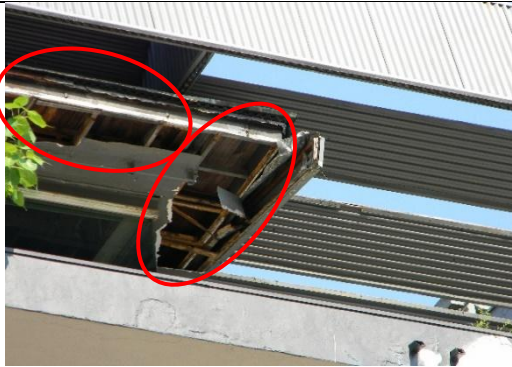
| Degraded and dangling external ceiling panels<br>[Source: BCA file] | Dangling board<br>[Source: BCA file] |

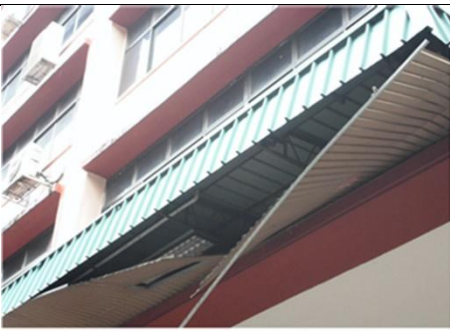
| <p>Dangling metal false ceiling<br/>[Source: BCA file]</p> | <p>Moulding on external ceiling board<br/>[Source: BCA file]</p> |

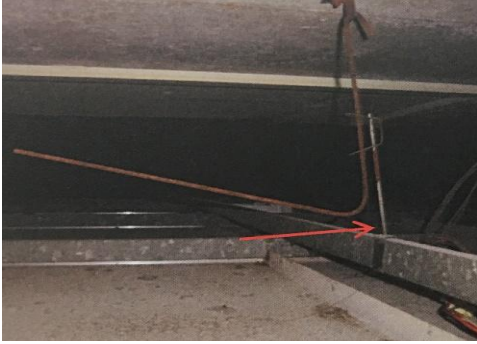
| <p>Corroded hanging rod supporting ceiling sub frame<br/>[Source: BCA file]</p> | <p>Broken hanging rod supporting ceiling sub frame<br/>[Source: local consultant]</p> |

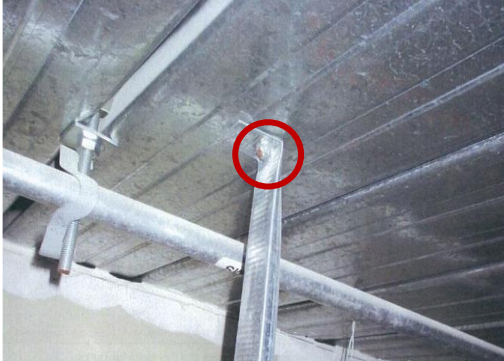
| <p>Corroded fixing<br/>[Source: BCA file]</p> | <p>Poor embedment of fixing<br/>[Source: local consultant]</p> |

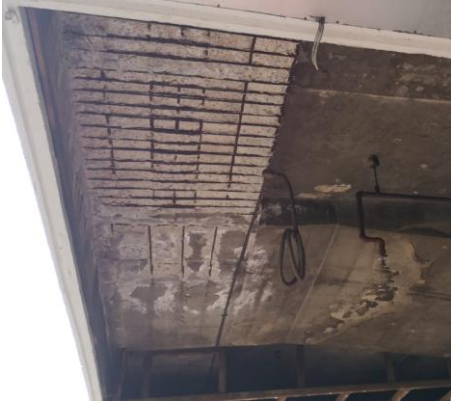
| <p>Spalling concrete substrate<br/>[Source: BCA file]</p> | <p>Fallen ceiling panel<br/>[Source: BCA file]</p> |

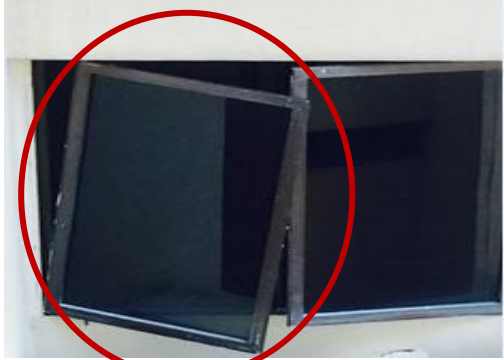
| <p>Dangling window<br/>[Source: BCA file]</p> | <p>Cracked window glass<br/>[Source: BCA file]</p> |

The Competent Person shall report to BCA any dangling windows spotted during the course of inspection.

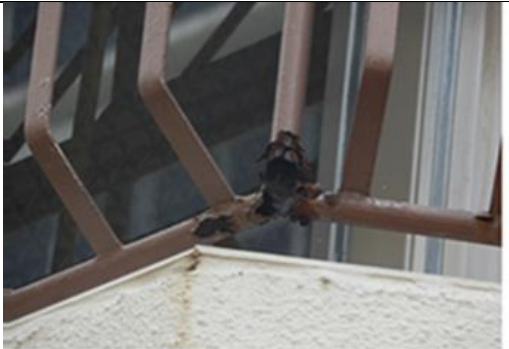
| <p>Corroded metal railing<br/>[Source: BCA file]</p> | <p>Damaged sealant<br/>[Source: BCA file]</p> |

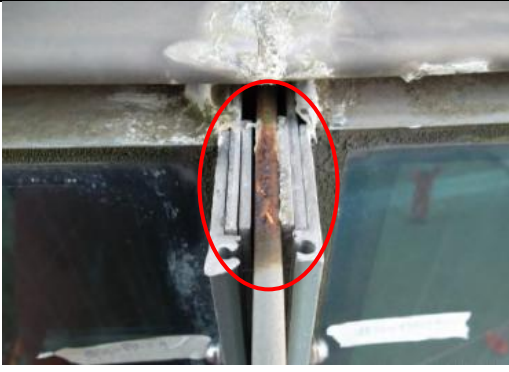
| <p>Corroded steel fin<br/>[Source: BCA file]</p> | <p>Corroded screws at louvres<br/>[Source: BCA file]</p> |

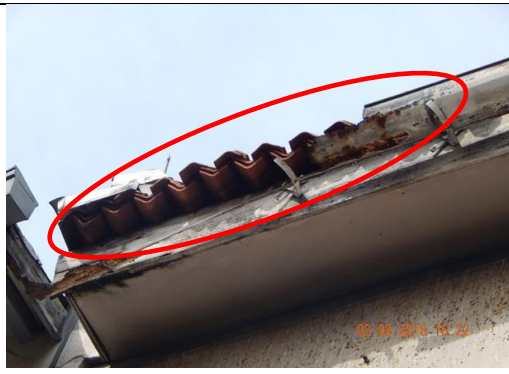
| <p>Corroded and missing gutter<br/>[Source: BCA file]</p> | <p>Dislodged timber board<br/>[Source: BCA file]</p> |

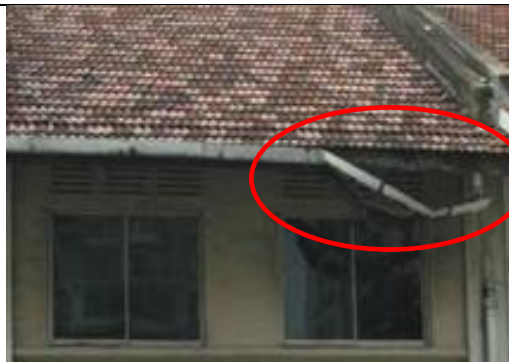
| <p>Dislodged gutter<br/>[Source: BCA file]</p> | <p>Dislodged fascia board and frame<br/>[Source: BCA file]</p> |

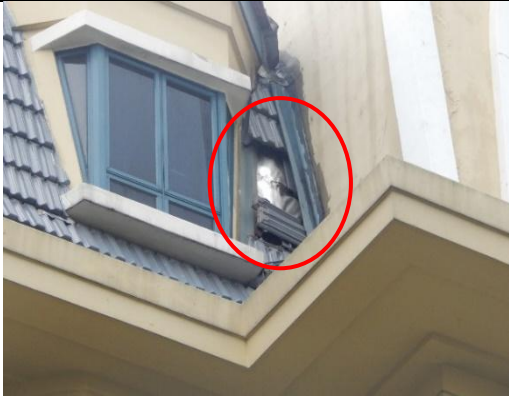
| <p>Fallen tiles<br/>[Source: BCA file]</p> | <p>Corroded and missing rainwater down-pipe<br/>[Source: BCA file]</p> |

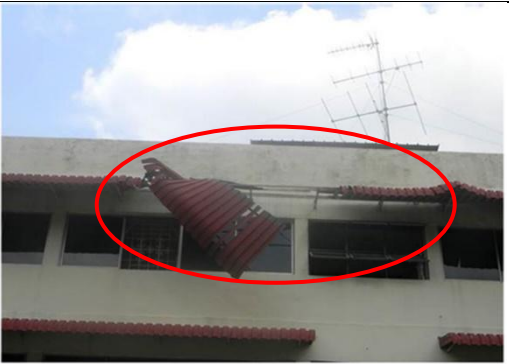
| <p>Detached awning<br/>[Source: BCA file]</p> | <p>Corroded sunshade support<br/>[Source: BCA file]</p> |

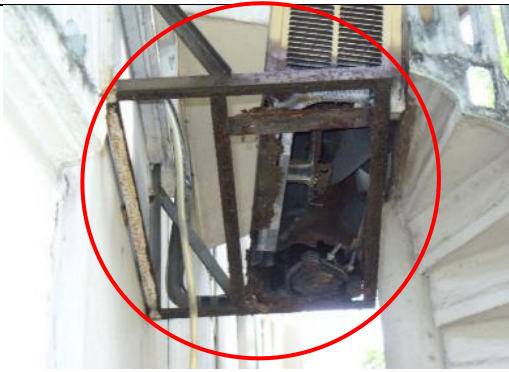
| <p>Corroded air-con bracket<br/>[Source: BCA file]</p> | <p>Corroded fixing<br/>[Source: <a href="http://www.daikin.com/anti-corrosion">www.daikin.com/anti-corrosion</a>]</p> |

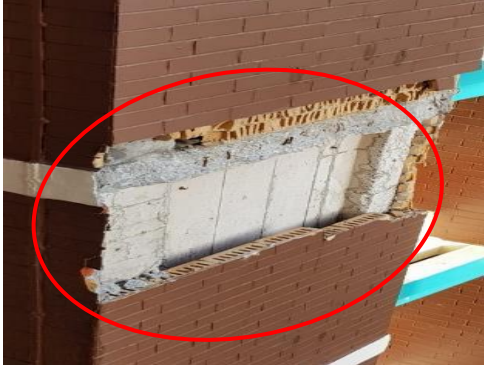
For Brick Wall Façade with inner and outer layer, it should be supported by a concrete nib at interval and steel ties to provide lateral stability. The common defects encountered are:

| <p><b>Vulnerable supporting structures for brick facades</b></p> <p>(1) The concrete nib: 150mm to 200mm thick.<br/>(2) The external face of the brick and concrete support is generally "flushed"</p> <p><small>Privileged/Confidential information may be contained in this presentation. Please do not circulate or reproduce without the permission of BCA.</small></p> | |
| <p>Figure showing support for brick facade<br/>[Source: BCA file]</p> | <p>Dislodged brick wall<br/>[Source: BCA file]</p> |

- a) The brick wall is not properly seated onto the concrete nib
- b) The concrete spalling of the nib
- c) Lateral steel ties corroded and lost their effectiveness
- d) Lateral steel ties are not space accordingly during construction

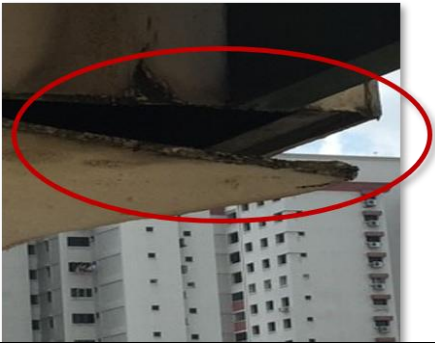
| <p>Lack of drainage for soffit panel<br/>[Source: BCA file]</p> | <p>Over drilled screws causing enlargement of drilled holes<br/>[Source: BCA file]</p> |
