BCA Seminar 2026

Managing travelator and escalator safety in Changi Airport

Darius Wee, Senior Manager

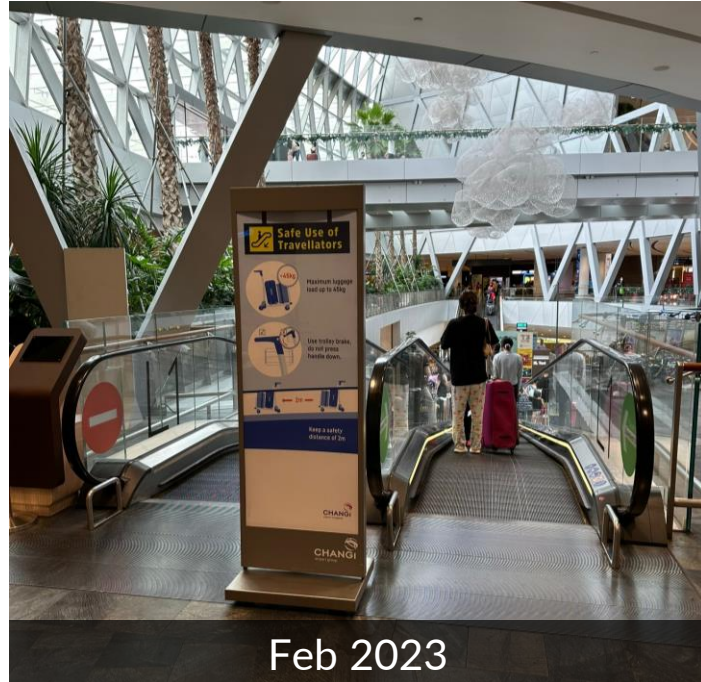
One-side signage, only provided at the entrance of travelator

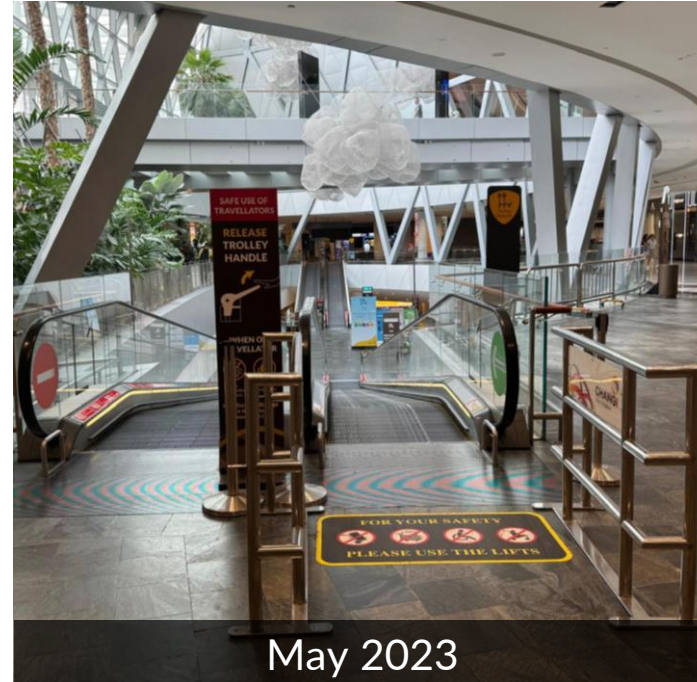
- Dual-side signage to provide visual guidance on usage of trolley
- Barricades to improve trolley alignment

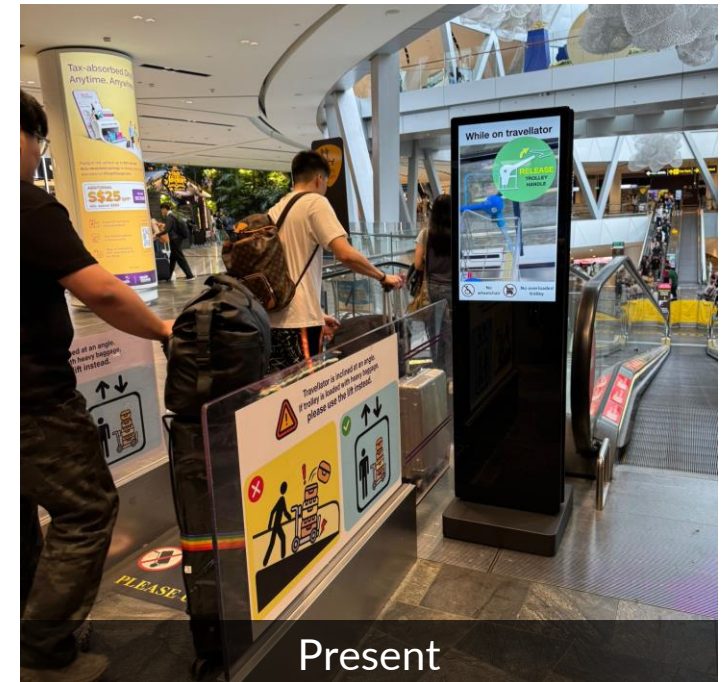
- Dual-side digital standee for language agnostic guidance on usage of trolley
- Improved barricades with advisory to inform the risk of overloaded trolley

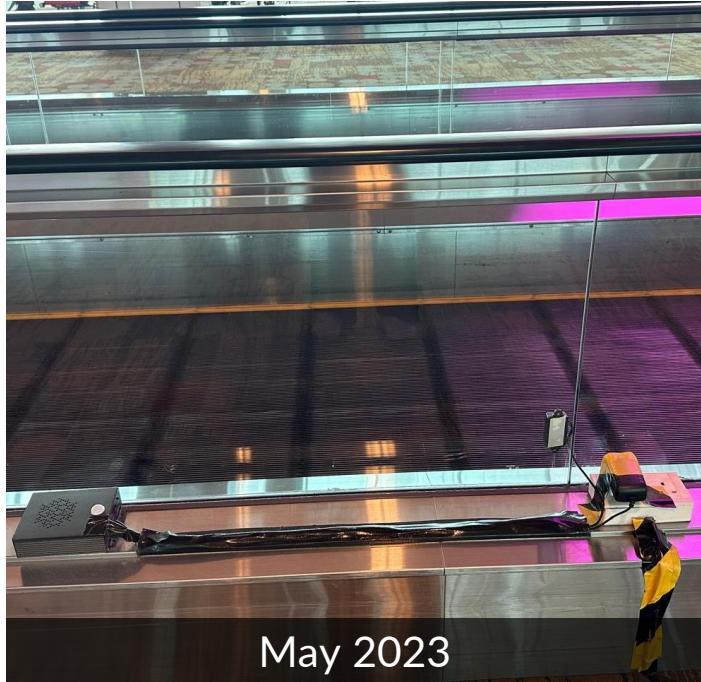
Using temporary power supply for trial

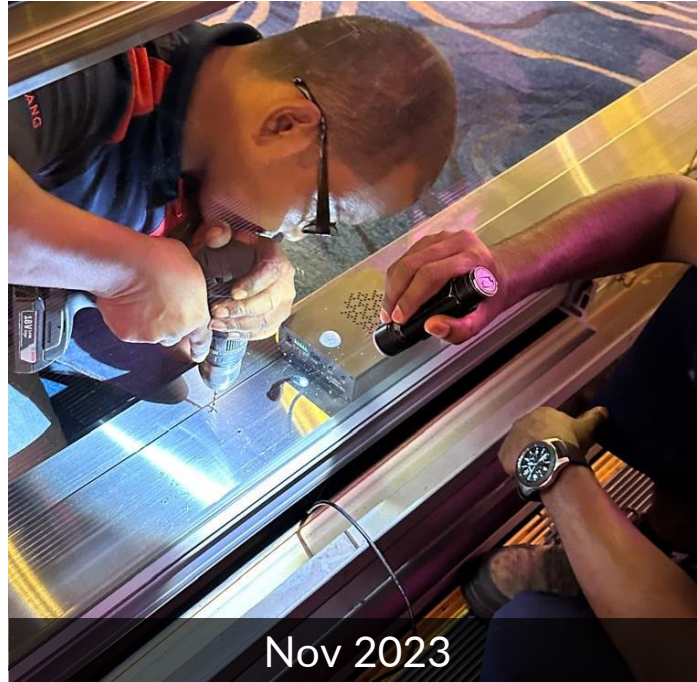
- Concealed cables within decking and
- Direct power source tapped from pit

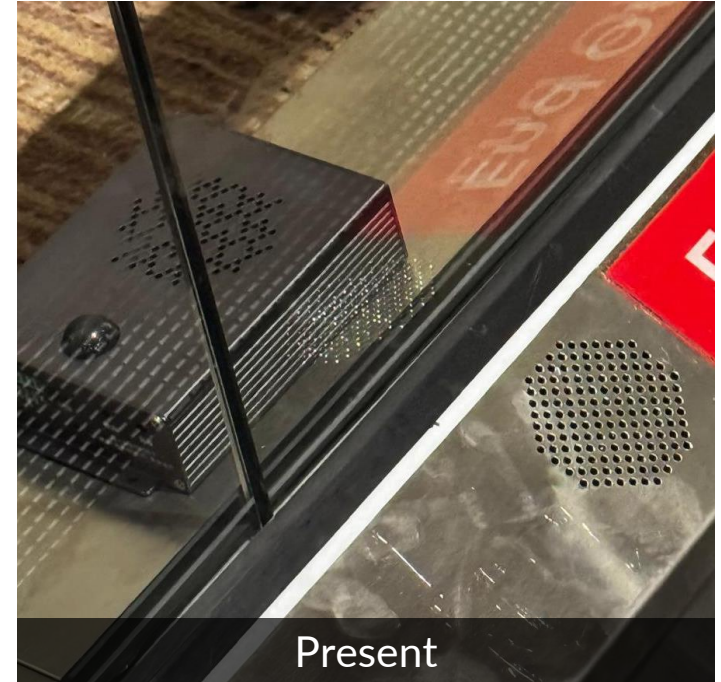
- Relocated speaker within decking and
- Modified decking to be perforated

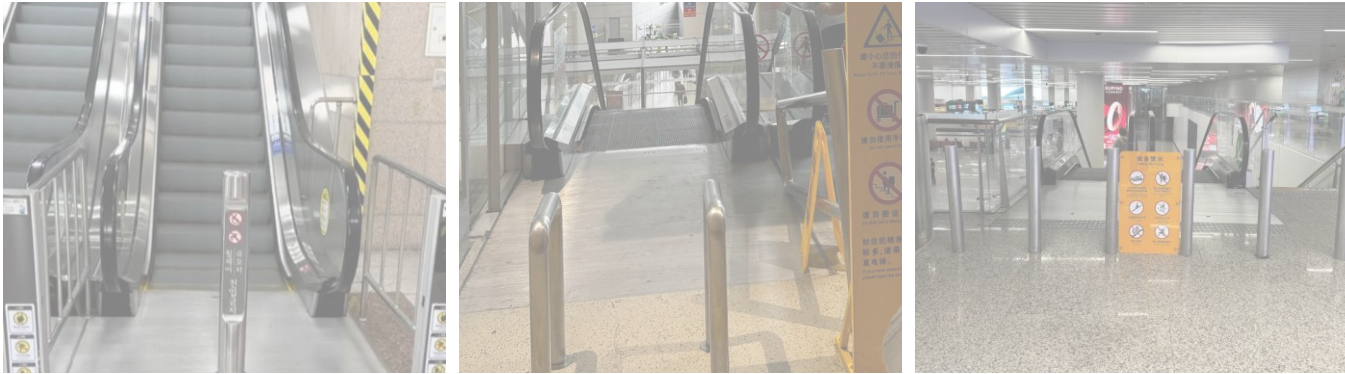
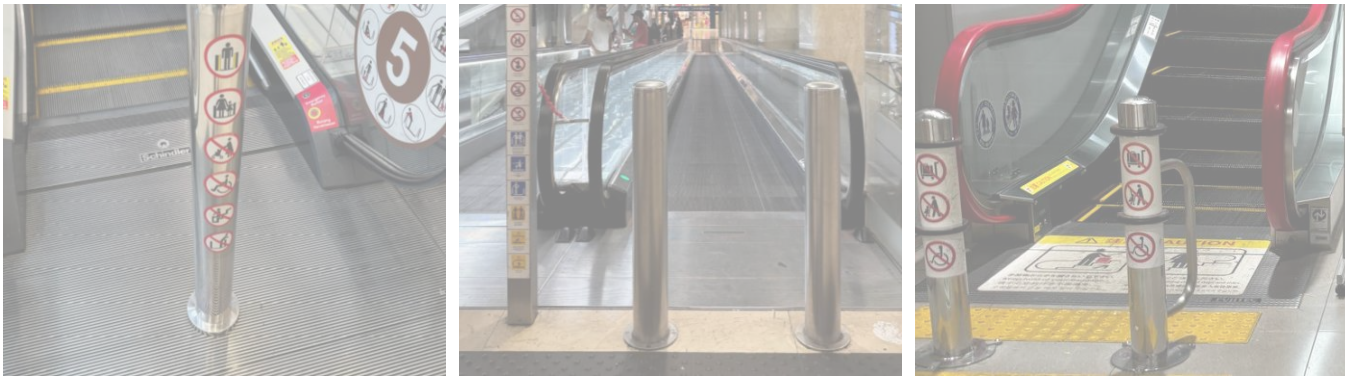
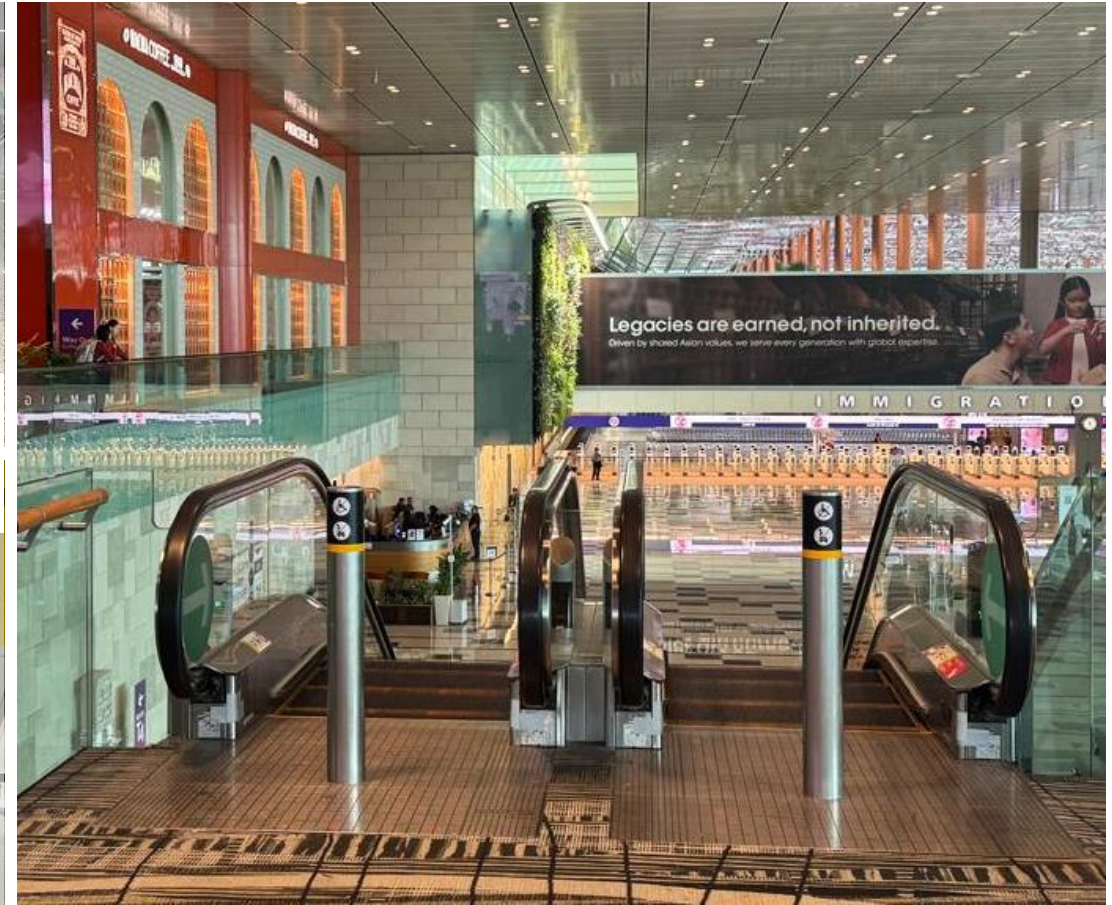
Best practices were adopted – targeted deployment of bollards

Bollards are commonly seen at escalators in airports, train stations, and commercial malls.

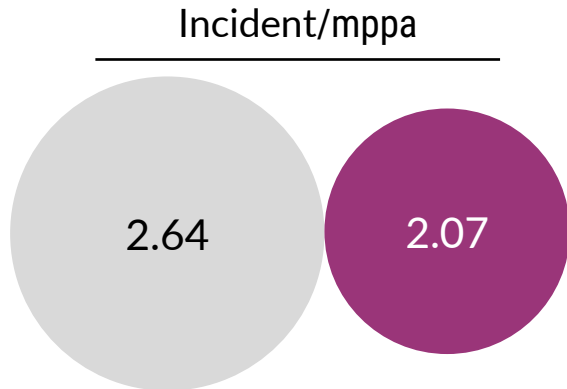
1

20% reduction in cases

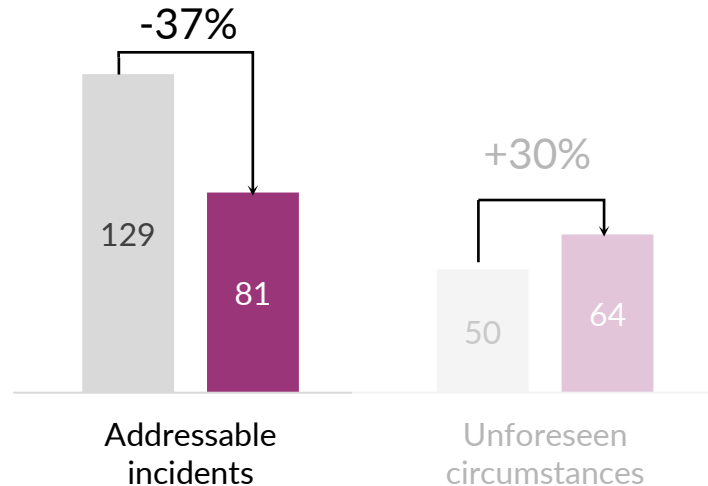
2

Almost 40% of the addressable incidents were reduced in 2025

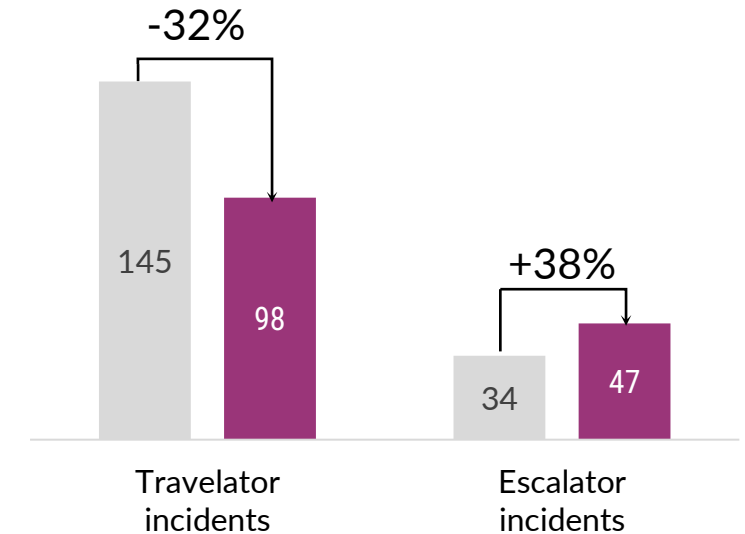
3

Travellator incidents decreased whilst escalator incidents increased
