Reference: 2017-003W

IMPORTANT FIELD SAFETY NOTICE

CYSTOSCOPY BRIDGES AND WORKING INSERTS (A20975A, A20976A, A20977A) – DETACHING FRAGMENTS OF ADHESIVES

Annex B: Identification of Model Number and Lot Number on Device

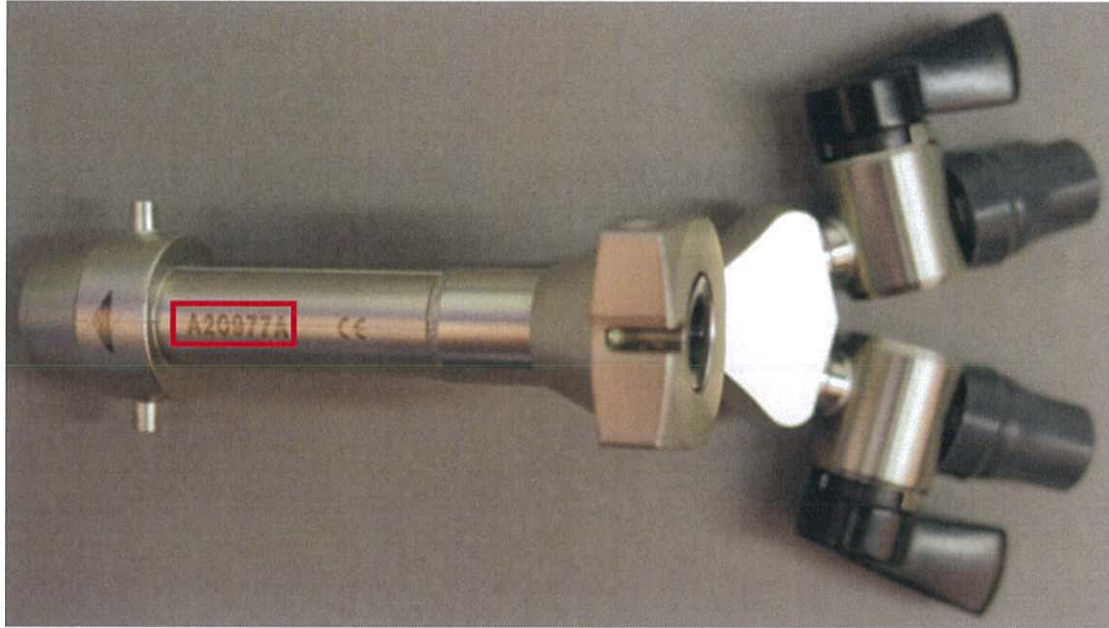
Figure 1: Model number on the cystoscopy bridge

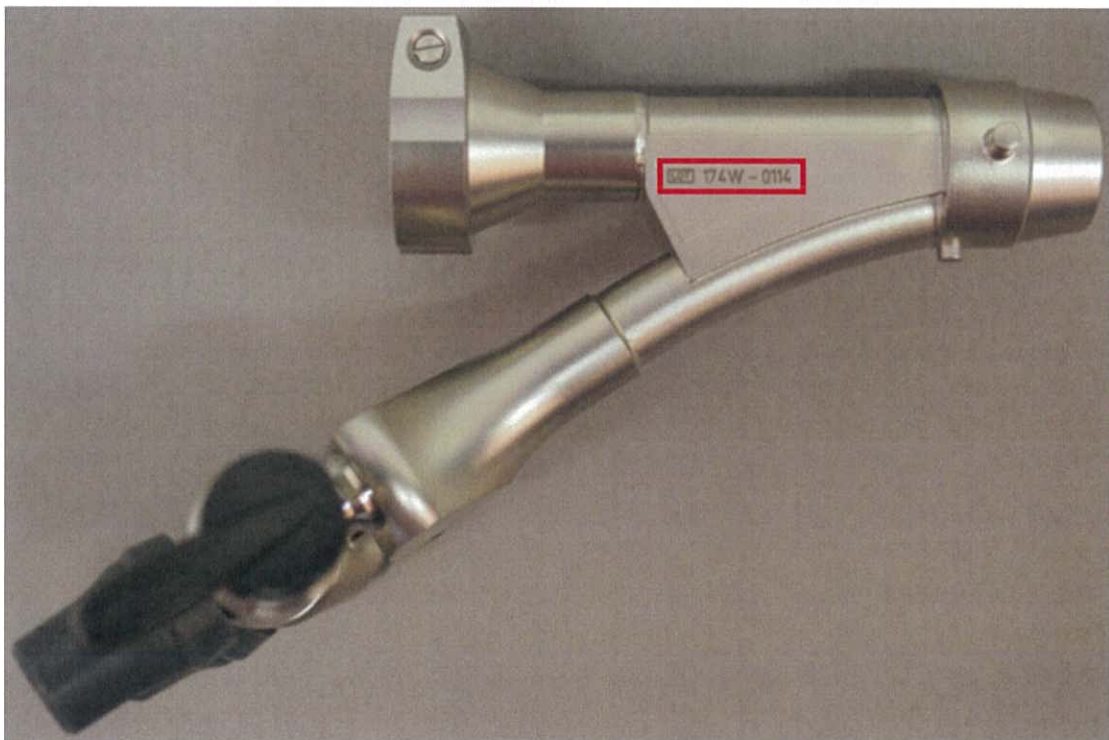
Figure 2: Lot number on the cystoscopy bridge

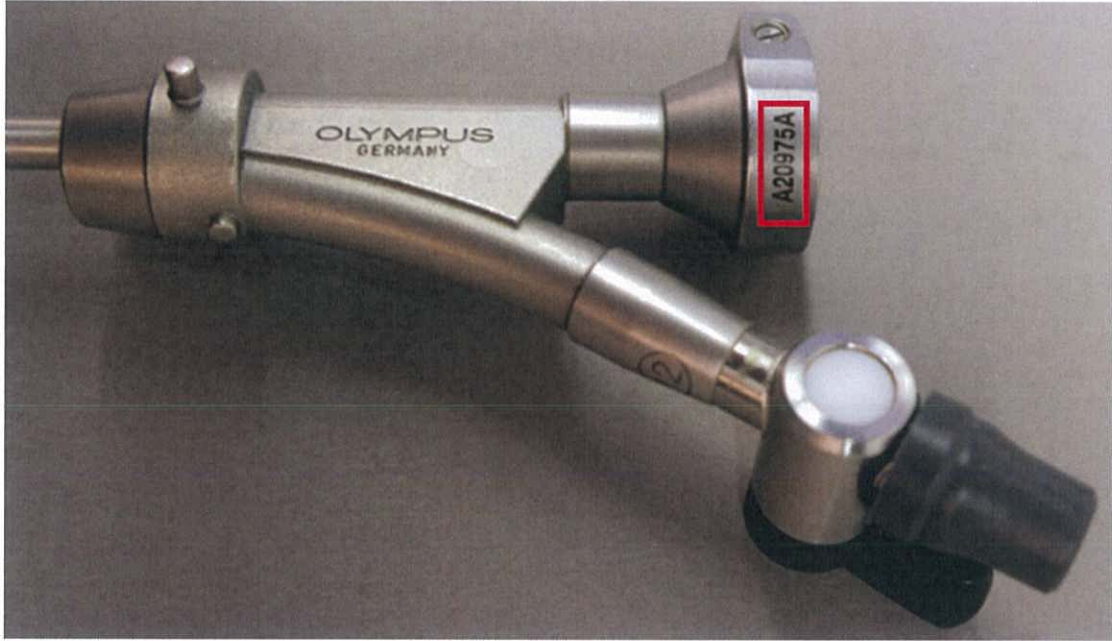
Figure 3: Model number on the working insert

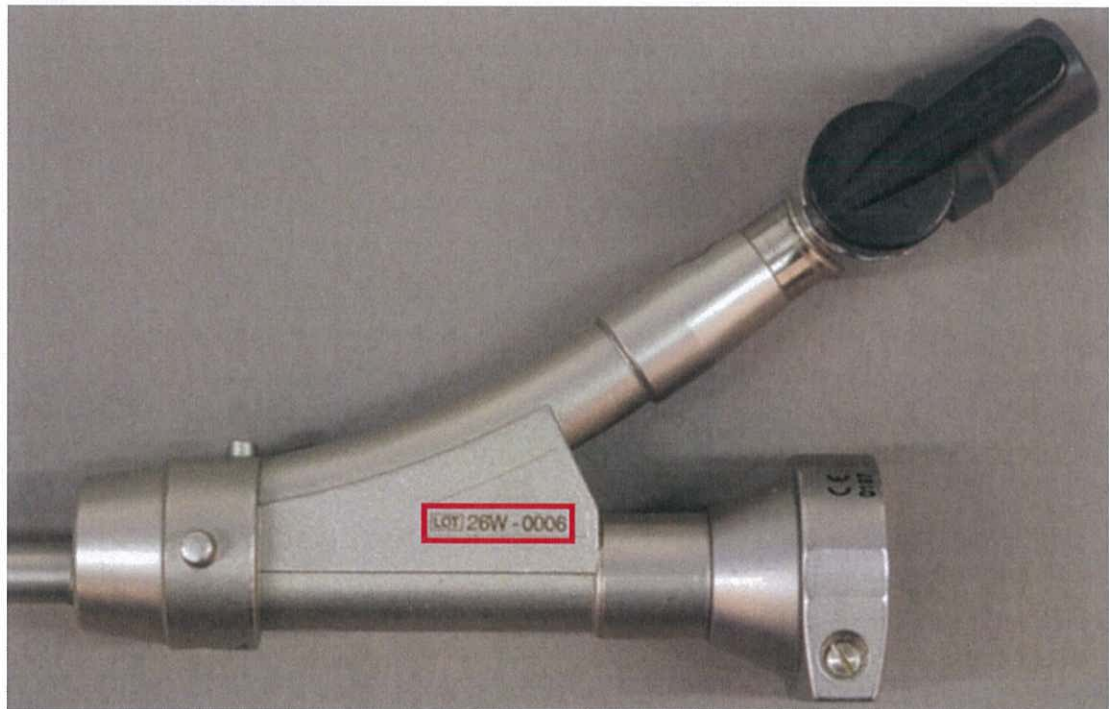
Figure 4: Lot number on the working insert
