# Appendix O Detailed Records of Stream Mapping

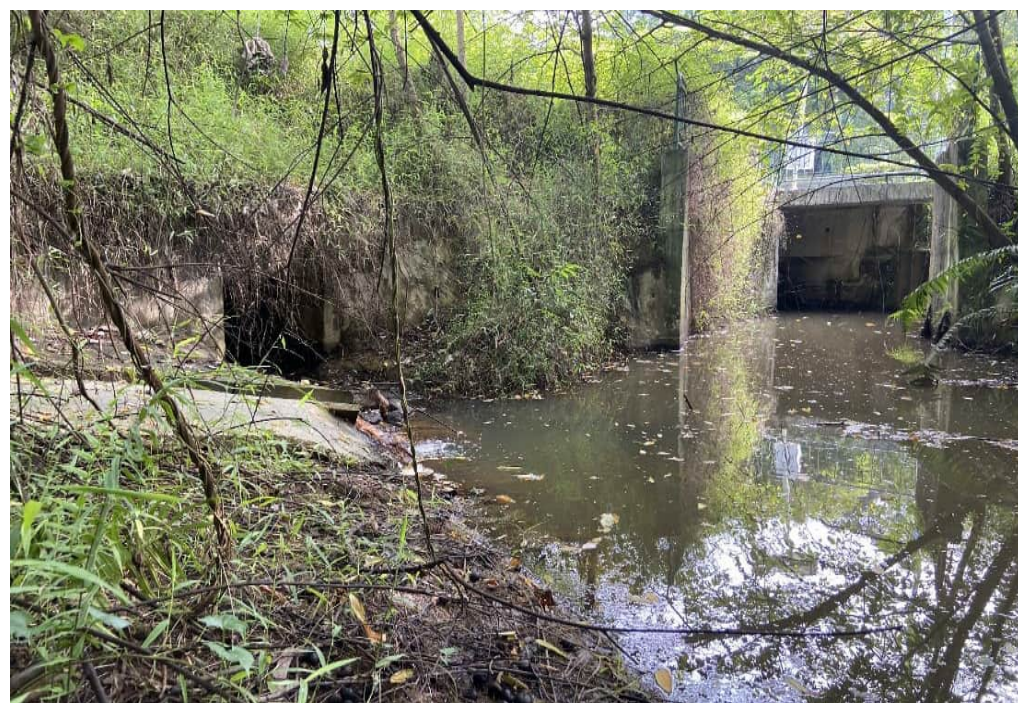
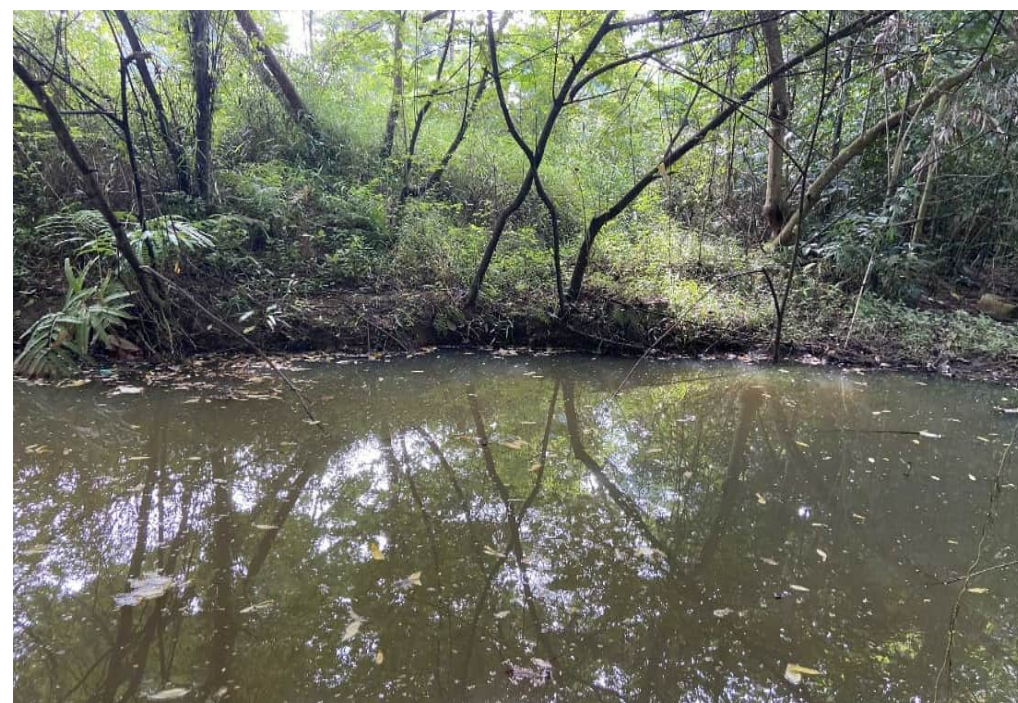
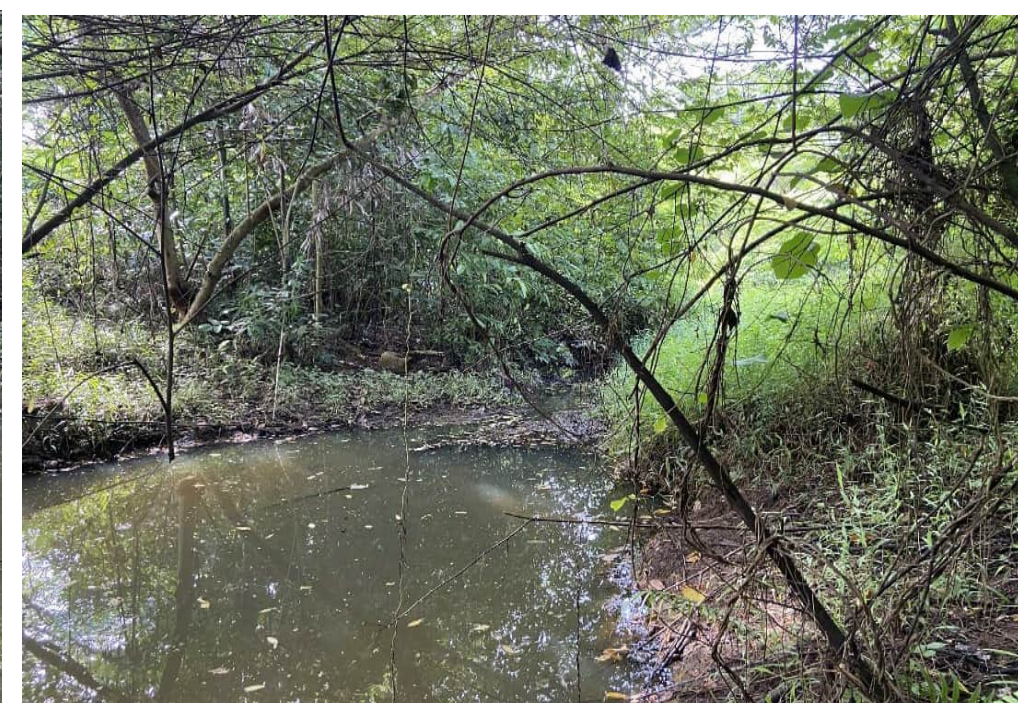
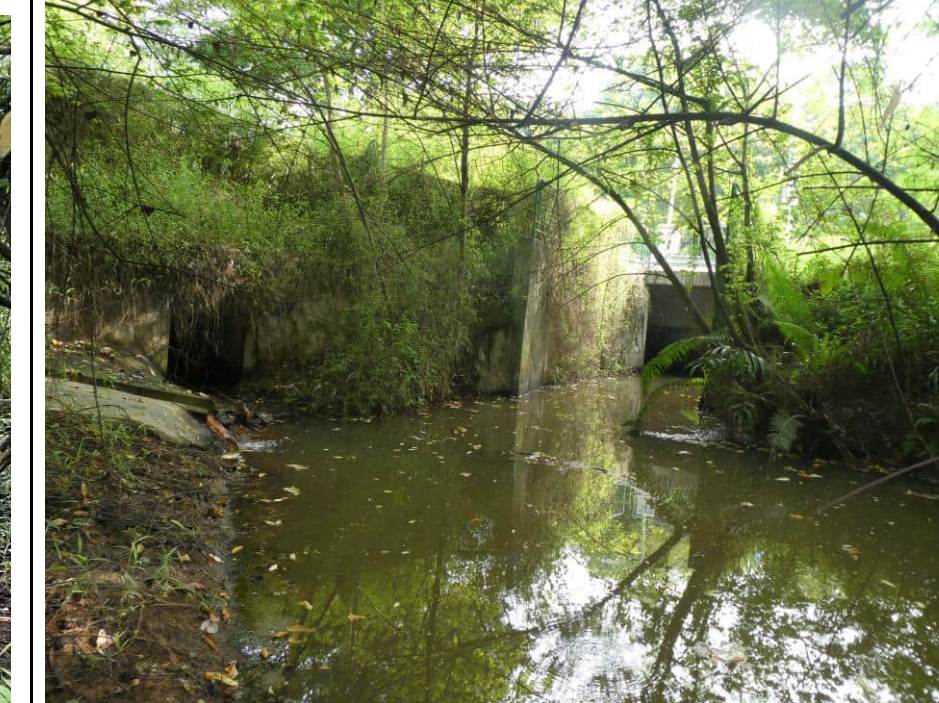
| Stream Mapping Point No. | Cross-section No. | Longitude | Latitude | Photo (In the order of: Upstream, Stream Bed and Downstream) | | | | Photos of Cross-section | Cross-section | Channel Wetted Width | Stream Depth | Flow Velocity (dry weather) | Bed Substrate and Bank Conditions | Riparian Vegetation | Leaf Litter Cover (%) | Canopy Cover (%) | Soil Erosion | Remarks | | | | | | | | | | | | | | | | | | | | | |
|---|---|---|---|---|---|---|---|---|---|---|---|---|---|---|---|---|---|---|---|---|---|--|---|---|---|---|---|---|---|---|---|---|---|---|---|---|---|---|---|
| AW1 | CS14 (Site A) | 103.80176 | 1.34329 | | | | | <div>DATUM= 15 M</div> <table><tr><td>ELEVATION</td><td></td><td>3.80</td><td>25.96</td><td>25.17</td><td>24.15</td><td>23.79m</td><td>24.41</td><td>24.41</td><td>25.02</td><td>26.02</td></tr><tr><td>DISTANCE</td><td>0.00</td><td></td><td></td><td></td><td></td><td></td><td>14.51</td><td>16.79</td><td>19.26</td><td></td></tr></table> <div>CROSS SECTION : CS14-CS14'</div> <div>horizontal scale 1 : 500</div> <div>vertical scale 1 : 500</div> | ELEVATION | | 3.80 | 25.96 | 25.17 | 24.15 | 23.79m | 24.41 | 24.41 | 25.02 | 26.02 | DISTANCE | 0.00 | | | | | | 14.51 | 16.79 | 19.26 | | 5 - 5.8 m | 1 - 1.1 m | stagnant | Unable to identify bed substrate type due to deep turbid waters. Likely muddy clay sediments, based on observed bank conditions. Earth banks with different steepness and vegetation cover (i.e. steep earth bank with dense vegetation on one side, and a less-steep earth bank which is covered by coir nets and sparsely covered by vegetation on other bank). | <i>Acrostichum aureum</i> , <i>Davallia denticulata</i> , <i>Cyclosorus polycarpus</i> , <i>Flagellaria indica</i> , <i>Muntingia calabura</i> | 5-10% | 72.8 | No | Water was turbid. |

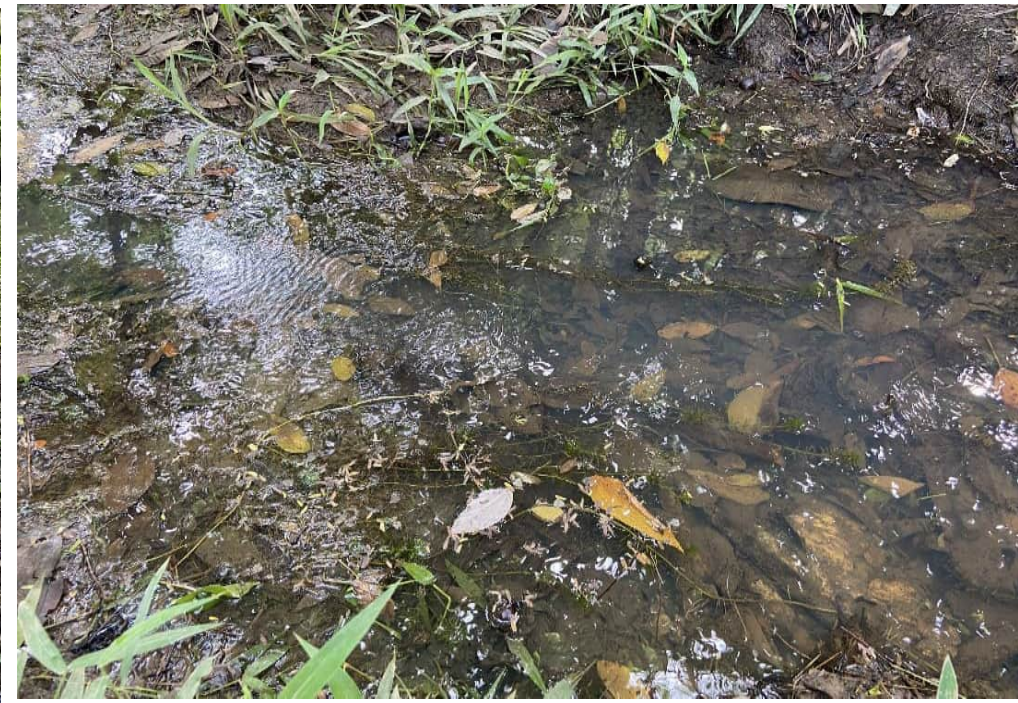
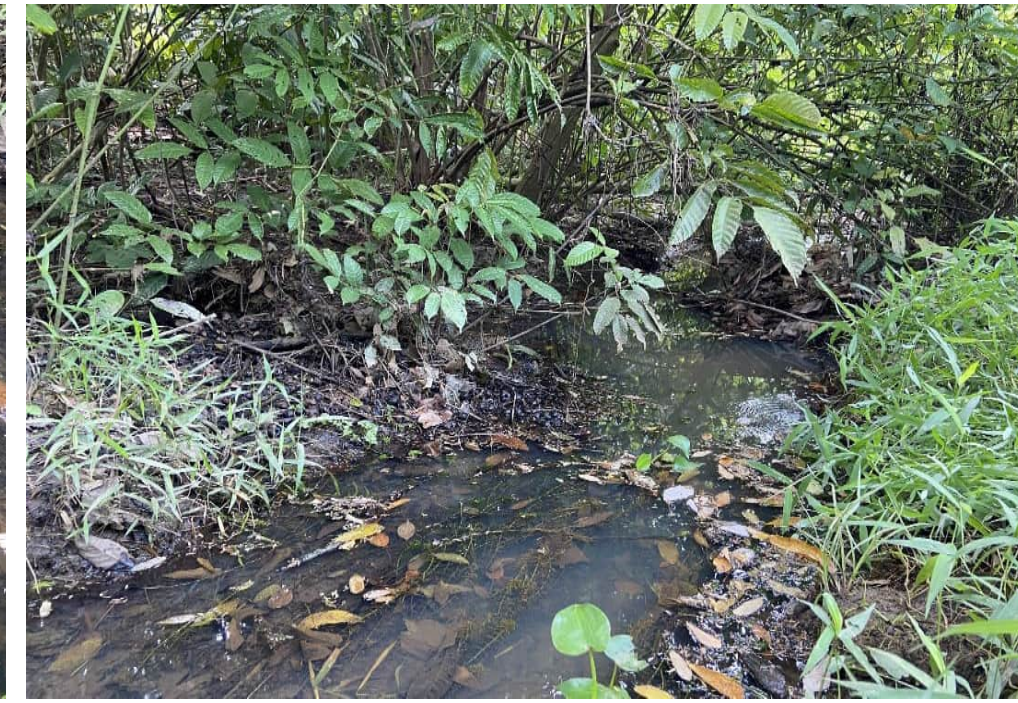
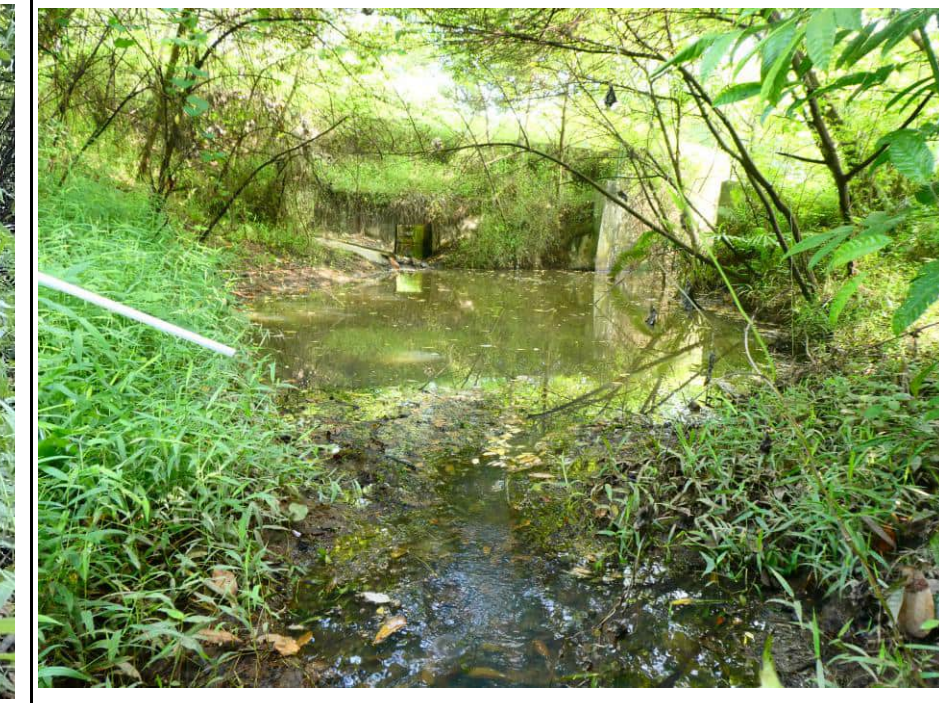
| Stream Mapping Point No. | Cross-section No. | Longitude | Latitude | Photo (In the order of: Upstream, Stream Bed and Downstream) | | | | Photos of Cross-section | Cross-section | Channel Wetted Width | Stream Depth | Flow Velocity (dry weather) | Bed Substrate and Bank Conditions | Riparian Vegetation | Leaf Litter Cover (%) | Canopy Cover (%) | Soil Erosion | Remarks | | | | | | | | | | | | | | | | | | | | | |
|---|---|---|---|---|---|---|---|---|---|---|---|---|---|---|---|---|---|---|---|---|---|--|---|---|---|---|---|---|---|---|---|---|---|---|---|---|---|---|---|
| AW2 | CS15 | 103.80180 | 1.3432140 | | | | | <div>DATUM= 15 M</div> <table><tr><td>ELEVATION</td><td></td><td>5.77</td><td>25.37</td><td>24.90</td><td></td><td>23.54</td><td>23.97m</td><td>23.93</td><td>24.89</td><td>25.99</td></tr><tr><td>DISTANCE</td><td>0.00</td><td></td><td>8.36</td><td></td><td></td><td>14.66</td><td>15.99</td><td>16.68</td><td>25.00</td><td>27.47</td></tr></table> <div>CROSS SECTION : CS15-CS15'</div> <div>horizontal scale 1 : 500</div> <div>vertical scale 1 : 500</div> | ELEVATION | | 5.77 | 25.37 | 24.90 | | 23.54 | 23.97m | 23.93 | 24.89 | 25.99 | DISTANCE | 0.00 | | 8.36 | | | 14.66 | 15.99 | 16.68 | 25.00 | 27.47 | 0.8 -1 m | 17 cm | 0.05 -0.1 m/s | Clayey bed with a layer of dead leaves. Earth banks with very mild slope and covered with vegetation. | <i>Leea indica</i> , <i>Ottochloa nodosa</i> , <i>Neptunia plena</i> , <i>Muntingia calabura</i> , <i>Pueraria phaseoloides</i> | 10-15% | 51.8 | No | Water was clear. |

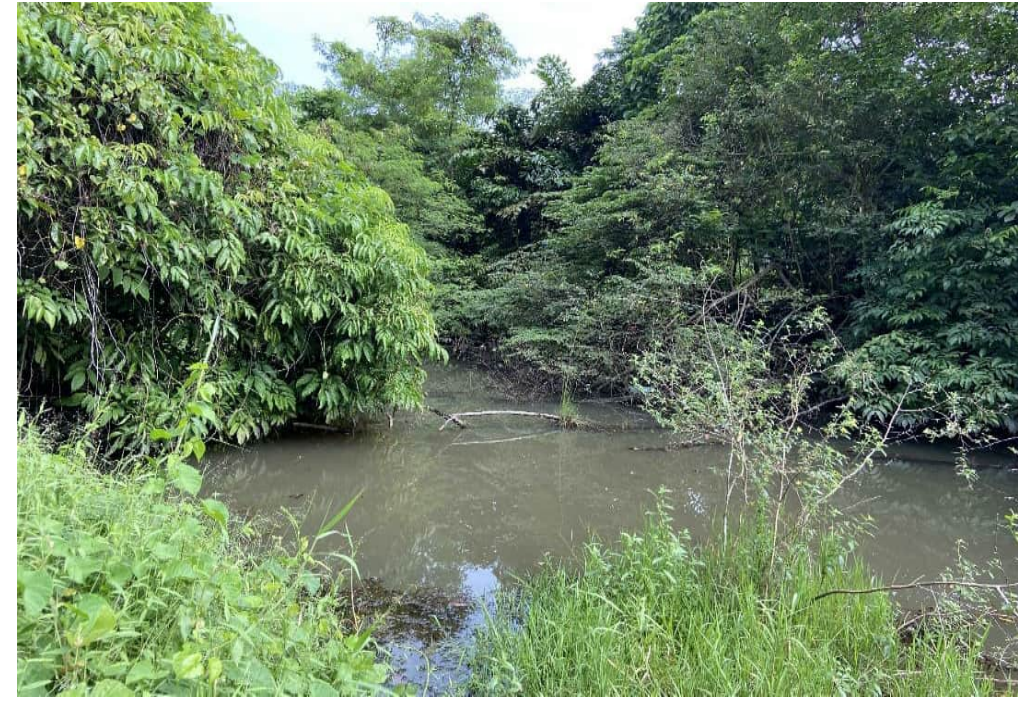
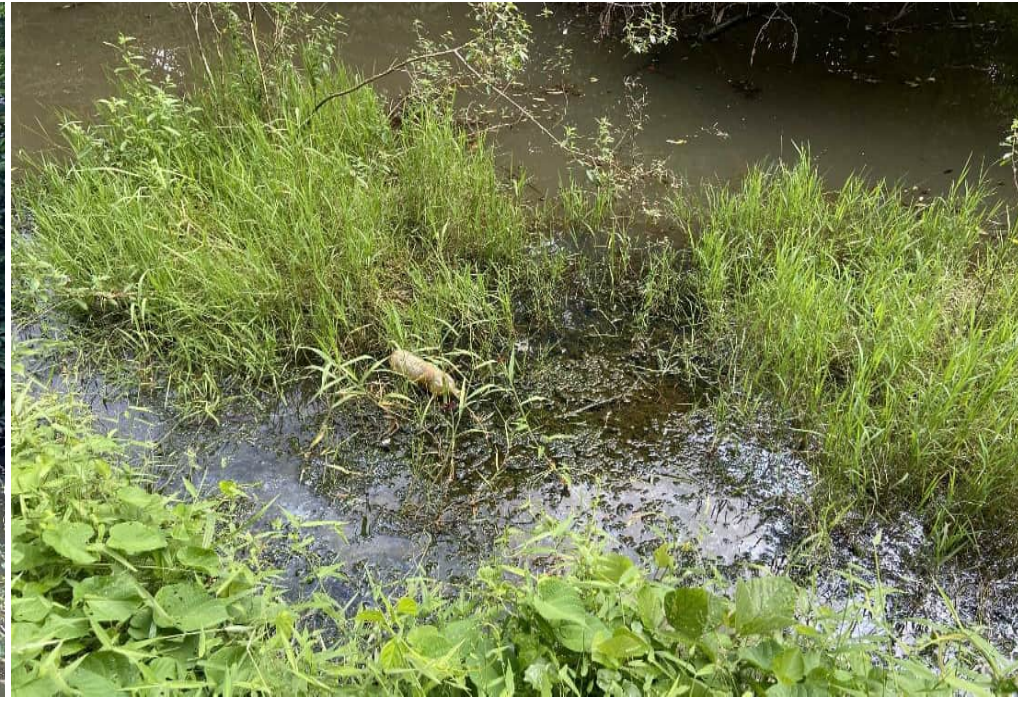
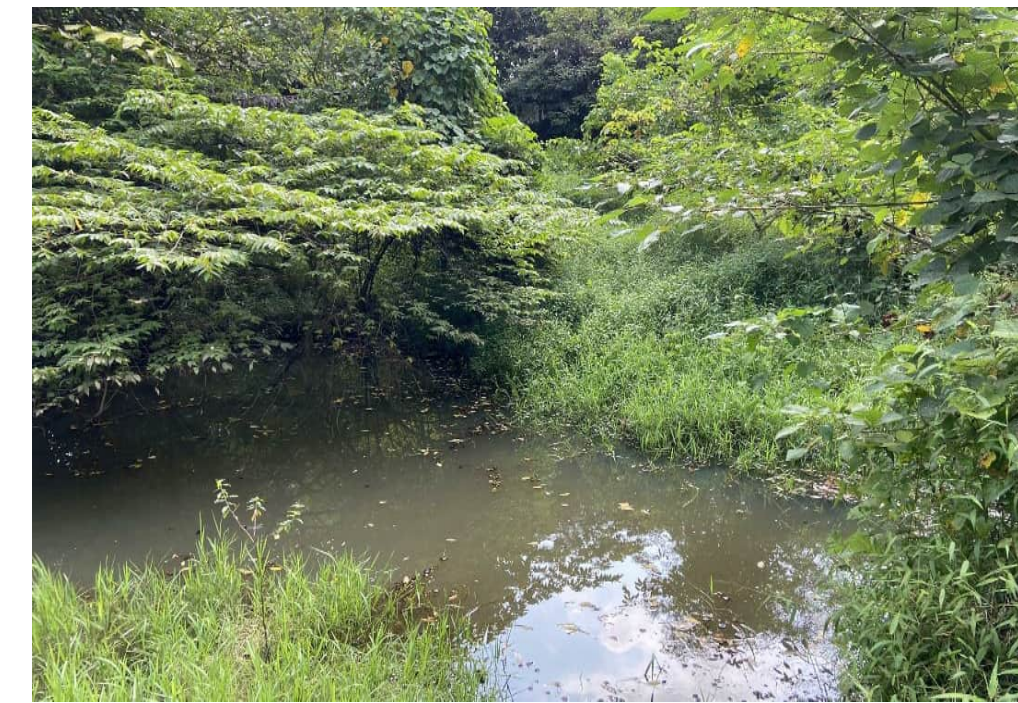
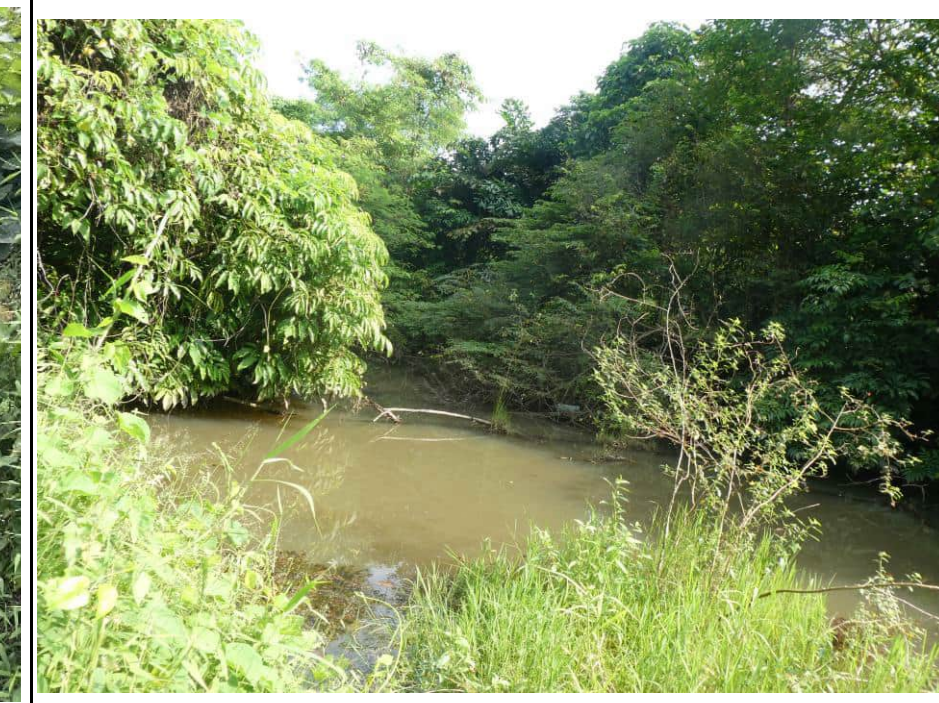
| Stream Mapping Point No. | Cross-section No. | Longitude | Latitude | Photo (In the order of: Upstream, Stream Bed and Downstream) | | | | Photos of Cross-section | Cross-section | Channel Wetted Width | Stream Depth | Flow Velocity (dry weather) | Bed Substrate and Bank Conditions | Riparian Vegetation | Leaf Litter Cover (%) | Canopy Cover (%) | Soil Erosion | Remarks | | | | | | | | | | | | | | | | | | | | | |
|---|---|---|---|---|---|---|---|---|---|---|---|---|---|---|---|---|---|---|---|---|---|--|---|---|---|---|---|---|---|---|---|---|---|---|---|---|---|---|---|
| AW3 | CS16 | 103.80192 | 1.3429990 | | | | | <div>DATUM= 15M</div> <table><tr><td>ELEVATION</td><td></td><td>4.08</td><td>27.07</td><td></td><td>24.91</td><td></td><td>21.91</td><td>20.90</td><td>22.81</td><td>23.81</td></tr><tr><td>DISTANCE</td><td>0.00</td><td></td><td>4.08</td><td></td><td>4.08</td><td></td><td>14.71</td><td>16.68</td><td>18.65</td><td>20.62</td></tr></table> <div>CROSS SECTION : CS16-CS16'</div> <div>horizontal scale 1 : 500</div> <div>vertical scale 1 : 500</div> | ELEVATION | | 4.08 | 27.07 | | 24.91 | | 21.91 | 20.90 | 22.81 | 23.81 | DISTANCE | 0.00 | | 4.08 | | 4.08 | | 14.71 | 16.68 | 18.65 | 20.62 | 8 - 10 m | 28 cm | stagnant | Unable to identify bed substrate type due to deep turbid waters. Likely muddy clay sediments, based on observed bank conditions. Asymmetrical earth banks with different steepness and width (i.e. steep earth bank with a shorter width on one side, and earth bank with a longer width and milder slope on the other bank). The bank with milder slope was waterlogged. | <i>Muntingia calabura</i> , <i>Caryota mitis</i> , <i>Leea indica</i> , <i>Ludwigia peruviana</i> , <i>Gluchion Species (like zeylanicum)</i> , <i>Cinnamomum iners</i> , <i>Merremia umbellata</i> , <i>Isachne globosa</i> | 0-5% | 0 | No | |

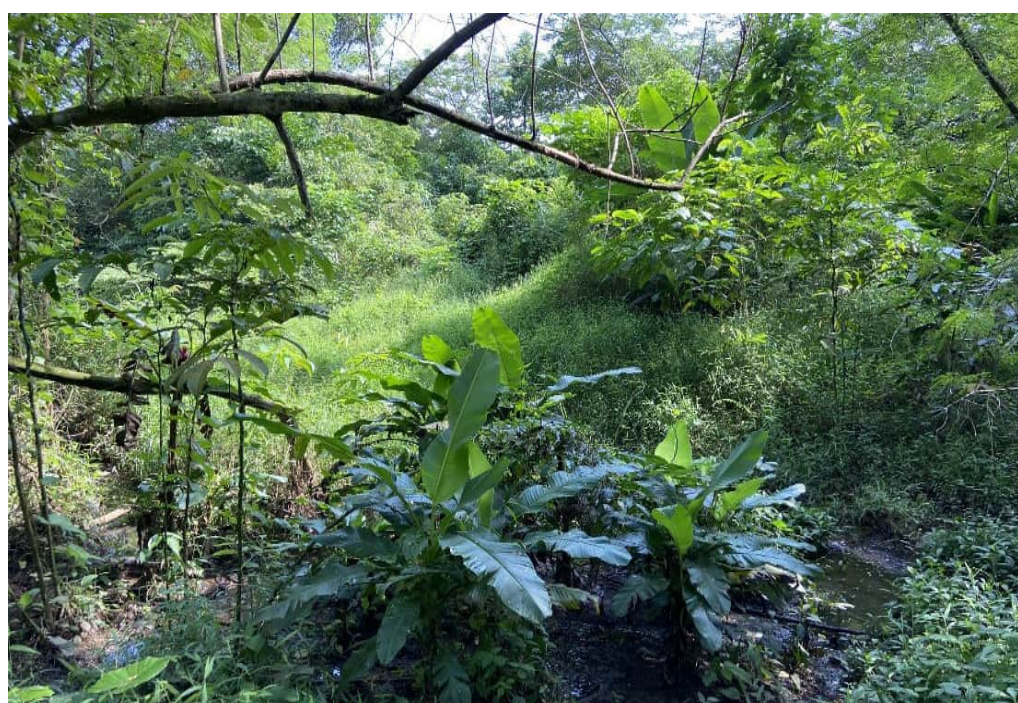
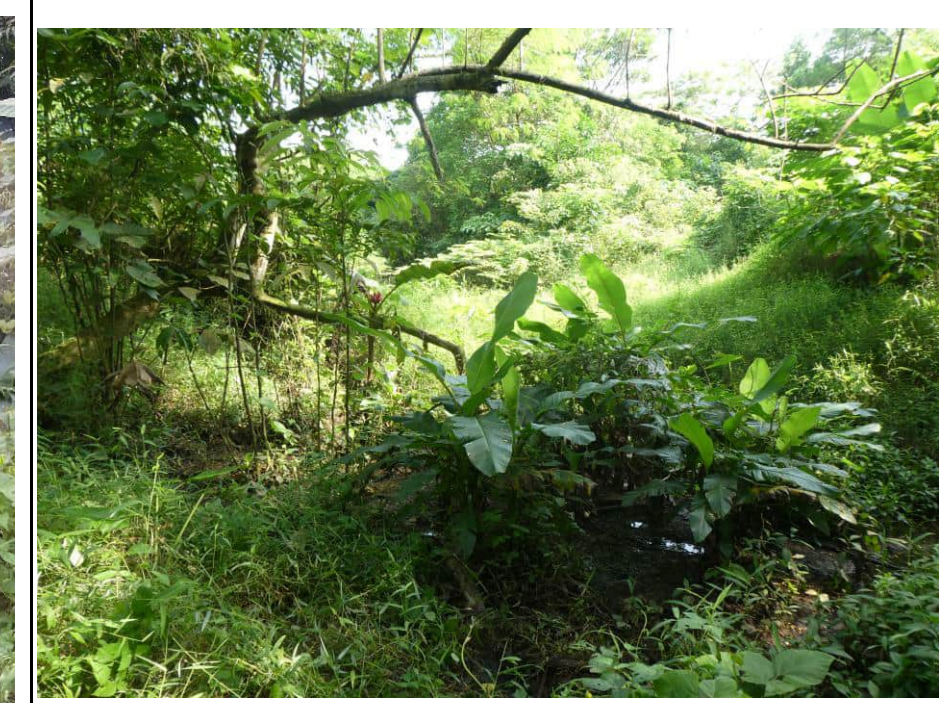
| Stream Mapping Point No. | Cross-section No. | Longitude | Latitude | Photo (In the order of: Upstream, Stream Bed and Downstream) | | | | Photos of Cross-section | Cross-section | Channel Wetted Width | Stream Depth | Flow Velocity (dry weather) | Bed Substrate and Bank Conditions | Riparian Vegetation | Leaf Litter Cover (%) | Canopy Cover (%) | Soil Erosion | Remarks | | | | | | | | | | | | | | | | | | | | | |
|---|---|---|---|---|---|---|---|---|---|---|---|---|---|---|---|---|---|---|---|---|---|--|---|---|---|---|---|---|---|---|---|---|---|---|---|---|---|---|---|
| AW4 | CS17 | 103.80204 | 1.3427680 | | | | | <div>DATUM= 15M</div> <table><tr><td>ELEVATION</td><td></td><td></td><td>24.92</td><td>25.93</td><td>25.93</td><td>23.93</td><td>23.93</td><td>23.93</td><td>24.94</td><td>25.94</td></tr><tr><td>DISTANCE</td><td>0.00</td><td></td><td>1.96</td><td>3.92</td><td>5.88</td><td>7.84</td><td>9.80</td><td>11.76</td><td>13.72</td><td>15.68</td></tr></table> <div>CROSS SECTION : CS17-CS17'</div> <div>horizontal scale 1 : 500</div> <div>vertical scale 1 : 500</div> | ELEVATION | | | 24.92 | 25.93 | 25.93 | 23.93 | 23.93 | 23.93 | 24.94 | 25.94 | DISTANCE | 0.00 | | 1.96 | 3.92 | 5.88 | 7.84 | 9.80 | 11.76 | 13.72 | 15.68 | 0.2 - 0.5 m | 1- 5 cm | 0.5 m/s | Bed covered with dead leaves. Many dead logs blocking the stream flow. Earth banks with mild slopes, covered by dense vegetation. Banks are also waterlogged. | <i>Asystasia gangetica</i> ssp. <i>Micrantha</i> , <i>Isachne globosa</i> , <i>Mikania micrantha</i> , <i>Pueraria phaseoloides</i> , <i>Strachum sparganophorum</i> , <i>Musa cultivar</i> , <i>Leucaena leucocephala</i> , <i>Caryota mitis</i> , <i>Heliconia cultivar</i> (Golden Torch) <i>Claoxylon indicum</i> | 0 | 24.2 | No | |

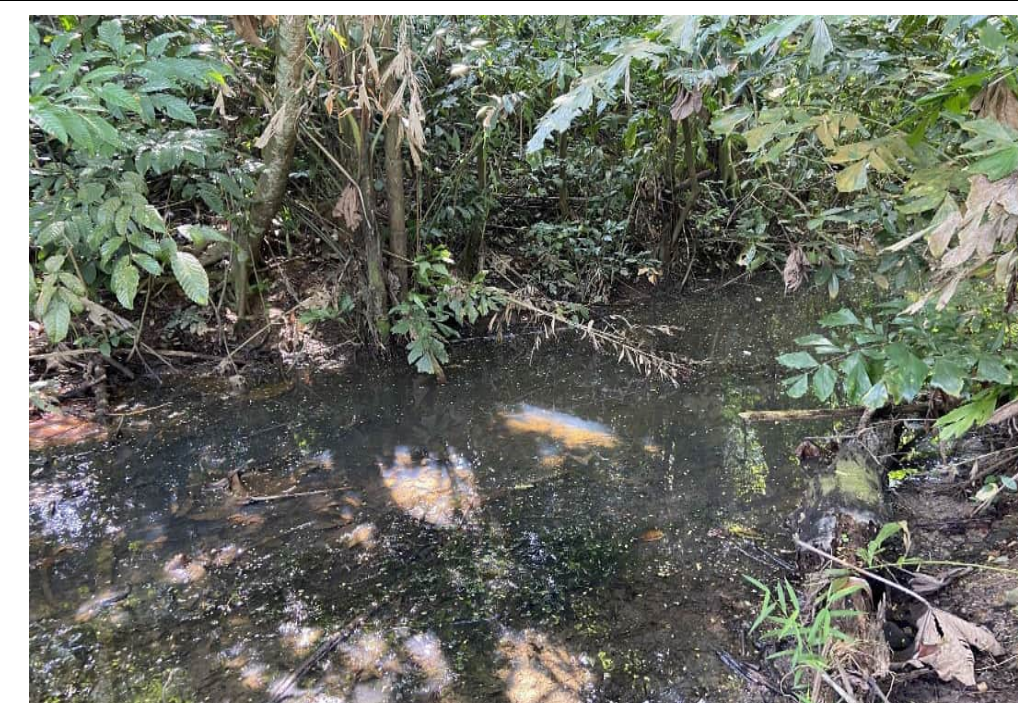
| Stream Mapping Point No. | Cross-section No. | Longitude | Latitude | Photo (In the order of: Upstream, Stream Bed and Downstream) | | | | Photos of Cross-section | Cross-section | Channel Wetted Width | Stream Depth | Flow Velocity (dry weather) | Bed Substrate and Bank Conditions | Riparian Vegetation | Leaf Litter Cover (%) | Canopy Cover (%) | Soil Erosion | Remarks | | | | | | | | | | | | | | | | | | | | | |
|---|---|---|---|---|---|---|---|---|---|---|---|---|---|---|---|---|---|---|---|---|---|--|---|---|---|---|---|---|---|---|---|---|---|---|---|---|---|---|---|
| AW5 | CS18 | 103.80210 | 1.34267 | | | | | <div>DATUM= 15 M</div> <table><tr><td>ELEVATION</td><td></td><td></td><td>24.98</td><td>24.90</td><td>23.76</td><td>23.66m</td><td>24.49</td><td>25.02</td><td>25.65</td><td></td></tr><tr><td>DISTANCE</td><td>0.00</td><td></td><td>6.85</td><td>8.11</td><td>11.11</td><td>14.23</td><td>17.74</td><td>21.28</td><td>23.56</td><td></td></tr></table> <div>CROSS SECTION : CS18-CS18'</div> <div>horizontal scale 1 : 500</div> <div>vertical scale 1 : 500</div> | ELEVATION | | | 24.98 | 24.90 | 23.76 | 23.66m | 24.49 | 25.02 | 25.65 | | DISTANCE | 0.00 | | 6.85 | 8.11 | 11.11 | 14.23 | 17.74 | 21.28 | 23.56 | | 4 - 6 m | 2 - 5 cm | stagnant | Bed covered with dead leaves, muddy clay bed substrate. Earth banks with mild slopes, covered with dense vegetation and are waterlogged. | <i>Pueraria phaseoloides</i> , <i>Isachne globosa</i> , <i>Tetracera indica</i> , <i>Leea indica</i> , <i>Caryota mitis</i> | 5 | 69.1 | No | |

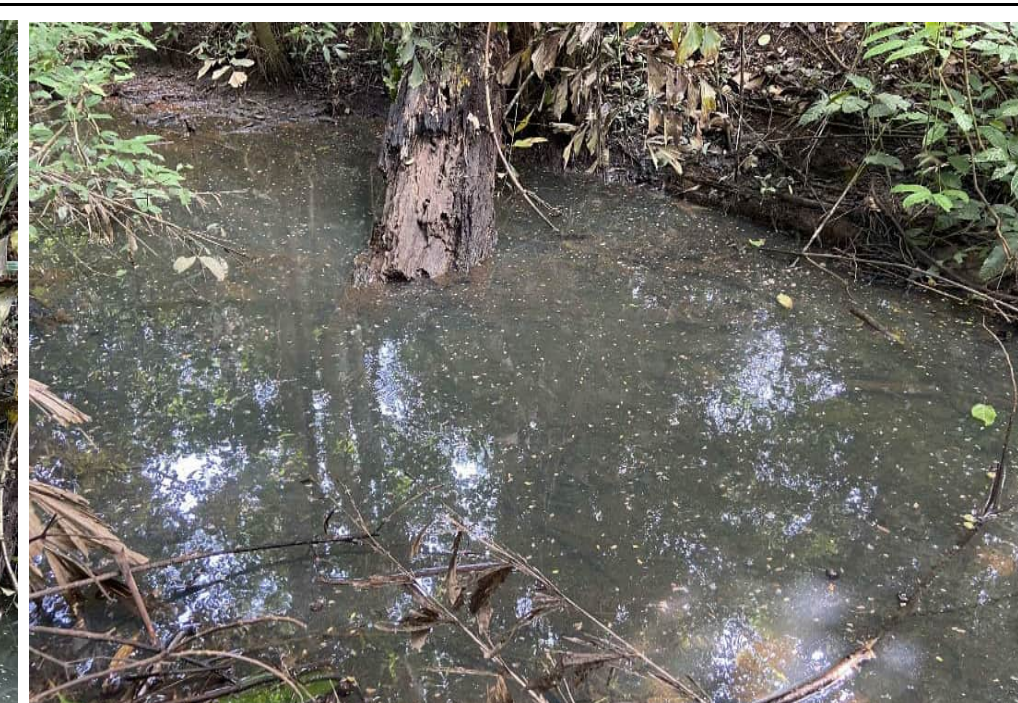
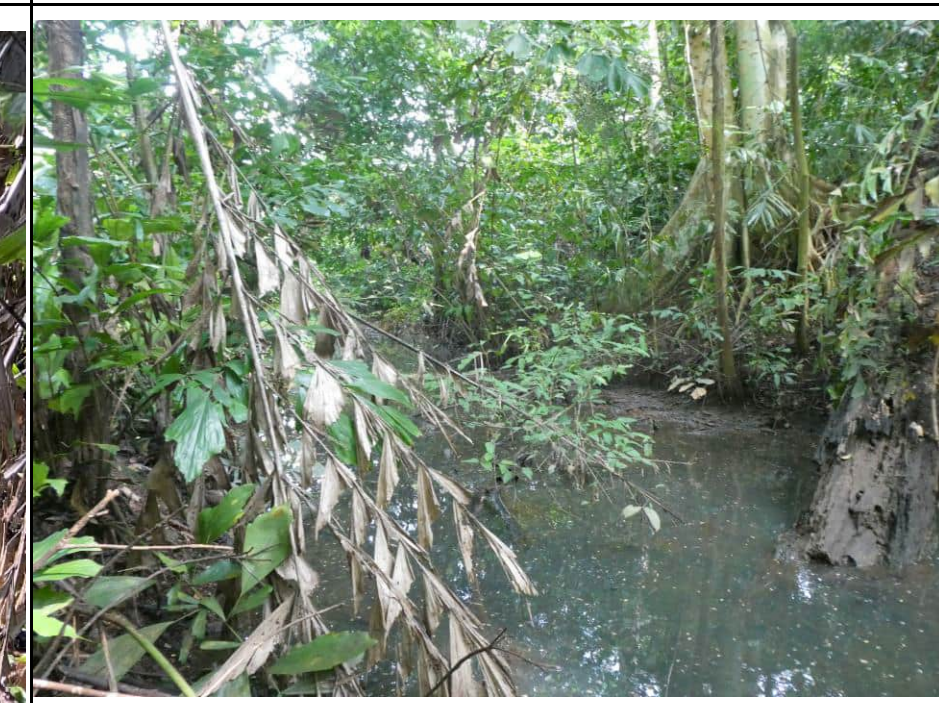
| Stream Mapping Point No. | Cross-section No. | Longitude | Latitude | Photo (In the order of: Upstream, Stream Bed and Downstream) | | | | Photos of Cross-section | Cross-section | Channel Wetted Width | Stream Depth | Flow Velocity (dry weather) | Bed Substrate and Bank Conditions | Riparian Vegetation | Leaf Litter Cover (%) | Canopy Cover (%) | Soil Erosion | Remarks | | | | | | | | | | | | | | | | | | | | | |
|---|---|---|---|---|---|---|---|---|---|---|---|---|---|---|---|---|---|---|---|---|---|--|---|---|---|---|---|---|---|---|---|---|---|---|---|---|---|---|---|
| AW6 | CS19 | 103.80216 | 1.342537 | | | | | <div>DATUM= 15 M</div> <table><tr><td>ELEVATION</td><td></td><td></td><td>24.92</td><td>24.45</td><td>24.17</td><td>23.89m</td><td>24.63</td><td>24.63</td><td>25.22</td><td>25.22</td></tr><tr><td>DISTANCE</td><td>0.00</td><td></td><td>3.15</td><td>6.04</td><td>7.19</td><td>12.43</td><td>13.37</td><td>16.69</td><td>18.65</td><td></td></tr></table> <div>CROSS SECTION : CS19-CS19'</div> <div>horizontal scale 1 : 500</div> <div>vertical scale 1 : 500</div> | ELEVATION | | | 24.92 | 24.45 | 24.17 | 23.89m | 24.63 | 24.63 | 25.22 | 25.22 | DISTANCE | 0.00 | | 3.15 | 6.04 | 7.19 | 12.43 | 13.37 | 16.69 | 18.65 | | 3 - 4 m | 10 - 20 cm | stagnant | Bed covered with dead leaves. Earth banks with steep slopes, covered with dense vegetation. | <i>Caryota mitis</i> , <i>Piper sarmentosa</i> , <i>Leea indica</i> , <i>Ficus variegata</i> , <i>Ptychosperma macarthurii</i> | 0-5% | 68.5 | No | |

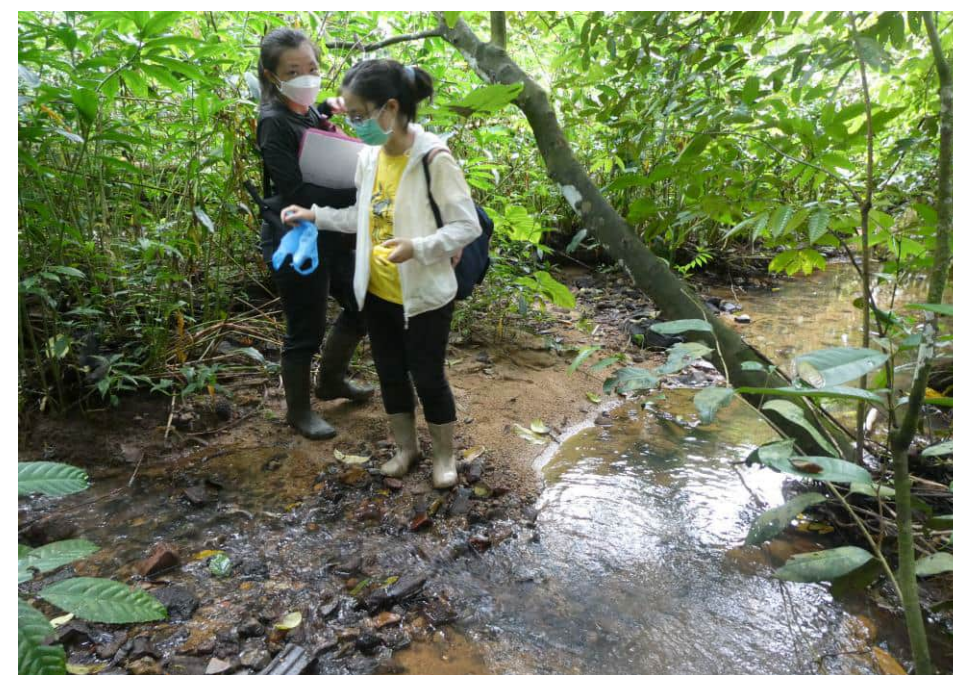
| Stream Mapping Point No. | Cross-section No. | Longitude | Latitude | Photo (In the order of: Upstream, Stream Bed and Downstream) | Photos of Cross-section | Cross-section | Channel Wetted Width | Stream Depth | Flow Velocity (dry weather) | Bed Substrate and Bank Conditions | Riparian Vegetation | Leaf Litter Cover (%) | Canopy Cover (%) | Soil Erosion | Remarks |
|---|---|---|---|---|---|---|---|---|---|---|---|---|---|---|---|
| AW19 | CS39 | 103.80314 | 1.339176 | <div><div><div><div>Tributary + 2nd Distributary</div><div>1st Distributary</div><div>Confluence</div></div><div><div>1st Distributary</div><div>Tributary + 2nd Distributary</div></div><div><div>Confluence</div><div>Downstream</div></div></div><div></div></div> | <div><div><div>1) 1st distributary: 0.5 m</div><div>2) tributary + 2nd distributary: 0.5 - 1 m</div><div>3) at the confluence: 1.5 m</div><div>4) downstream of the confluence: 2-3m</div></div><div><div>1) 1st distributary: y: 5 - 7cm</div><div>2) tributary + 2nd distributary: y: 2-3 cm</div><div>3) at the confluence: 25 cm</div><div>4) downstream of the confluence: 10-25 cm</div></div></div> <div><div><div>1) 1st distributary: 0.3 m/s</div><div>2) tributary + 2nd distributary: 0.1 m/s</div><div>3) at the confluence: Not Applicable</div><div>4) downstream of the confluence: 0.15 m/s</div></div></div> <div><div>1) 1st distributary: sandy bed with many medium-large rocks and broken bricks. Earth banks with very mild slopes, covered with vegetation.</div><div>2) tributary + 2nd distributary: sandy bed with some small rocks. Presence of litter. Earth banks with asymmetrical slopes (e.g. one is mild slope gradient, while the other very mild slope gradient), covered with vegetation.</div><div>3) at the confluence: sandy bed with a few rocks of various sizes. Earth banks with asymmetrical slopes (e.g. one is mild slope gradient, while the other very mild slope gradient), covered with vegetation.</div></div> <div><div><i>Leea indica</i>, <i>Alcoccia macrorrhizos</i>, <i>Cheilocostus speciosus</i>, <i>Cinnamomum iners</i>, <i>Caryota mitis</i>, <i>Syzygium grande</i></div></div> <div>5</div> <div>80.4</div> <div>No</div> <div>3) at the confluence: stream depth is significantly deeper due to turbulent mixing from the merging of the flows.</div> | | | | | | | | | | |

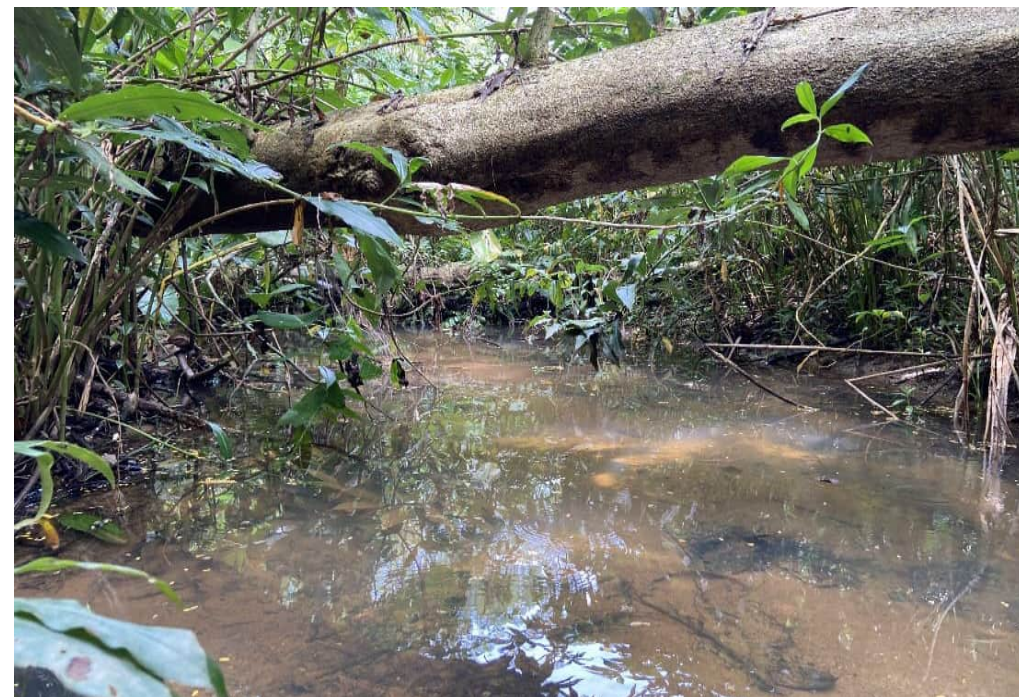
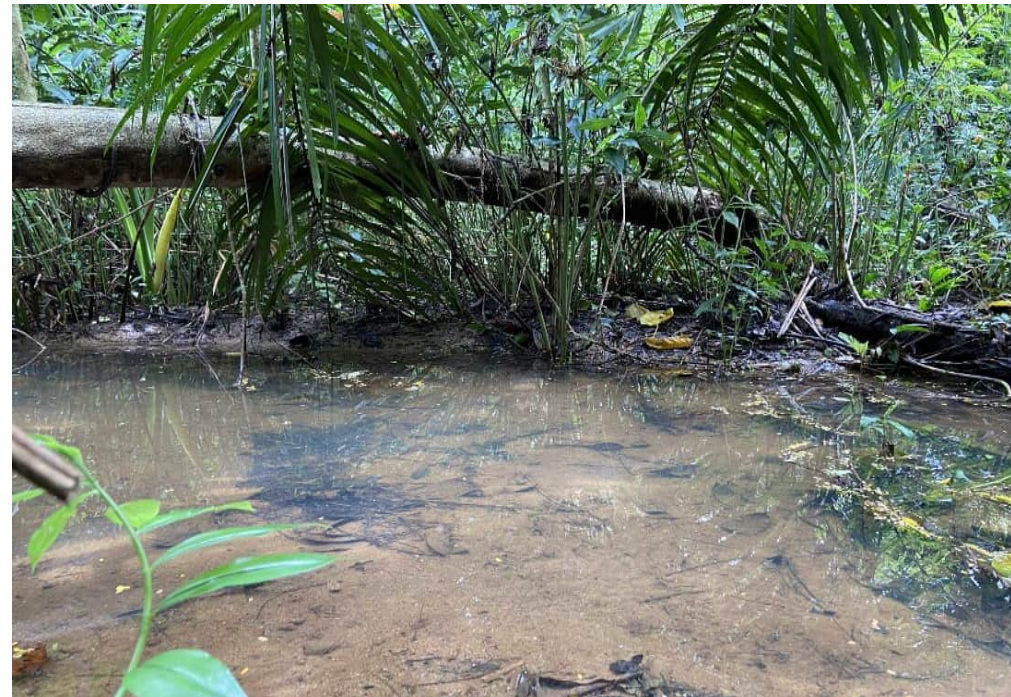
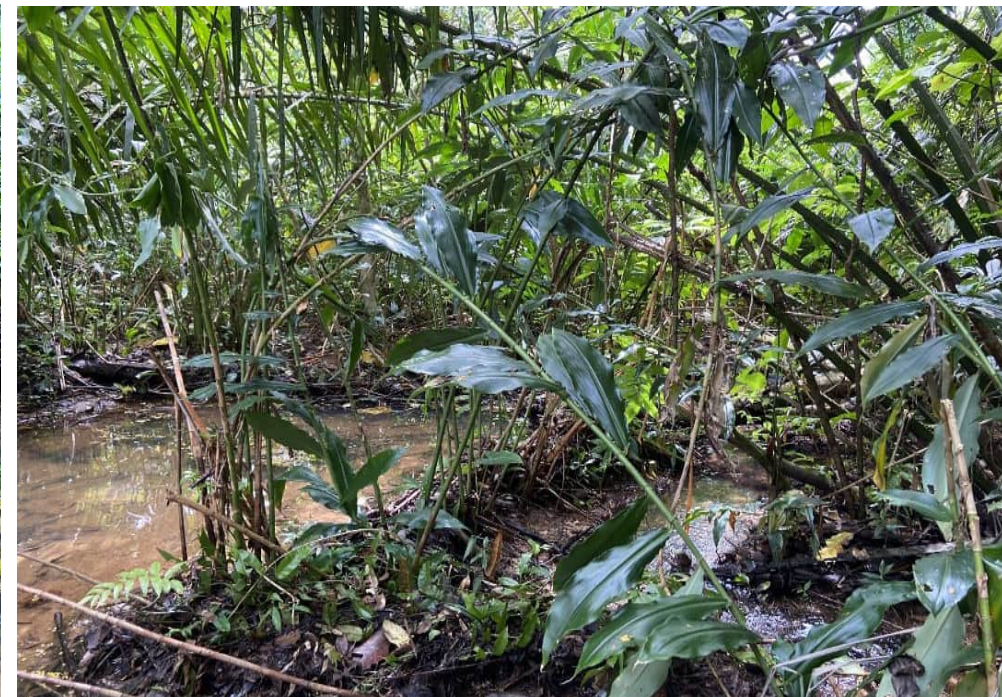
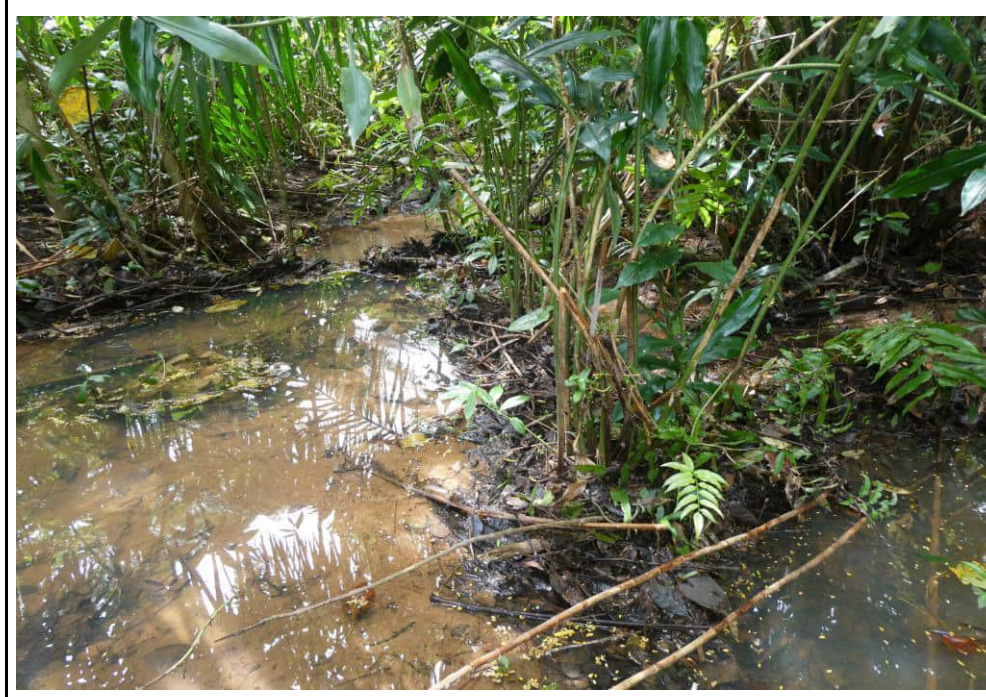
| Stream Mapping Point No. | Cross-section No. | Longitude | Latitude | Photo (In the order of: Upstream, Stream Bed and Downstream) | Photos of Cross-section | Cross-section | Channel Wetted Width | Stream Depth | Flow Velocity (dry weather) | Bed Substrate and Bank Conditions | Riparian Vegetation | Leaf Litter Cover (%) | Canopy Cover (%) | Soil Erosion | Remarks |
|---|---|---|---|---|---|---|---|---|---|---|---|---|---|---|---|
| AW20 | CS40 | 103.80331 | 1.339028 | <div><div><div></div><div></div><div></div></div><div></div></div> | <div><div><div>1) 1st distributary: 0.5 m</div><div>2) tributary + 2nd distributary: 0.5 - 1 m</div><div>3) at the confluence: 1.5 m</div><div>4) downstream of the confluence: 2-3 m</div></div><div><div>1) 1st distributary: y: 5 - 7cm</div><div>2) tributary + 2nd distributary: y: 2-3 cm</div><div>3) at the confluence: 25 cm</div><div>4) downstream of the confluence: 10-25 cm</div></div></div> <div><div><div>1) 1st distributary: 0.3 m/s</div><div>2) tributary + 2nd distributary: 0.1 m/s</div><div>3) at the confluence: Not Applicable</div><div>4) downstream of the confluence: 0.15 m/s</div></div></div> <div><div>1) 1st distributary: Sandy bed with some dead leaves. Earth banks with very mild slopes, covered with dense vegetation.</div></div> <div><div><i>Elaeis guineensis</i>, <i>Caryota mitis</i>, <i>Cheilocostus speciosus</i>, <i>Stenochlaena palustris</i>, <i>Syngonium podophyllum</i></div></div> <div>50</div> <div>65.1</div> <div>No</div> <div>A vegetation strip running through the middle of the stream separates it into two sections: one stagnant and the other with flow. The stagnant section was captured in this stream mapping, due to its larger area. Water from this stagnant area</div> | | | | | | | | | | |

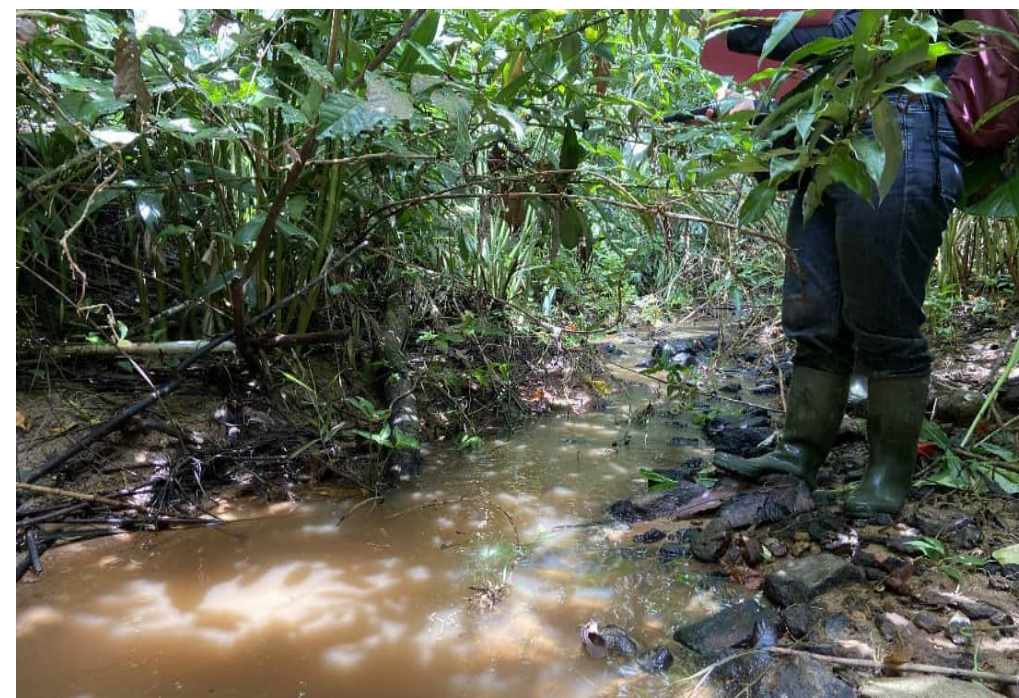
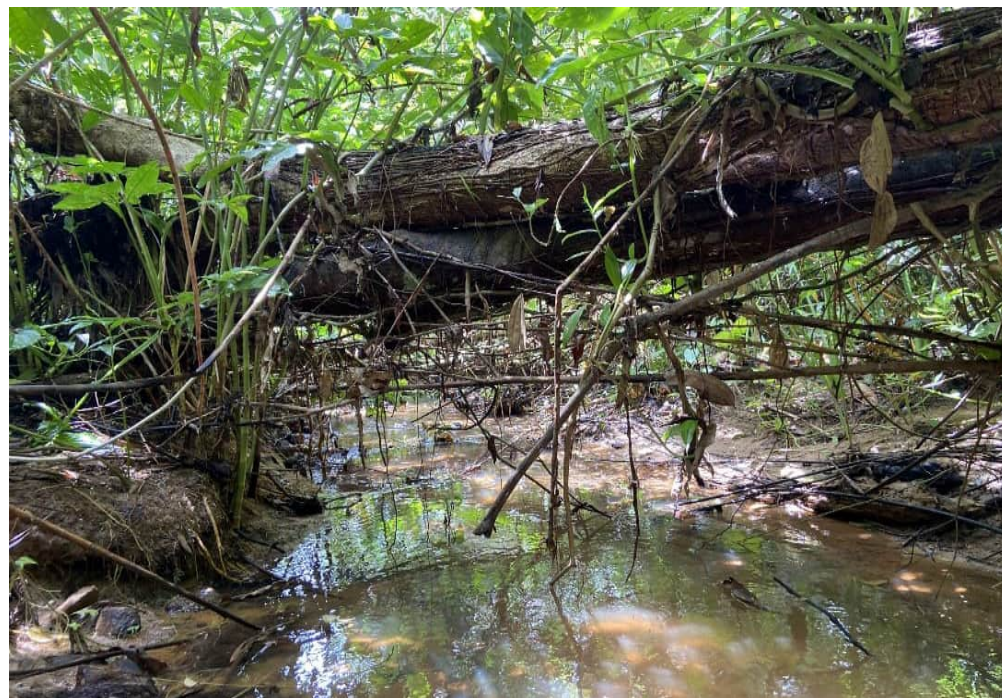
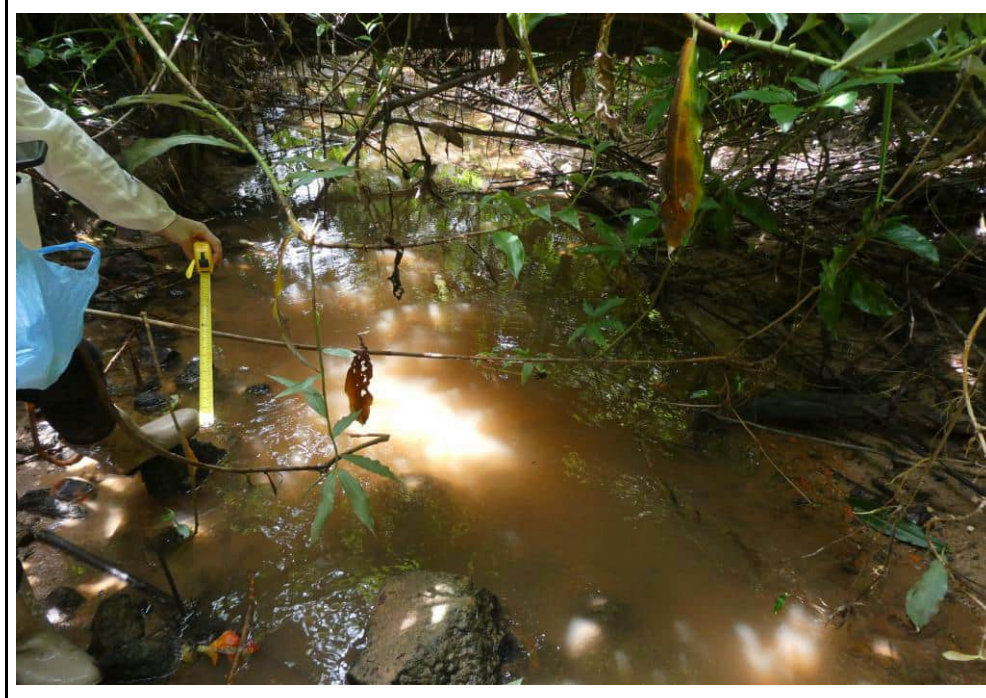
| Stream Mapping Point No. | Cross-section No. | Longitude | Latitude | Photo (In the order of: Upstream, Stream Bed and Downstream) | Photos of Cross-section | Cross-section | Channel Wetted Width | Stream Depth | Flow Velocity (dry weather) | Bed Substrate and Bank Conditions | Riparian Vegetation | Leaf Litter Cover (%) | Canopy Cover (%) | Soil Erosion | Remarks |
|---|---|---|---|---|---|---|---|---|---|---|---|---|---|---|---|
| AW21 | CS41 | 103.80342 | 1.338909 | <div><div><div></div><div></div><div></div></div><div></div></div> | <div><div><div>1) 1st distributary: 0.5 m</div><div>2) tributary + 2nd distributary: 0.5 - 1 m</div><div>3) at the confluence: 1.5 m</div><div>4) downstream of the confluence: 2-3 m</div></div><div><div>1) 1st distributary: y: 5 - 7cm</div><div>2) tributary + 2nd distributary: y: 2-3 cm</div><div>3) at the confluence: 25 cm</div><div>4) downstream of the confluence: 10-25 cm</div></div></div> <div><div><div>1) 1st distributary: 0.3 m/s</div><div>2) tributary + 2nd distributary: 0.1 m/s</div><div>3) at the confluence: Not Applicable</div><div>4) downstream of the confluence: 0.15 m/s</div></div></div> <div><div>1) 1st distributary: Sandy bed with a few large rocks. Earth banks with very mild slopes, covered with dense vegetation.</div></div> <div><div><i>Cheilocostus speciosus</i>, <i>Syngonium podophyllum</i>, <i>Cinnamomum iners</i>, <i>Nephellium lippaceum</i></div></div> <div>0</div> <div>70.5</div> <div>No</div> <div></div> | | | | | | | | | | |
