# Appendix O Detailed Records of Stream Mapping

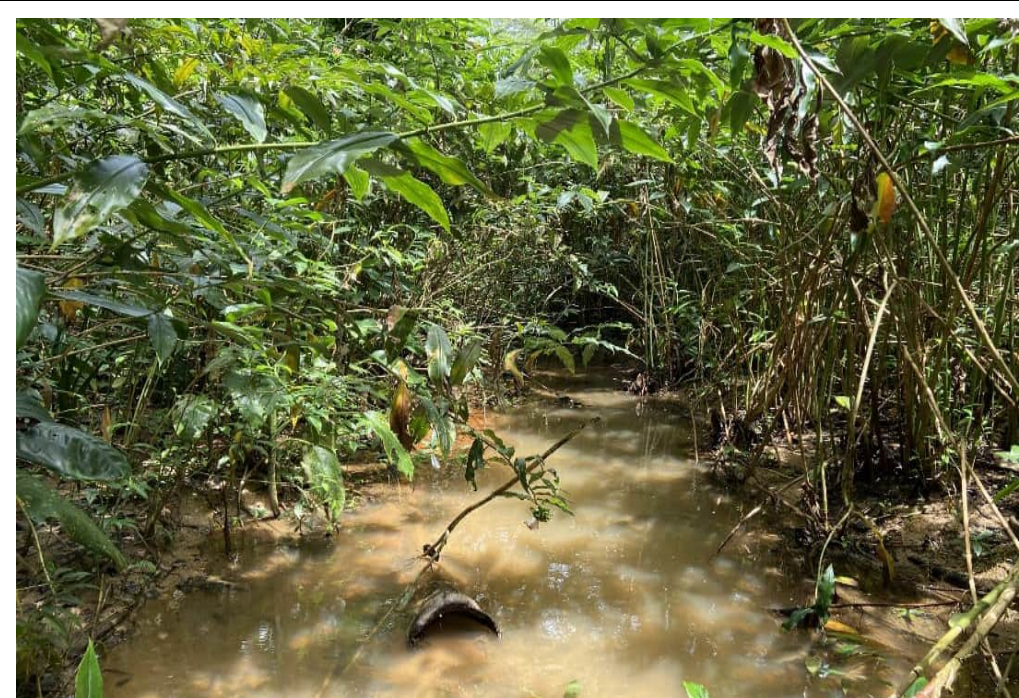
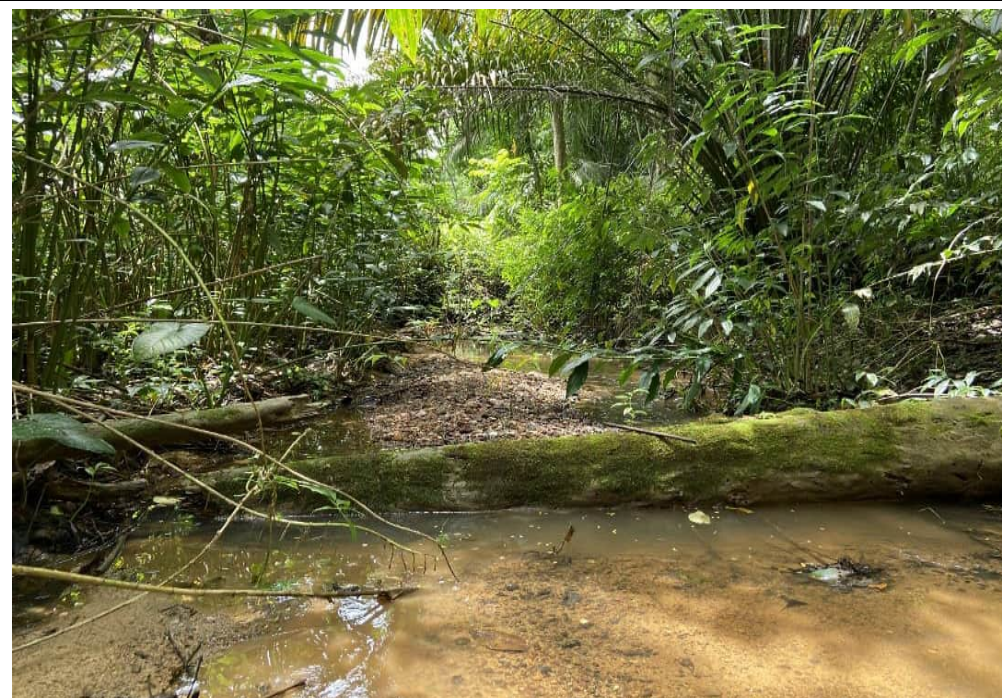
| Stream Mapping Point No. | Cross-section No. | Longitude | Latitude | Photo (In the order of: Upstream, Stream Bed and Downstream) | Photos of Cross-section | Cross-section | Channel Wetted Width | Stream Depth | Flow Velocity (dry weather) | Bed Substrate and Bank Conditions | Riparian Vegetation | Leaf Litter Cover (%) | Canopy Cover (%) | Soil Erosion | Remarks |
|---|---|---|---|---|---|---|---|---|---|---|---|---|---|---|---|
| AW22 | CS42 | 103.80360 | 1.33864 | <div><div><div></div><div></div><div></div></div><div></div></div> | <div><div><div>1) 1st distributary: 0.5 m</div><div>2) tributary + 2nd distributary: 0.5 - 1 m</div><div>3) at the confluence: 1.5 m</div><div>4) downstream of the confluence: 2-3 m</div></div><div><div>1) 1st distributary: y: 5 - 7cm</div><div>2) tributary + 2nd distributary: y: 2-3 cm</div><div>3) at the confluence: 25 cm</div><div>4) downstream of the confluence: 10-25 cm</div></div></div> <div><div><div>1) 1st distributary: 0.3 m/s</div><div>2) tributary + 2nd distributary: 0.1 m/s</div><div>3) at the confluence: Not Applicable</div><div>4) downstream of the confluence: 0.15 m/s</div></div></div> <div><div>1) 1st distributary: Sandy-rocky bed, as there are many small rocks present which mixes well with the sand. Earth banks with very mild slopes, covered with dense vegetation.</div></div> <div><div><i>Cheilocostus speciosus</i>, <i>Syngonium podophyllum</i>, <i>Alcoccia macrorrhizos</i>, <i>Elaeis guineensis</i></div></div> <div>5</div> <div>67.1</div> <div>No</div> <div></div> | | | | | | | | | | |

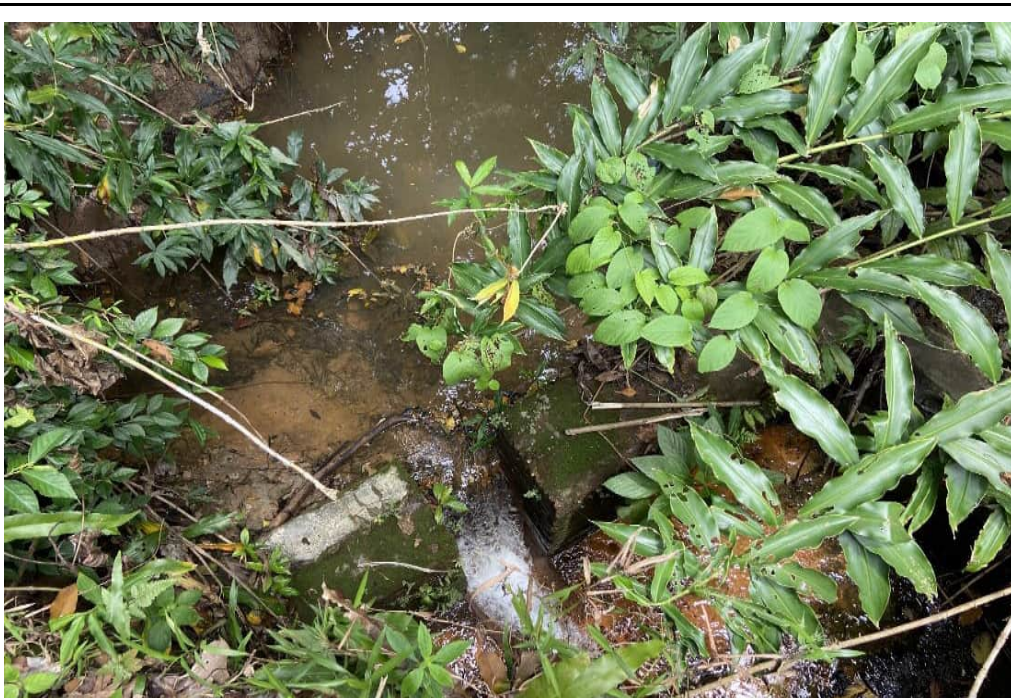
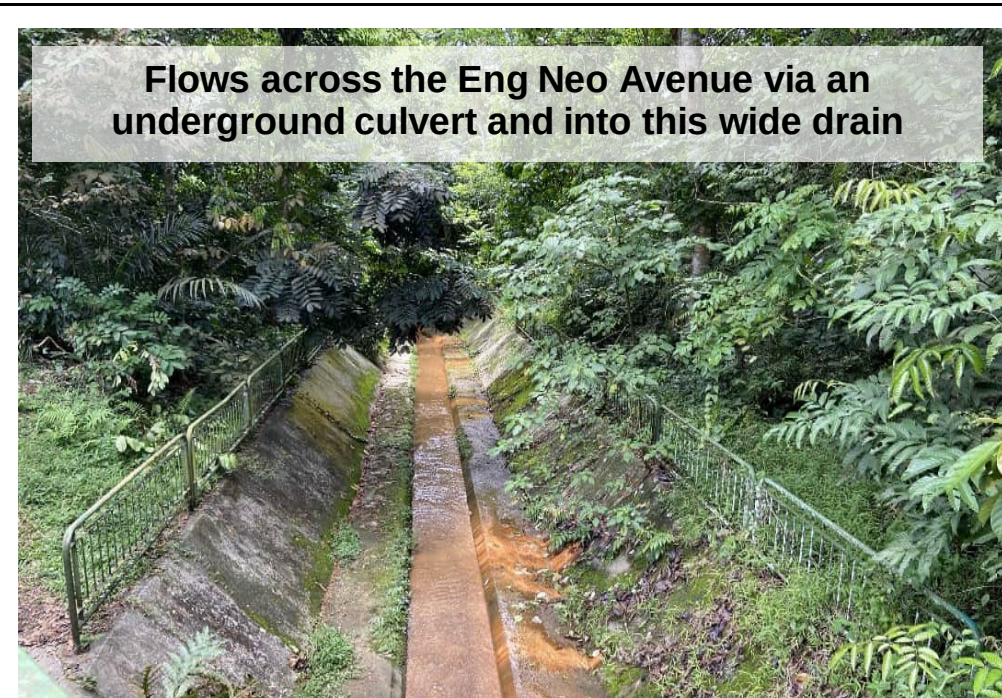
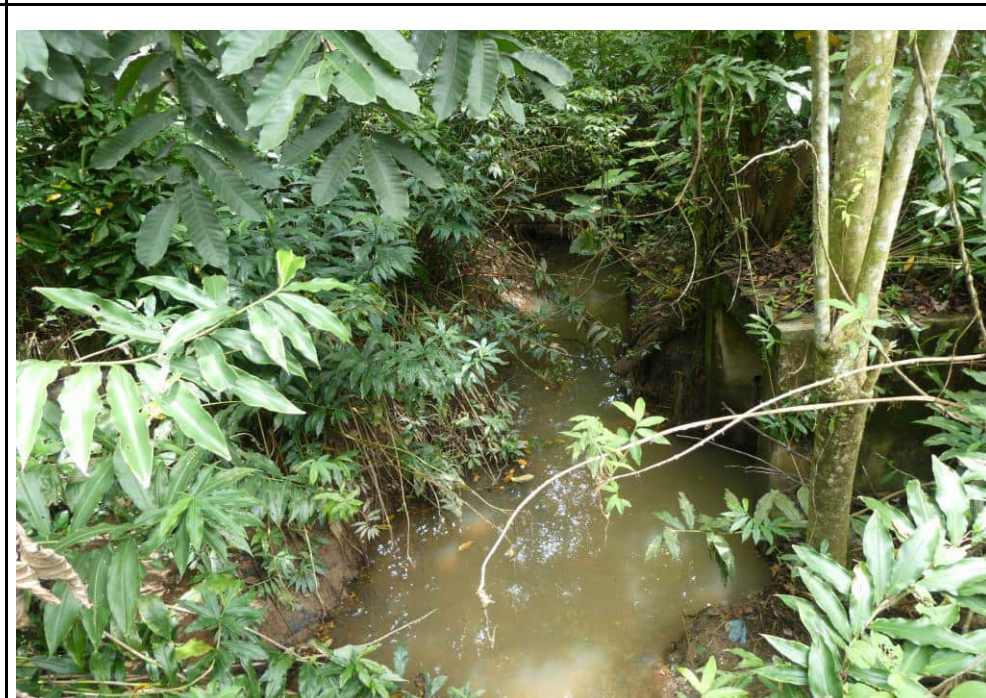
| Stream Mapping Point No. | Cross-section No. | Longitude | Latitude | Photo (In the order of: Upstream, Stream Bed and Downstream) | Photos of Cross-section | Cross-section | Channel Wetted Width | Stream Depth | Flow Velocity (dry weather) | Bed Substrate and Bank Conditions | Riparian Vegetation | Leaf Litter Cover (%) | Canopy Cover (%) | Soil Erosion | Remarks |
|---|---|---|---|---|---|---|---|---|---|---|---|---|---|---|---|
| AW23 | CS43 | 103.80375 | 1.338335 | <div><div><div></div><div></div><div><div>Flows across the Eng Neo Avenue via an underground culvert and into this wide drain</div></div></div><div></div></div> | <div><div><div>1) 1st distributary: 0.5 m</div><div>2) tributary + 2nd distributary: 0.5 - 1 m</div><div>3) at the confluence: 1.5 m</div><div>4) downstream of the confluence: 2-3 m</div></div><div><div>1) 1st distributary: y: 5 - 7cm</div><div>2) tributary + 2nd distributary: y: 2-3 cm</div><div>3) at the confluence: 25 cm</div><div>4) downstream of the confluence: 10-25 cm</div></div></div> <div><div><div>1) 1st distributary: 0.3 m/s</div><div>2) tributary + 2nd distributary: 0.1 m/s</div><div>3) at the confluence: Not Applicable</div><div>4) downstream of the confluence: 0.15 m/s</div></div></div> <div><div>1) 1st distributary: Concrete drain with a sandy bed and dead leaves. Flow discharges via a weir downstream. Earth banks with mild slopes just upstream of this discharge outlet.</div></div> <div><div><i>Cheilocostus speciosus</i>, <i>Aphanamix polystachya</i>, <i>Syngonium podophyllum</i>, <i>Alcoccia macrorrhizos</i>, <i>Acalypha siamensis</i></div></div> <div>30</div> <div>68.1</div> <div>Yes</div> <div>The outlet at AW23 discharges to the wide concrete drain, as shown by the downstream photo.</div> | | | | | | | | | | |
