Specialist Consultancy Services for Environmental Impact Assessment (EIA) for Redevelopment of the Former Turf Club at Bukit Timah

Final Report

Urban Redevelopment Authority

Project reference: URA/T/22/031

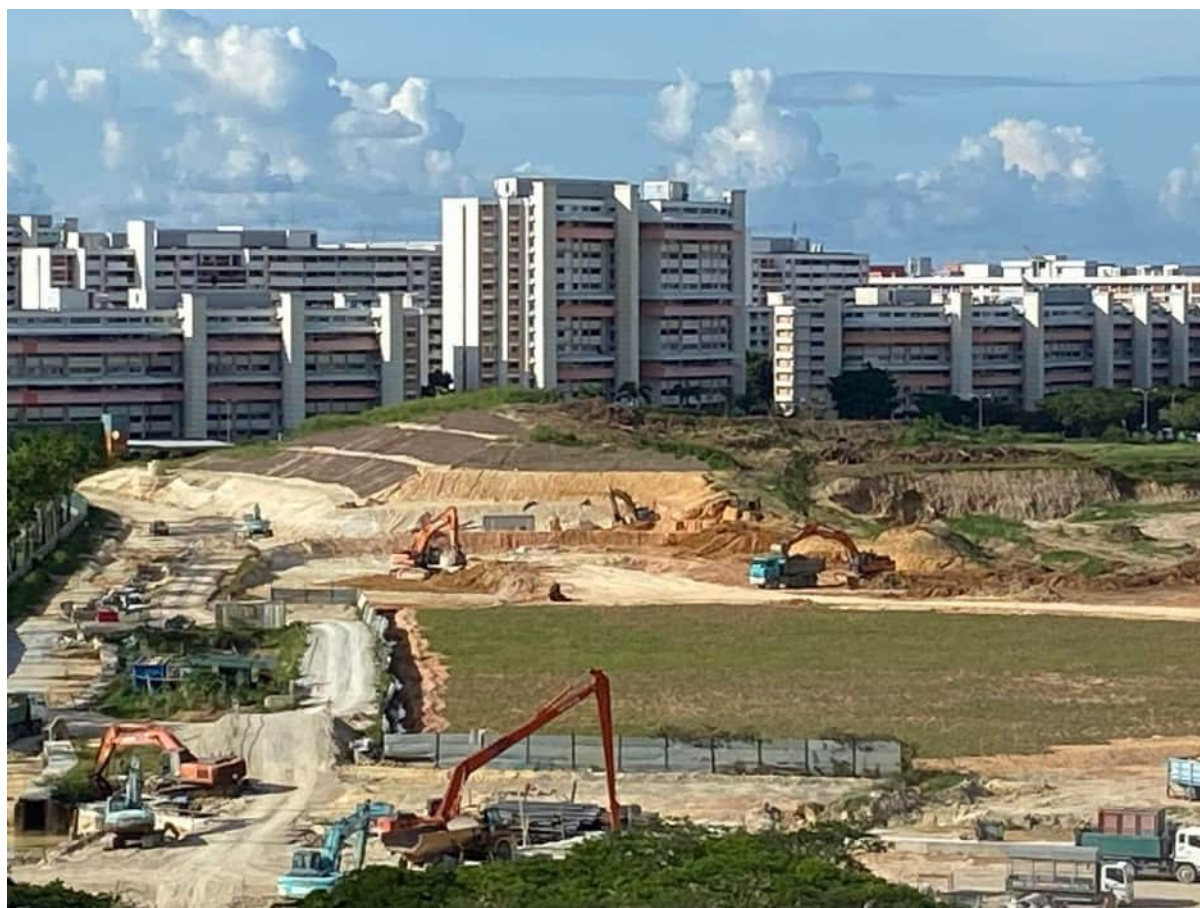
Figure 3-6 An example of site levelling at construction worksite in Singapore (AECOM©)

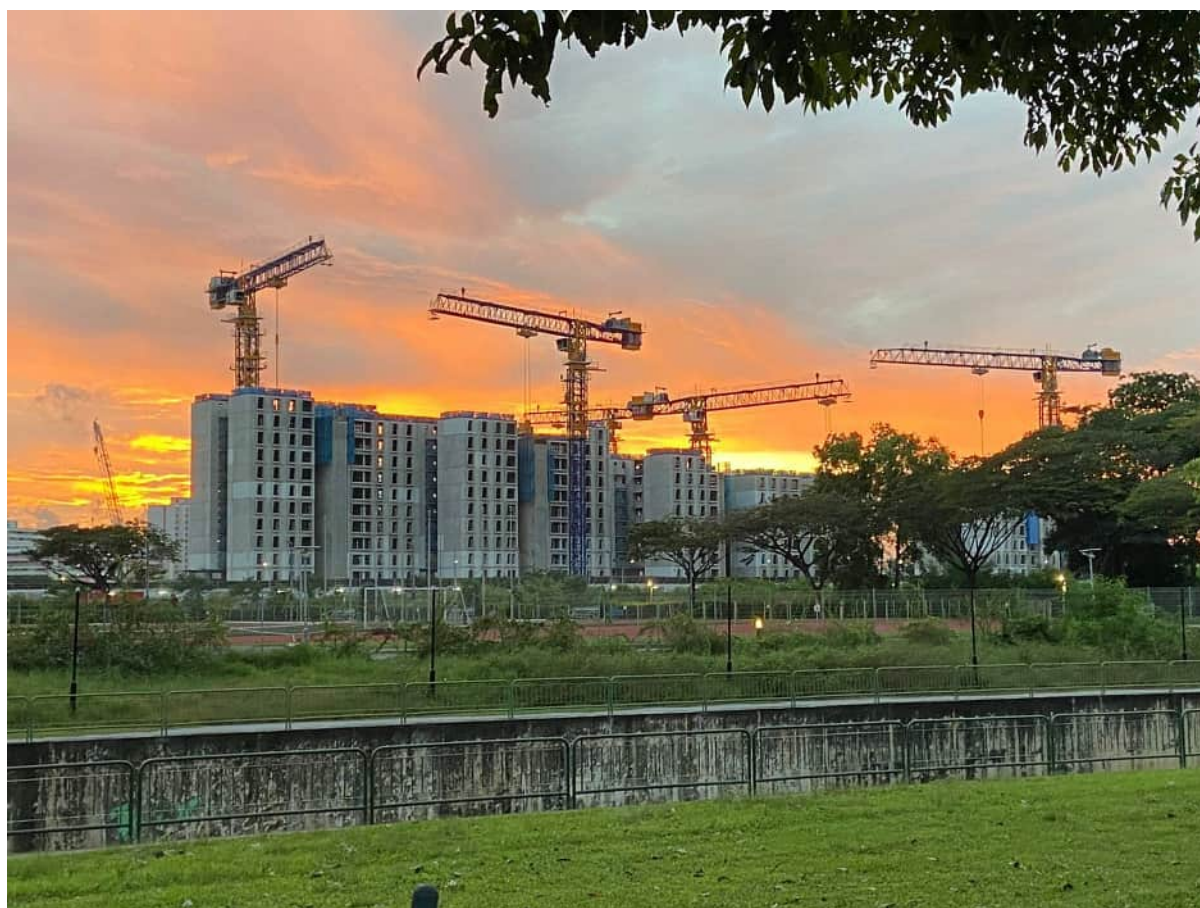
Figure 3-7 An example of superstructure construction works in Singapore (AECOM ©)

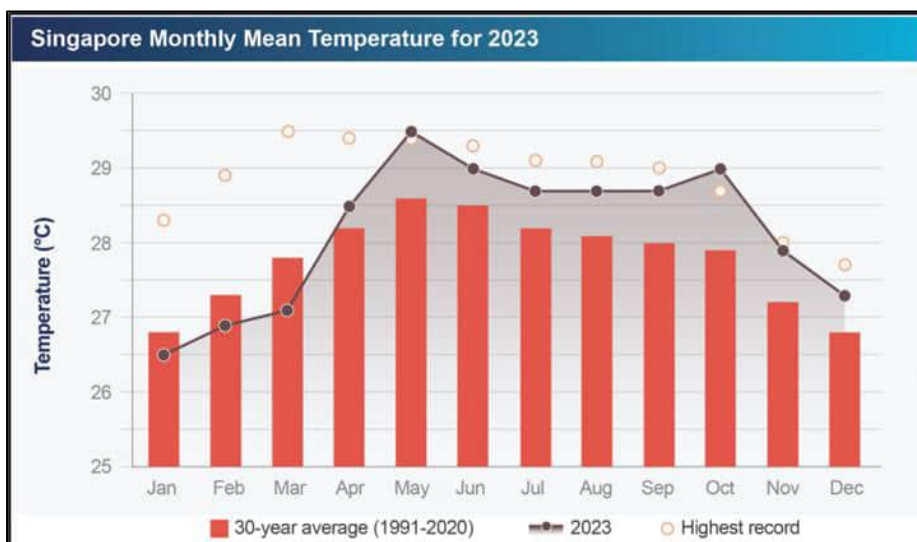
Figure 4-11 Singapore monthly mean temperature for 30-years average from Changi Climate Station with comparison to Year 2023 monthly mean temperature [W-5]

Generally, the temperature variation throughout the year is relatively small as compared to the mid-latitude regions [W-7]. The mean temperature from 2013 to 2022 was 28.01°C, which is 0.04°C higher than the previous record of 27.97°C for the decade from 2012 to 2021. In Year 2023, the annual mean temperature was 28.2°C, with May 2023 being the warmest month at 29.5°C and December 2023 being the coolest month at 26.5°C.

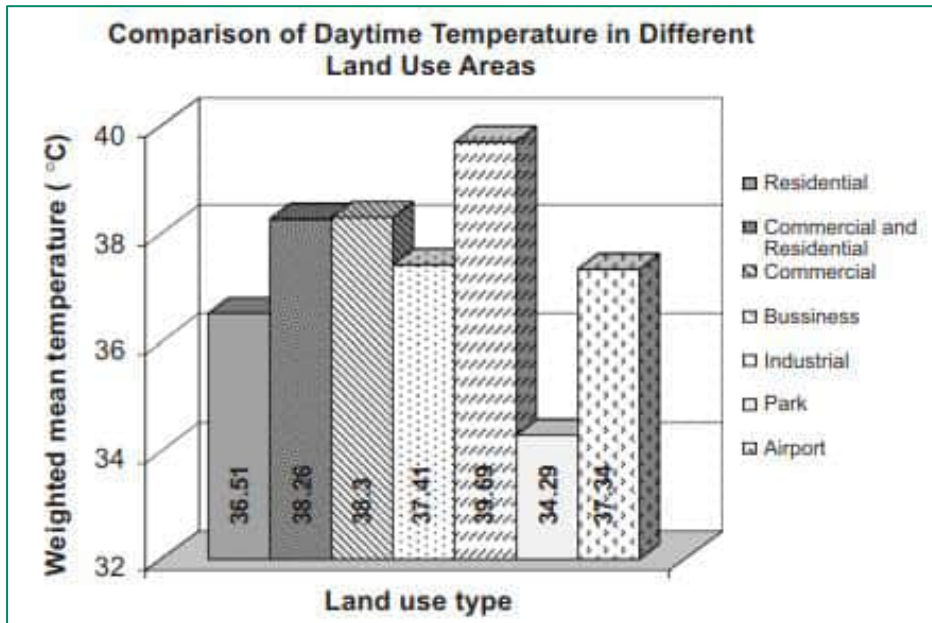
Figure 4-12 Comparison of daytime and night time temperature in different land use areas [P-25]

Although there is no distinct borderline between “urban” and “rural” areas in Singapore, maximum temperature difference of 4.01°C was observed between well-planted area, such as Lim Chu Kang area, and the Central Business District (CBD) area [P-26]. This shows the presence of an Urban Heat Island (UHI) effect in Singapore. Green areas in cities have been considered as potential measure in mitigating the UHI effect. This finding is also supported by a study conducted by Jusuf et al (2007), which shows different daytime temperature at different type of land use areas in Singapore. As observed in Figure 4-12, the daytime temperature in park areas is considerably lower compared to other type of land use areas [P-25].

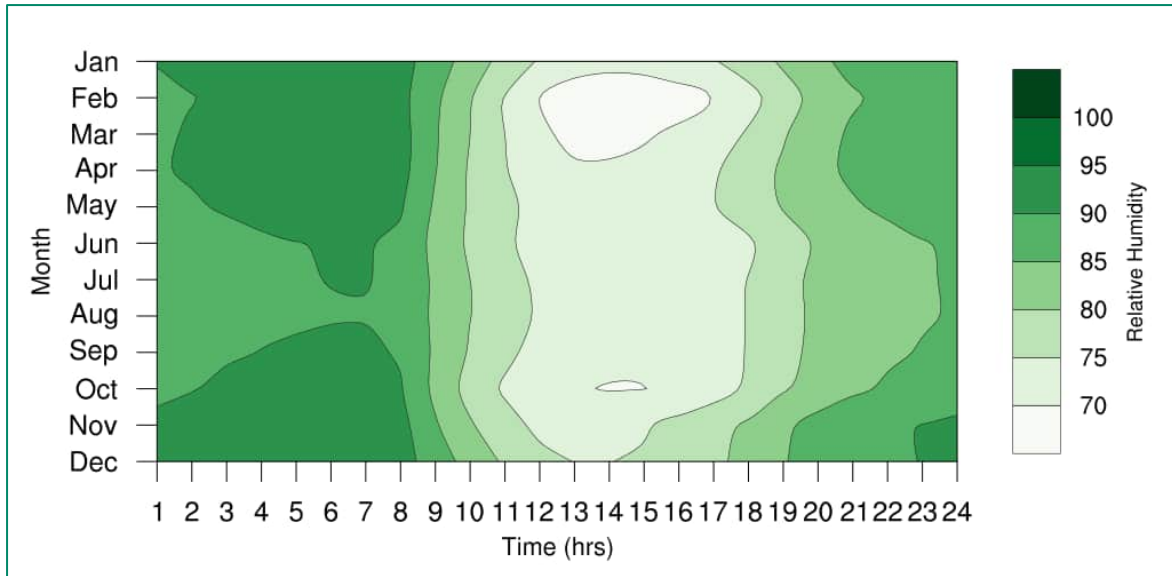
Figure 4-13 Hourly variation of relative humidity for each month from 1981 to 2010 (sourced from MSS [W-4])

Relative humidity shows a fairly uniform pattern throughout the year and does not vary much from month to month (refer to Figure 4-13). Its daily variation is more marked, varying from more than 90% before sunrise to around 60% in the mid-afternoon on days when there is no rain. While the mean annual relative humidity is 83.9%, the relative humidity frequency reaches 100% during prolonged periods of rain.

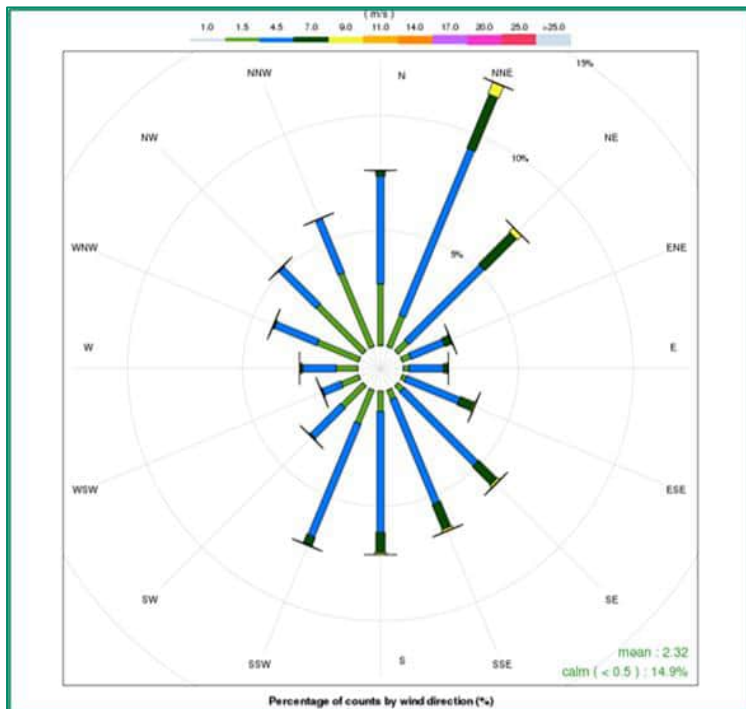
Figure 4-14 Annual wind rose of Singapore (1991 – 2020) (sourced from MSS [W-4])

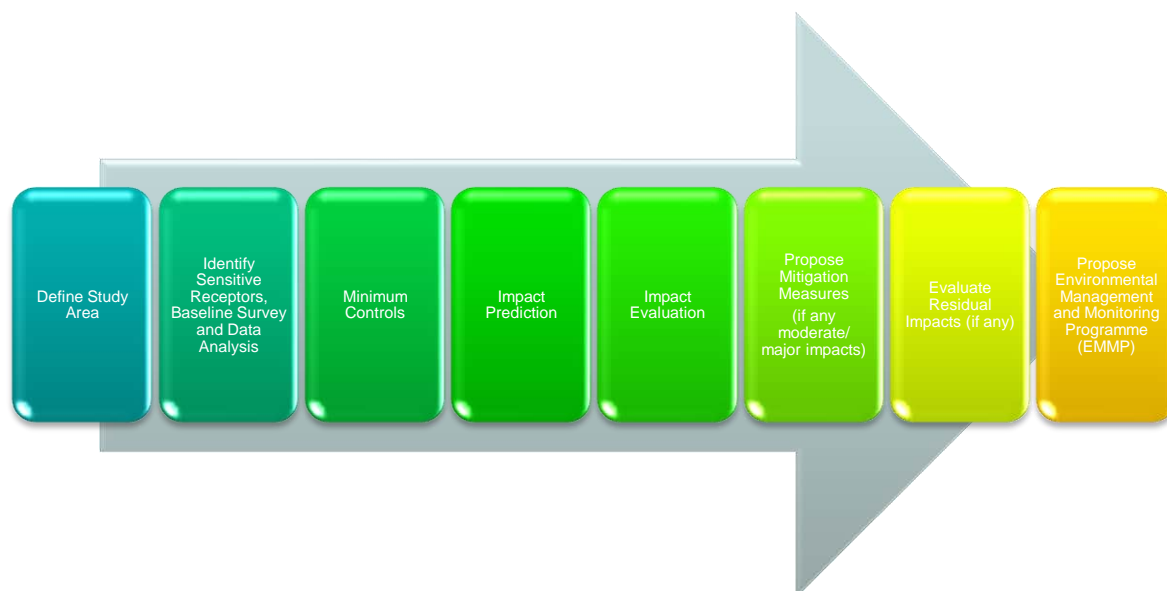
Figure 6-1 Overall EIA workflow

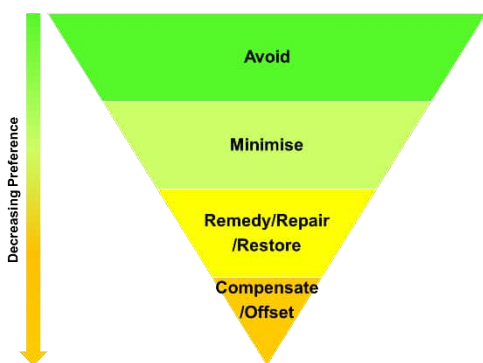
Figure 6-2 Mitigation hierarchy

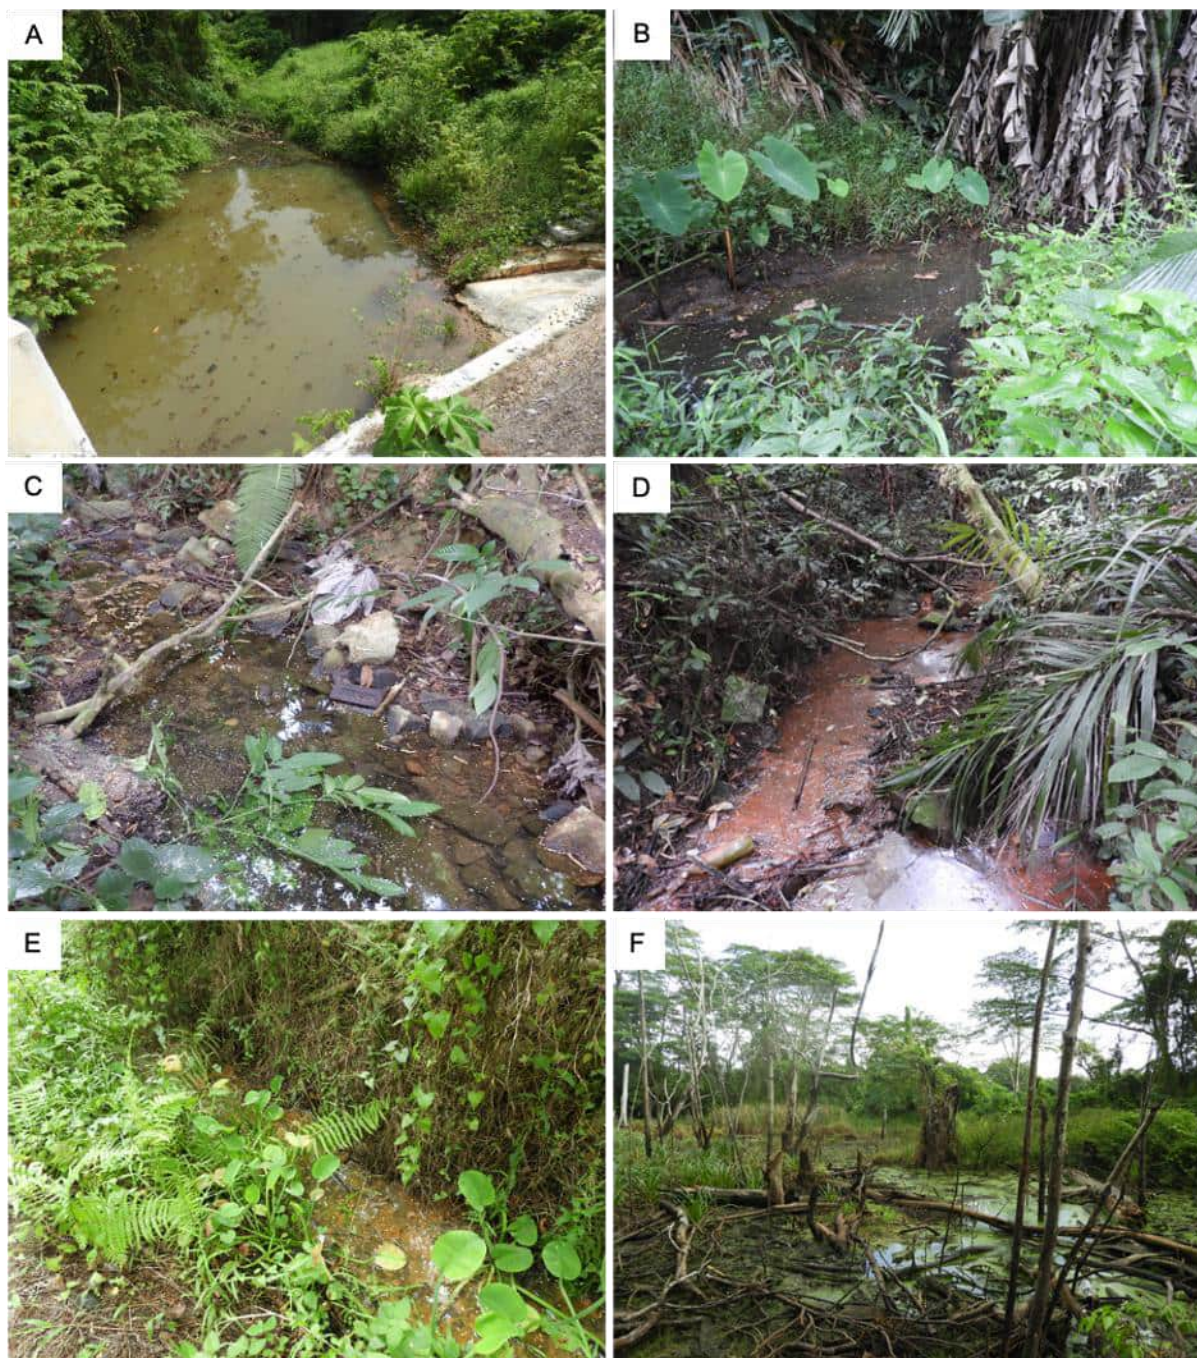
Figure 7-34 Waterbodies in Site A. (A) Upstream of outflow from culvert under the PIE; (B) Semi-open country stream; (C–D) Forested streams with canopy cover; (E) Man-made shallow waterbodies along the old road; (F) A large unmanaged pond (D4) in the centre part of the Study Area.

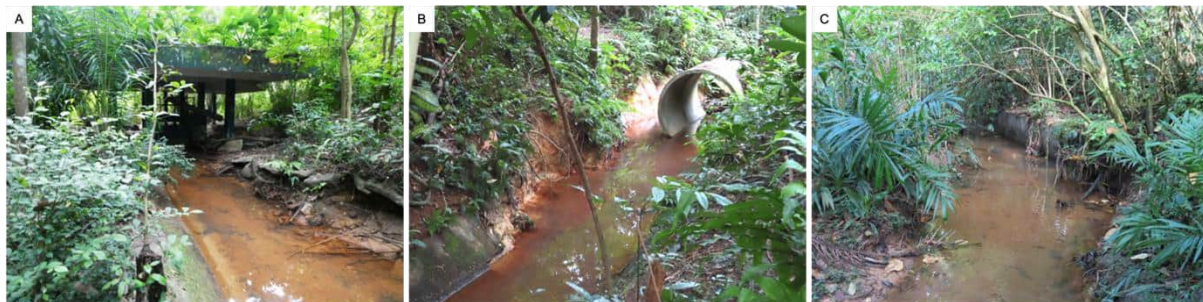
Figure 7-37 Waterbodies in in the forested area within racecourse oval. (A) naturalised concrete canal south of waterbody and Study Area; (B) steep banks and concrete structures along stream; (C) forested stream with canopy cover north of waterbody and Study Area.

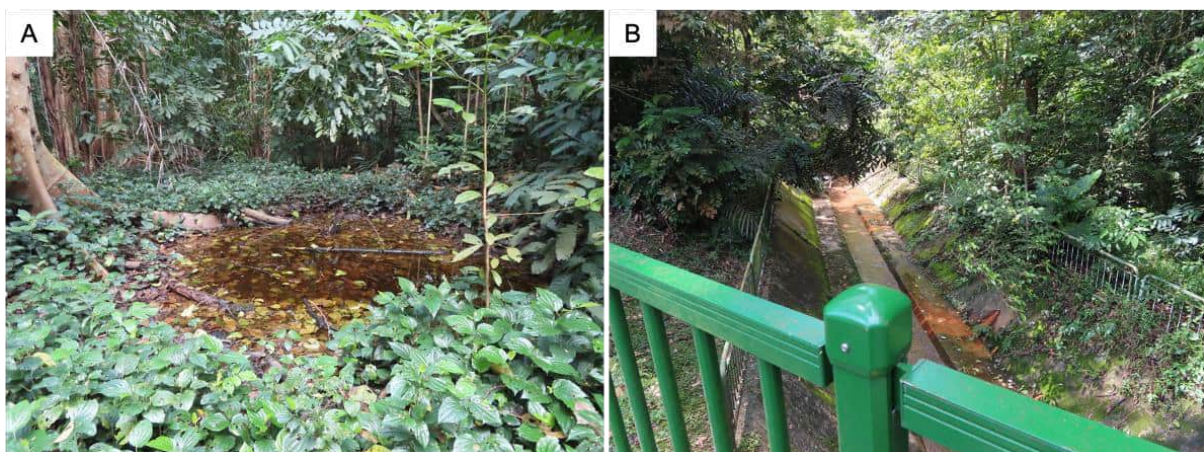
Figure 7-40 (A) A natural ponding area within Site F; (B) An existing concrete canal that runs from Site A to Site F

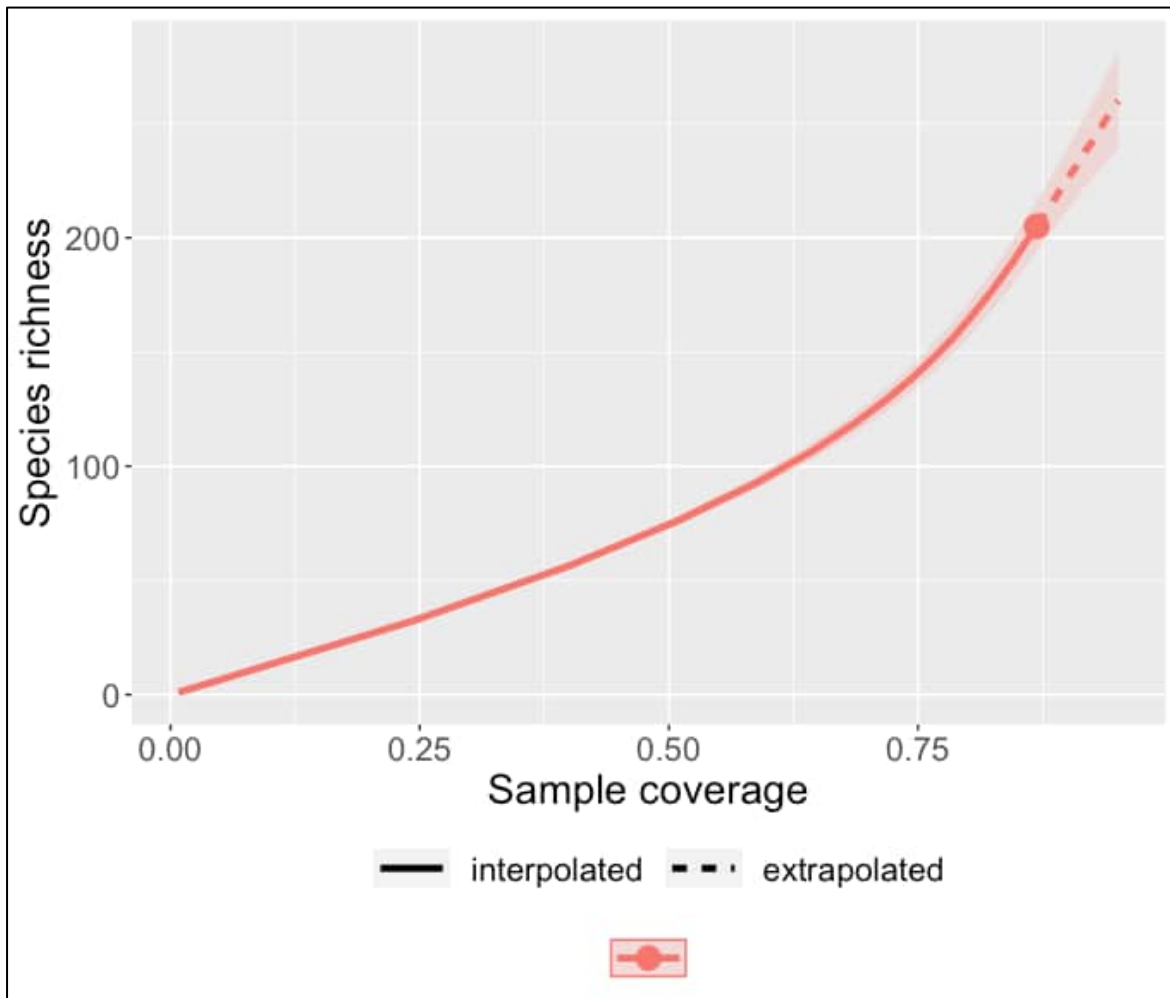
Figure 7-62 Coverage-based sampling curve from eighteen 20 × 20 m vegetation plots in sites A–F

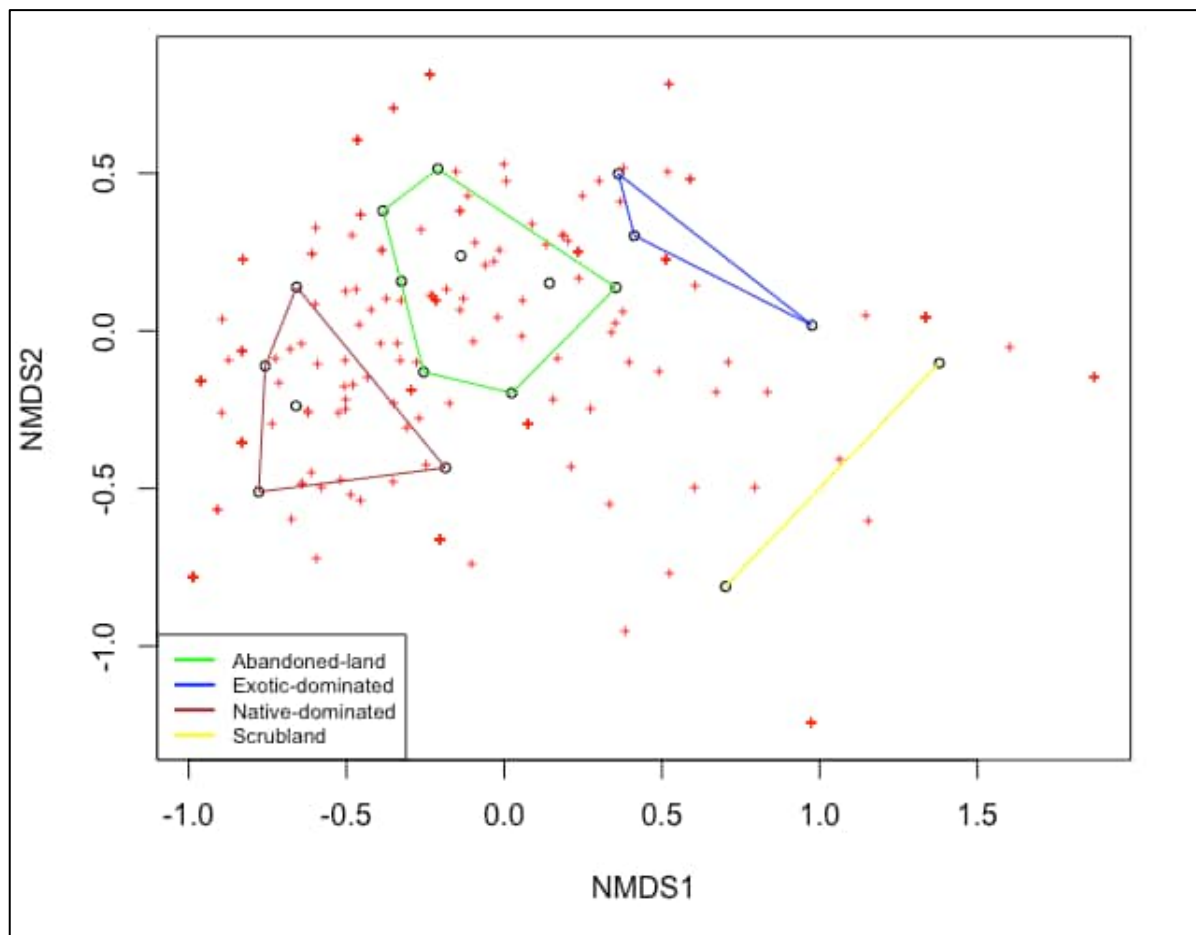
Figure 7-63 NMDS ordination of the 18 vegetation plots (open circles) based on species composition. Red crosses represent the plant species found in the plots. Stress value = 0.11, k = 2.

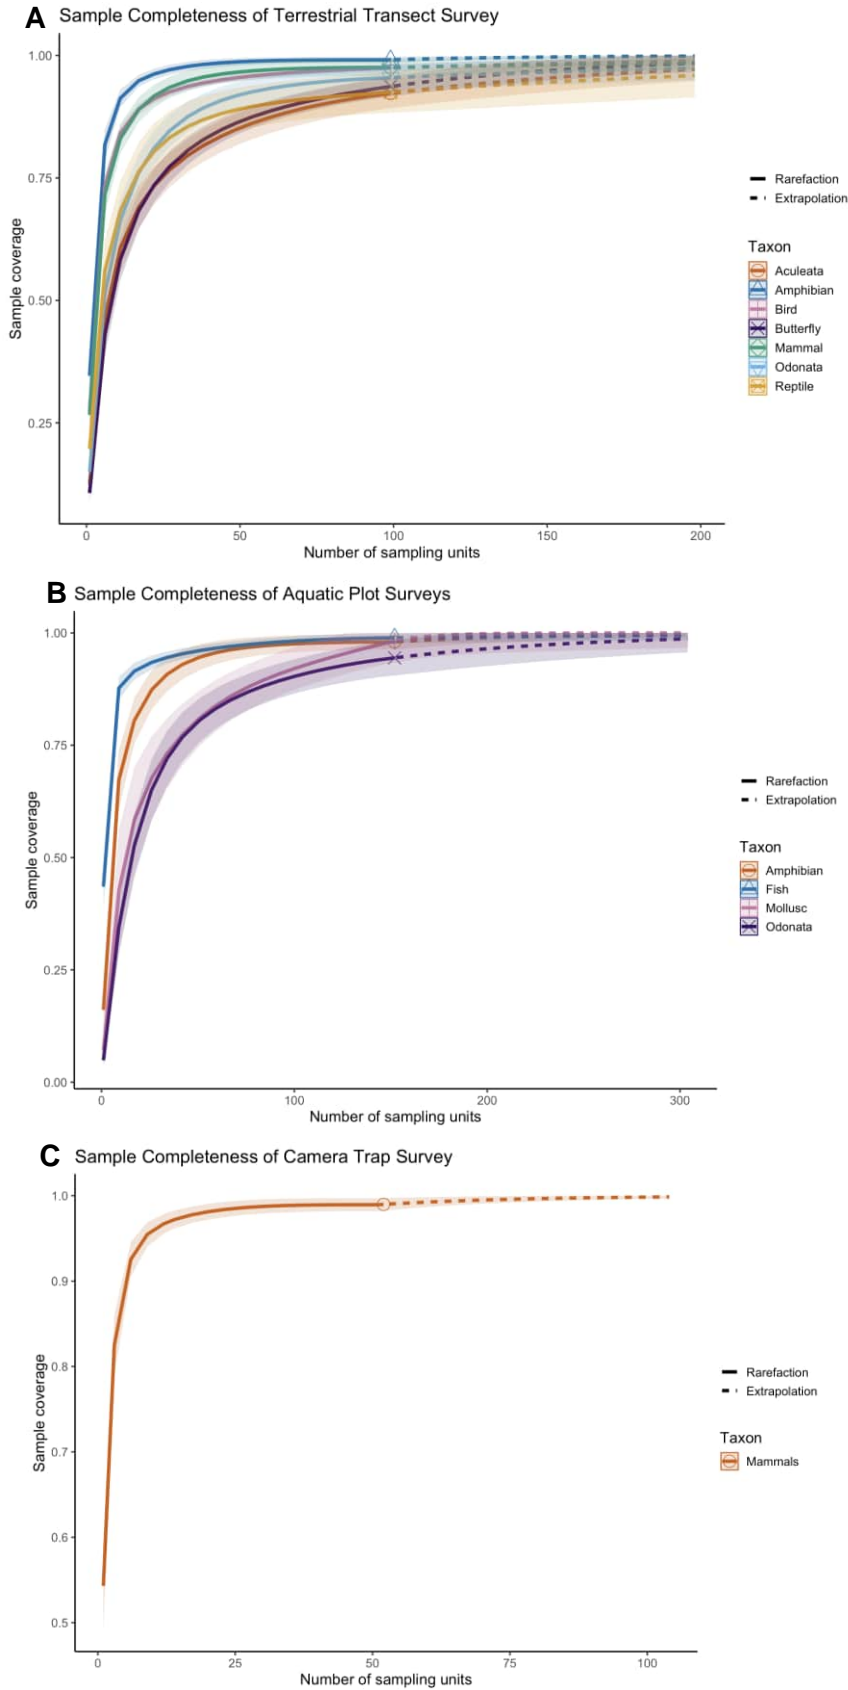
Figure 7-65 Taxon sampling curves for (A) terrestrial surveys; (B) aquatic surveys; (C) camera trapping

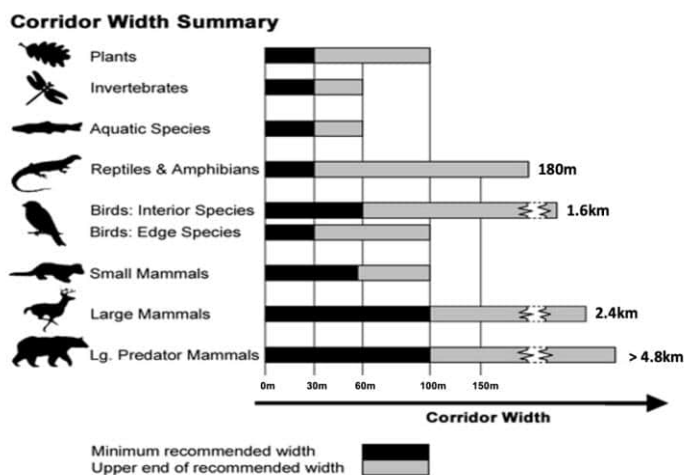
Figure 7-81 Corridor width of different fauna groups [P-36]. Extracted from USDA National Agroforestry Centre Guidelines

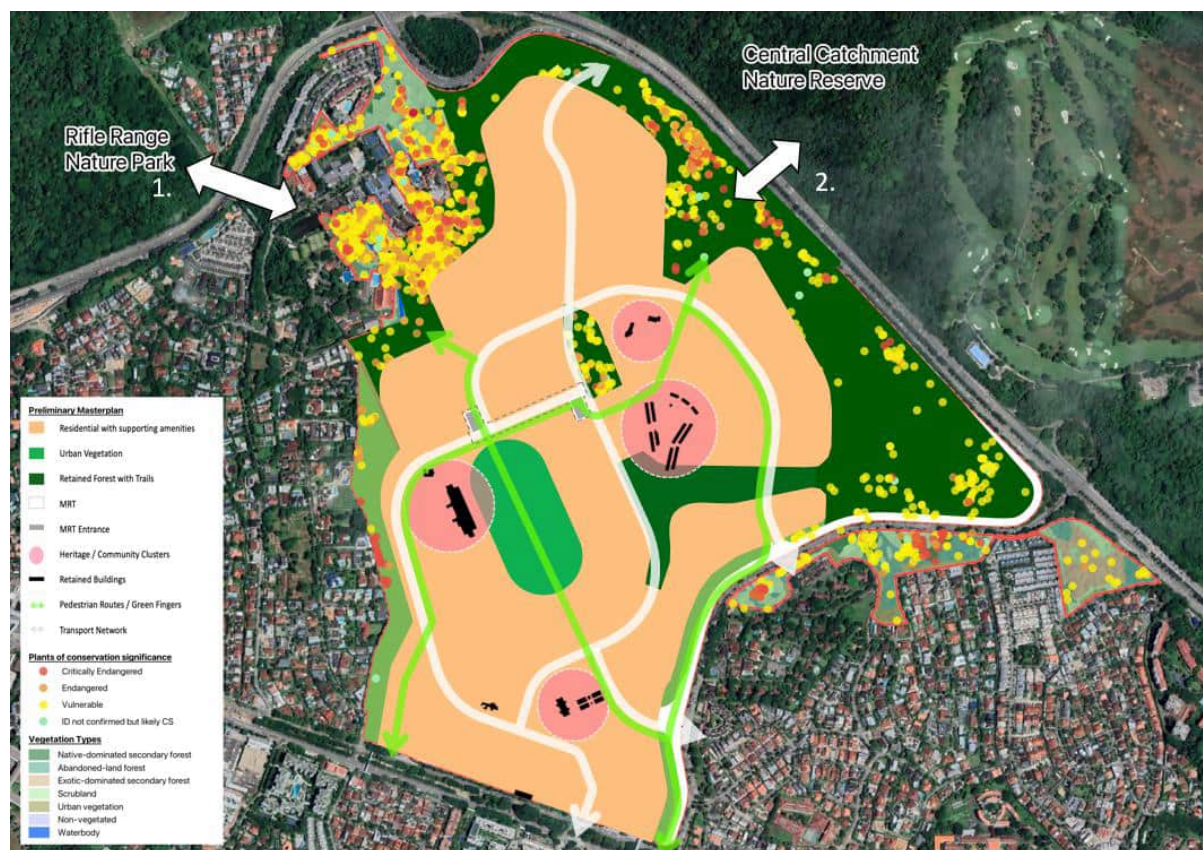
Figure 7-83 Possible connectivity outside Project Area

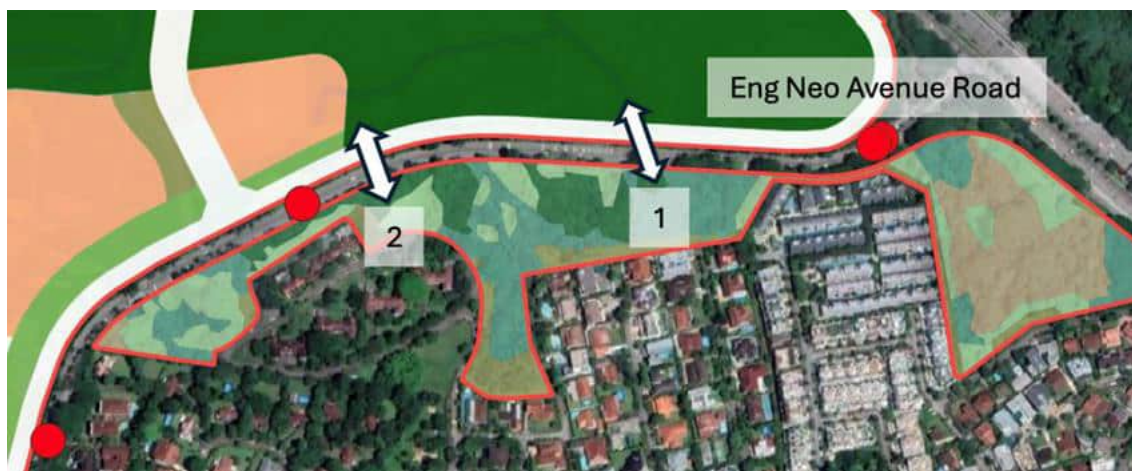
Figure 7-87 Suggested culvert location under Eng Neo Avenue
