1. Introduction

Recurring slips and falls, especially during wet weather, on the vehicle ramp linking street level and basement 1 access at Women's Tower. There was no direct pedestrian access from street level to the basement 1.

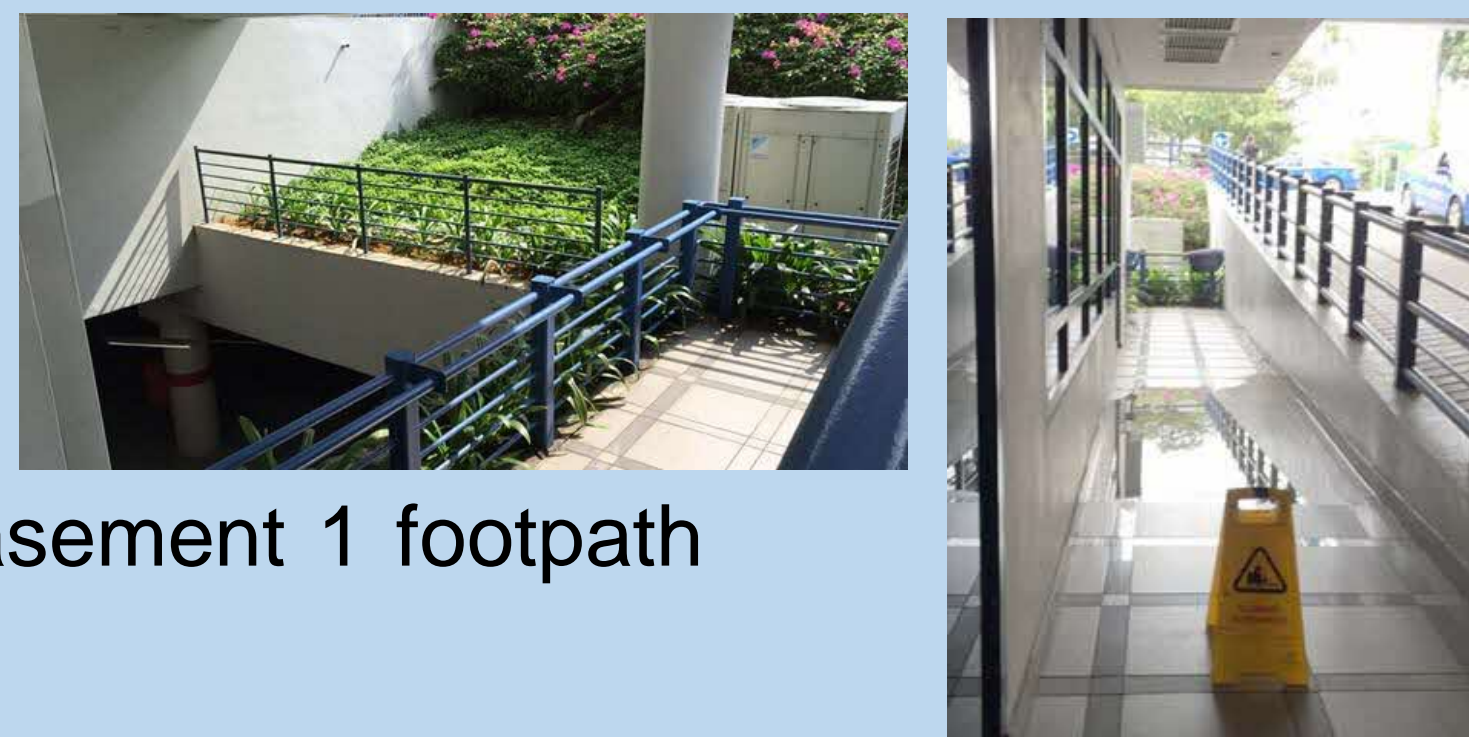
To eliminate recurring water-ponding at basement 1 footpath beside the vehicle ramp.

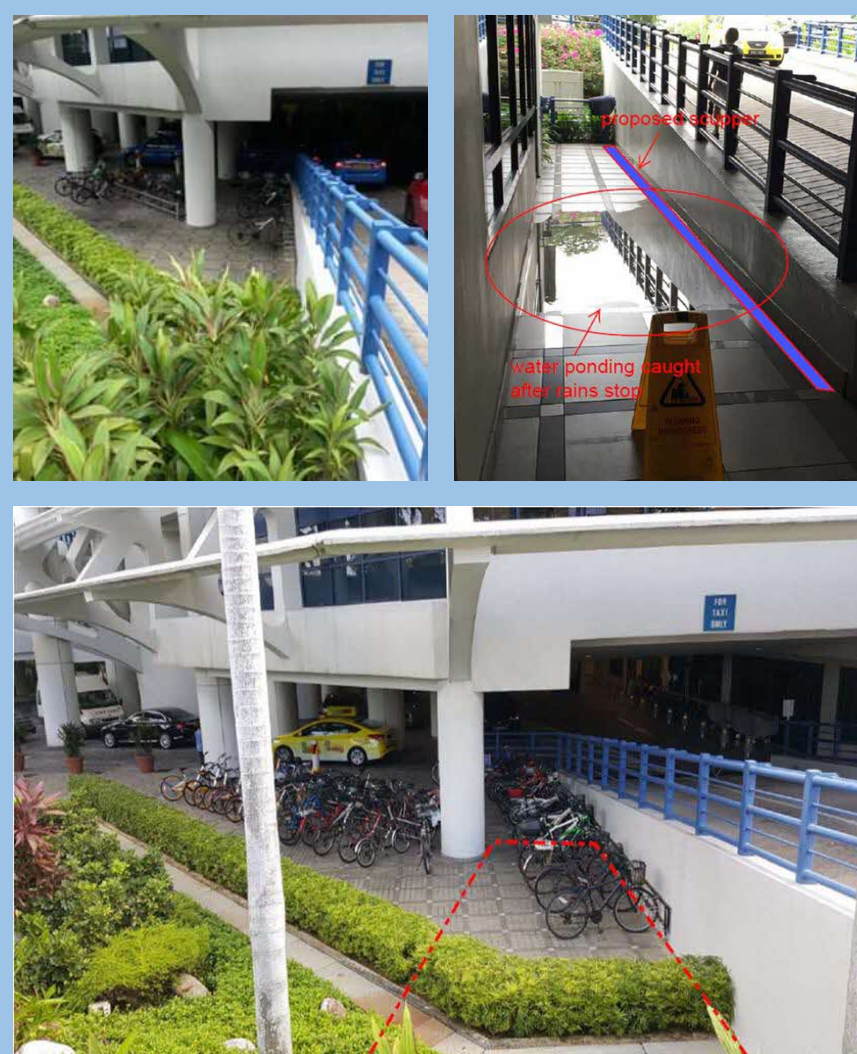
3. Methodology

Surveyed the site and found that we could not safely fit a pedestrian ramp in the tight space.

Decided to build a staircase beside the vehicle ramp and improve drainage at the base of the proposed staircase and along the footpath.

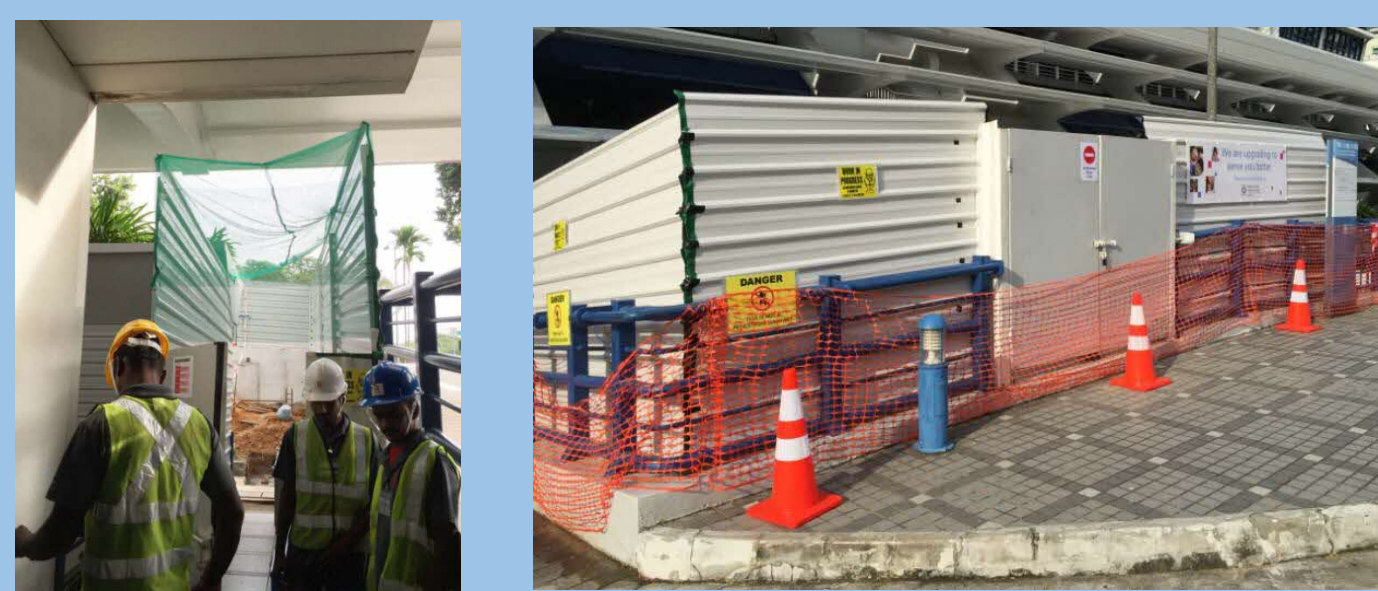
3b. Do

Implemented strict infection and noise control measures to safeguard well-being of occupants in adjacent clinics and nearby wards, plus operations of the nearby KKIVF Lab.

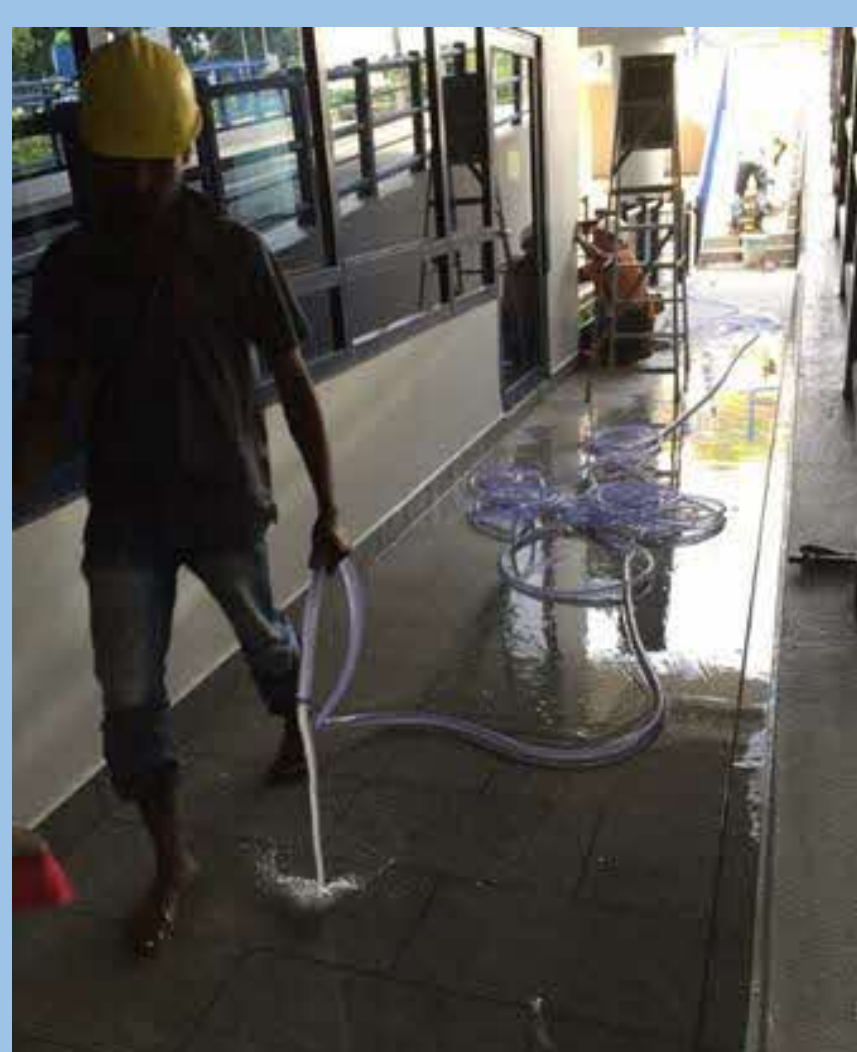
3c. Check

Assessed anti-slip tiles and tested drainage provisions to ensure rapid drain off even during prolonged, heavy rain.

Assessed various designs for signage to advise pedestrians to use the new staircase and avoid using the vehicle ramp.

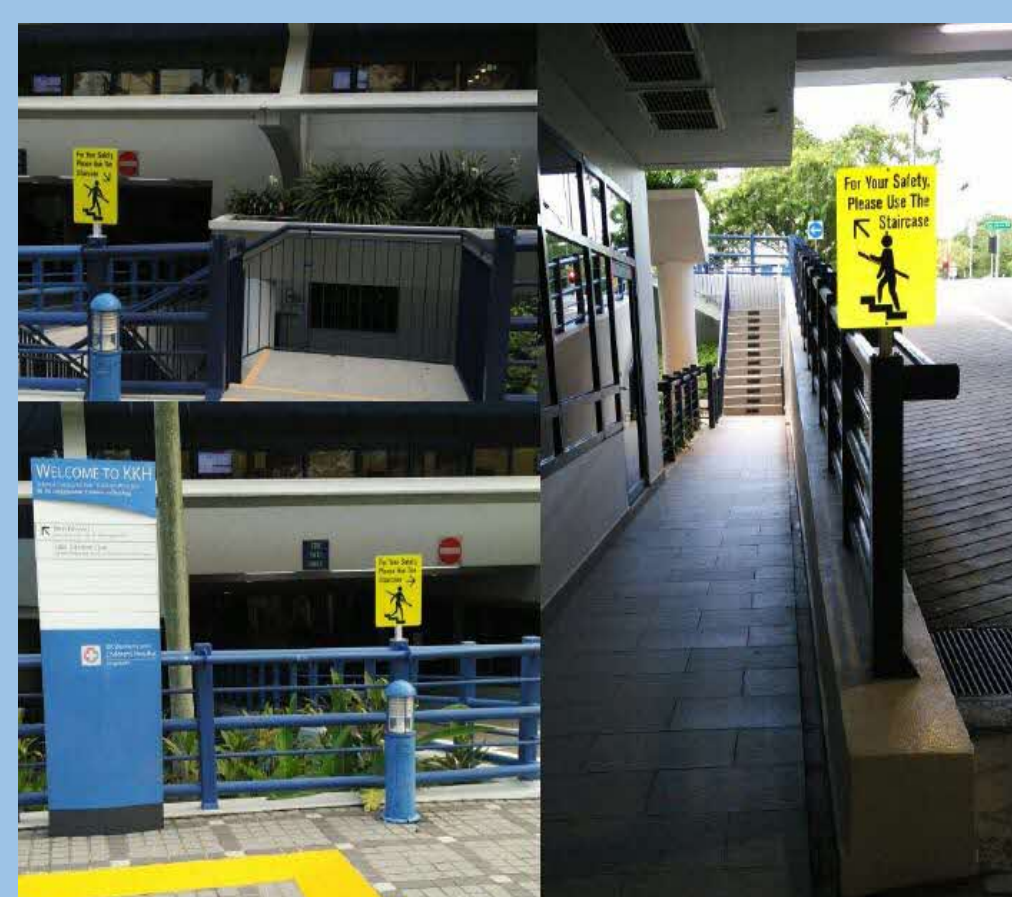
3d. Action

Installed clear, eye-catching signage at street level and basement 1 to alert and advise pedestrians to use the new staircase.

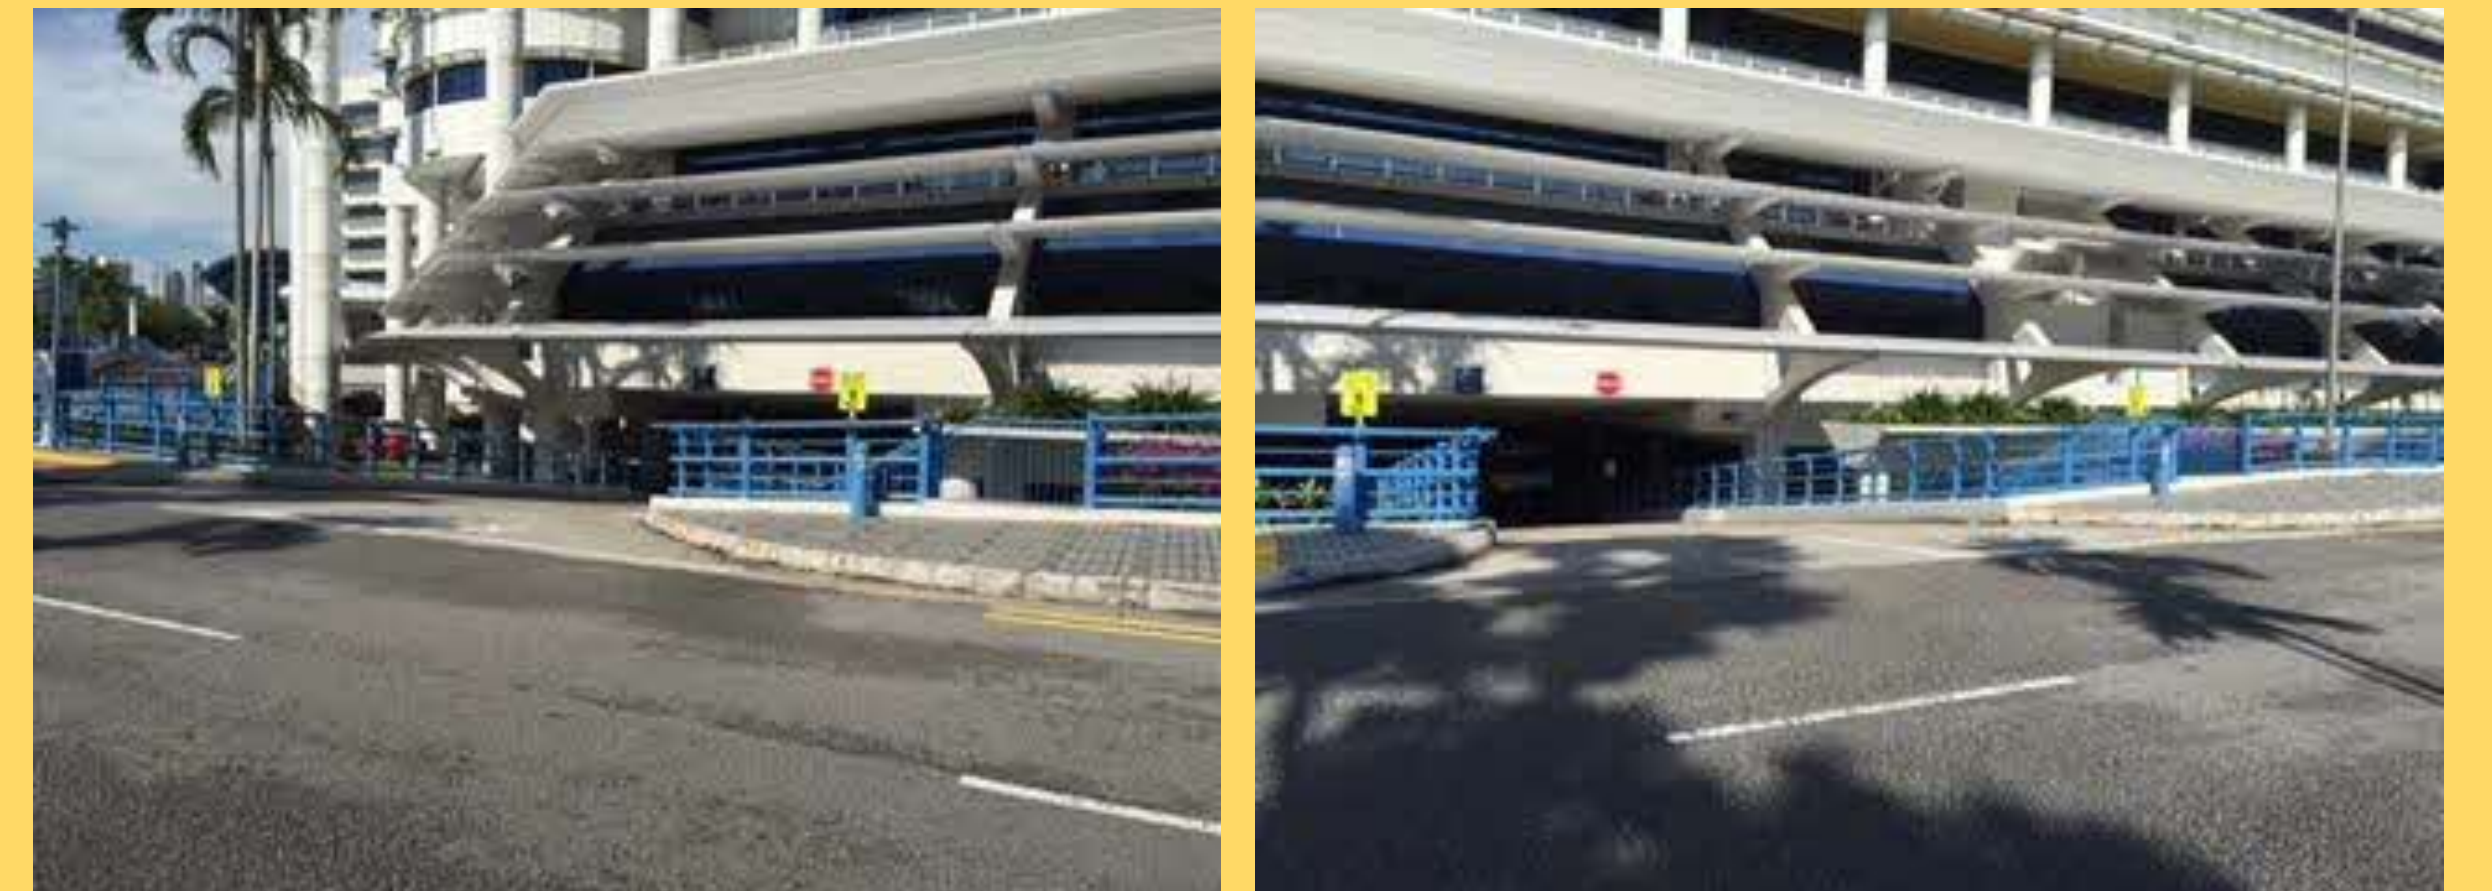
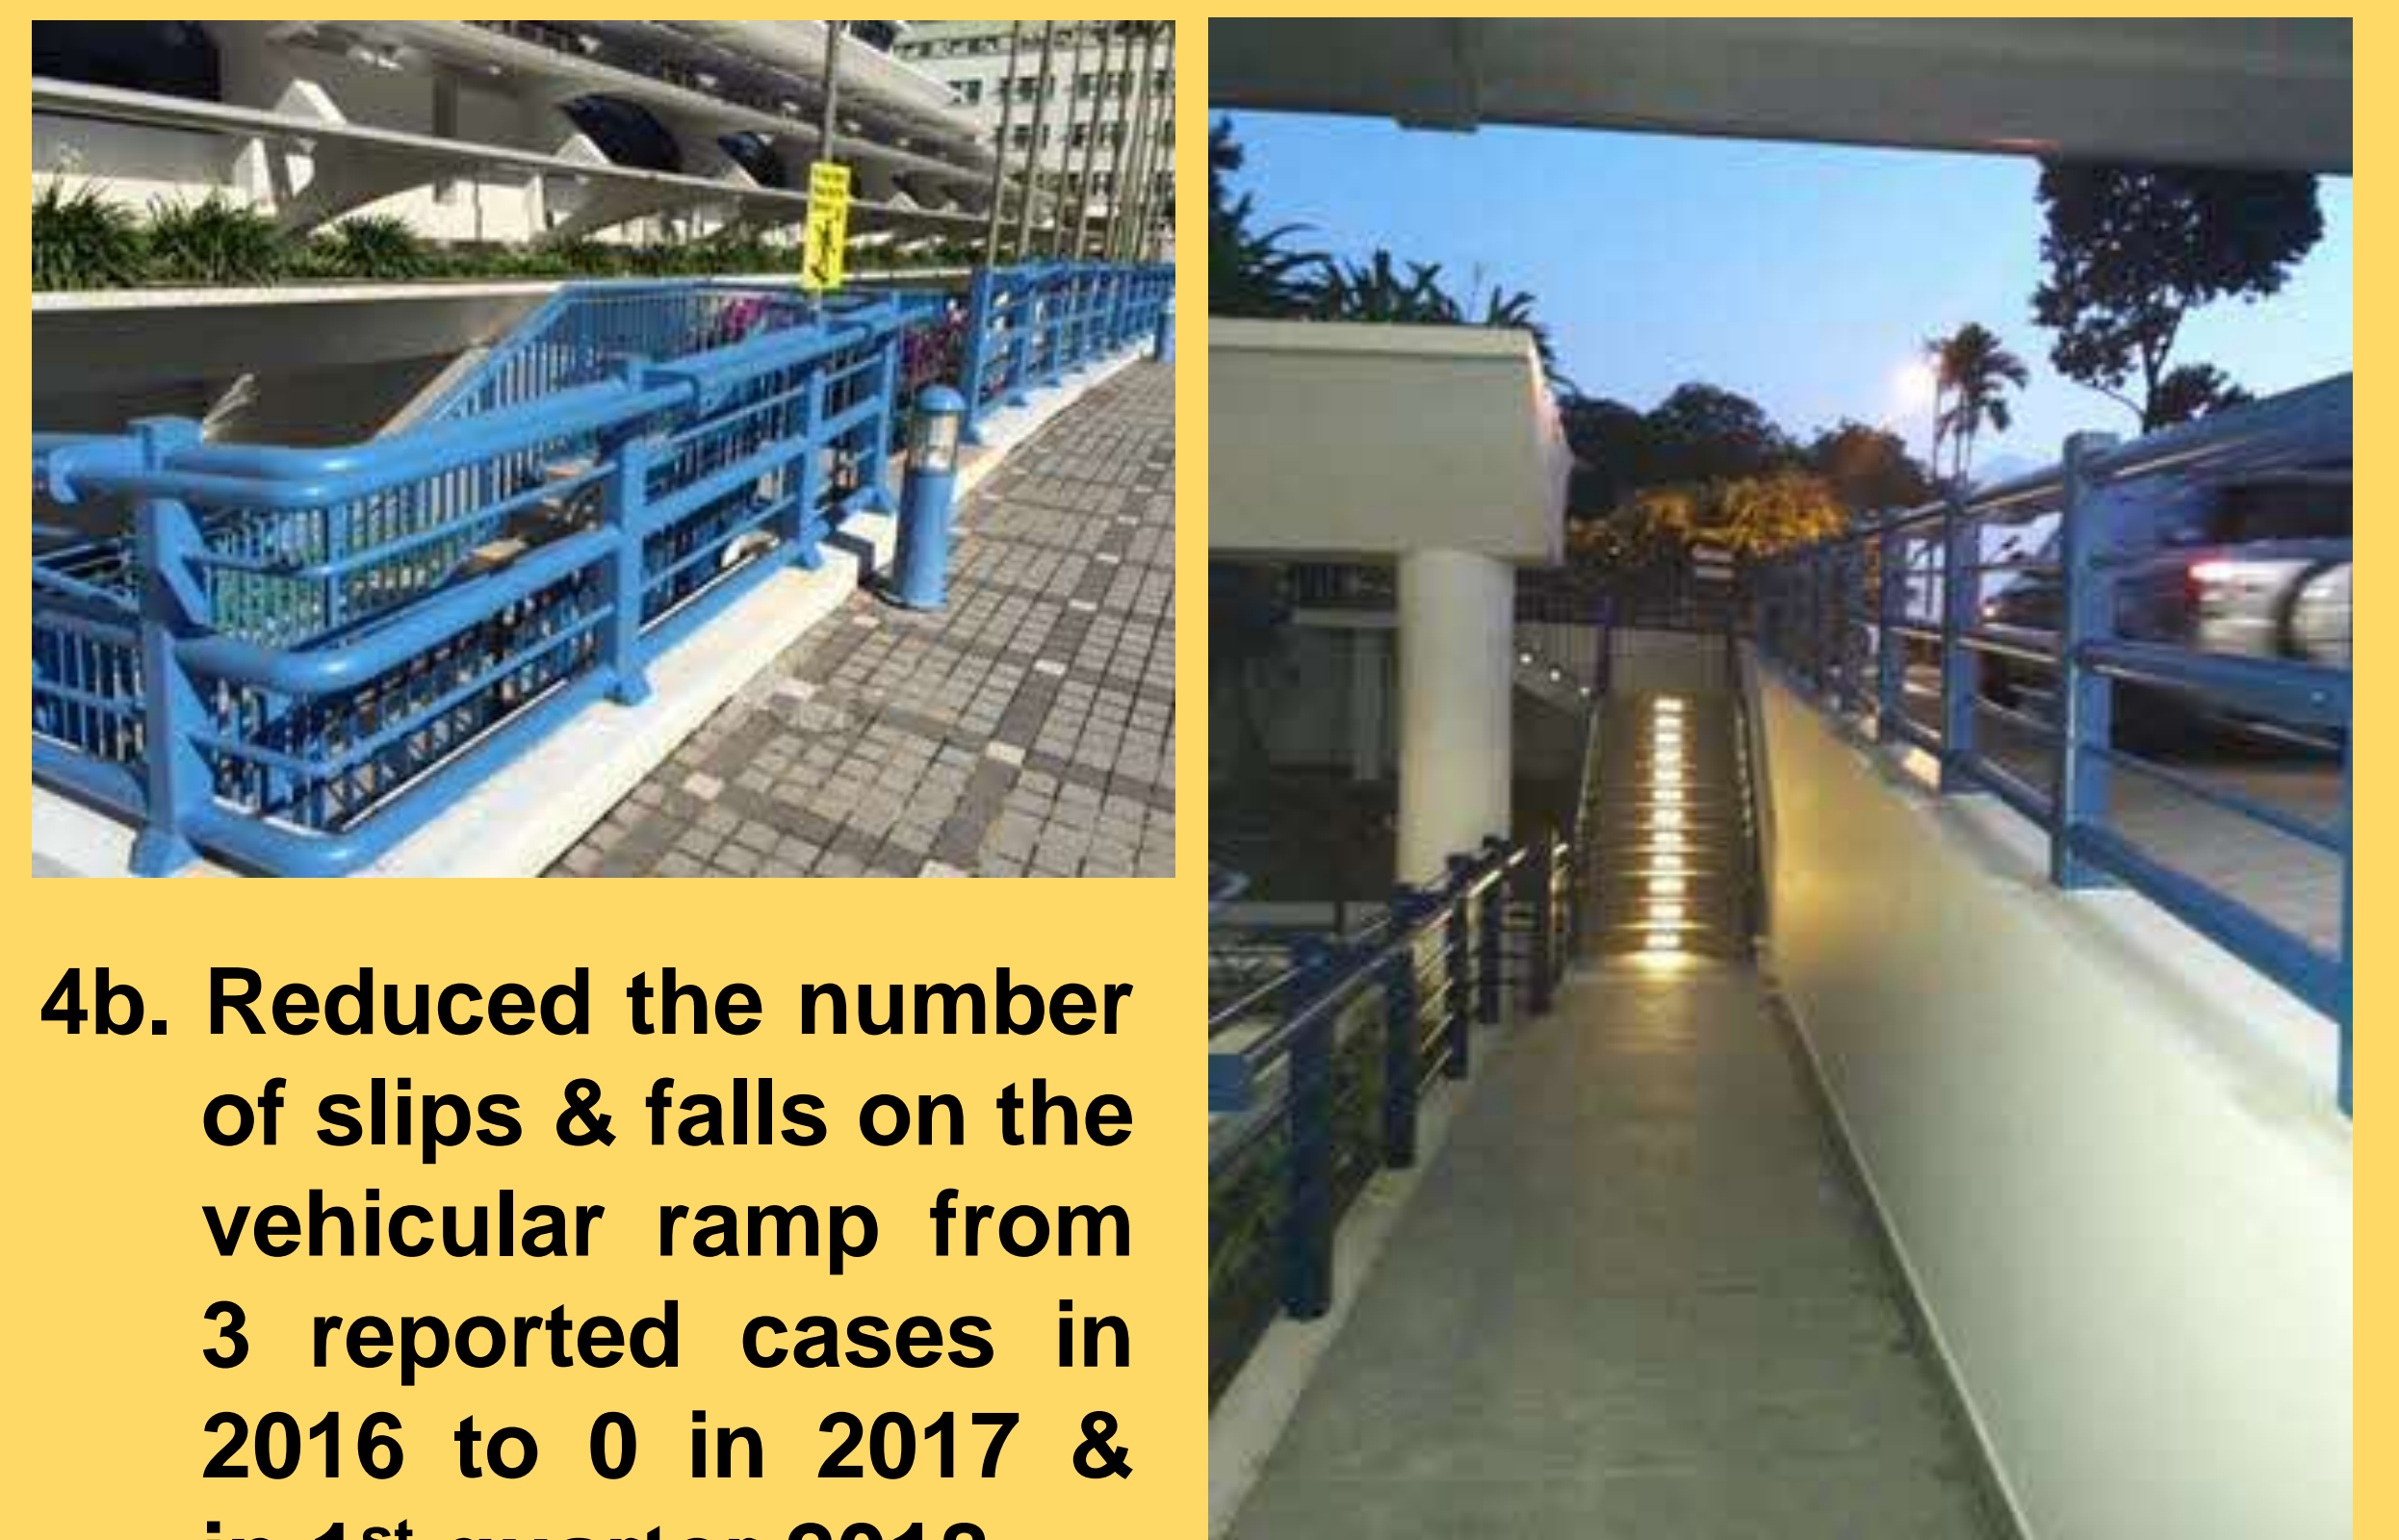
4. Results and Conclusion

4a. Provided pedestrians with a direct, well-lit, anti-slip staircase linking street level & basement 1 at the entrance of Women's Tower.

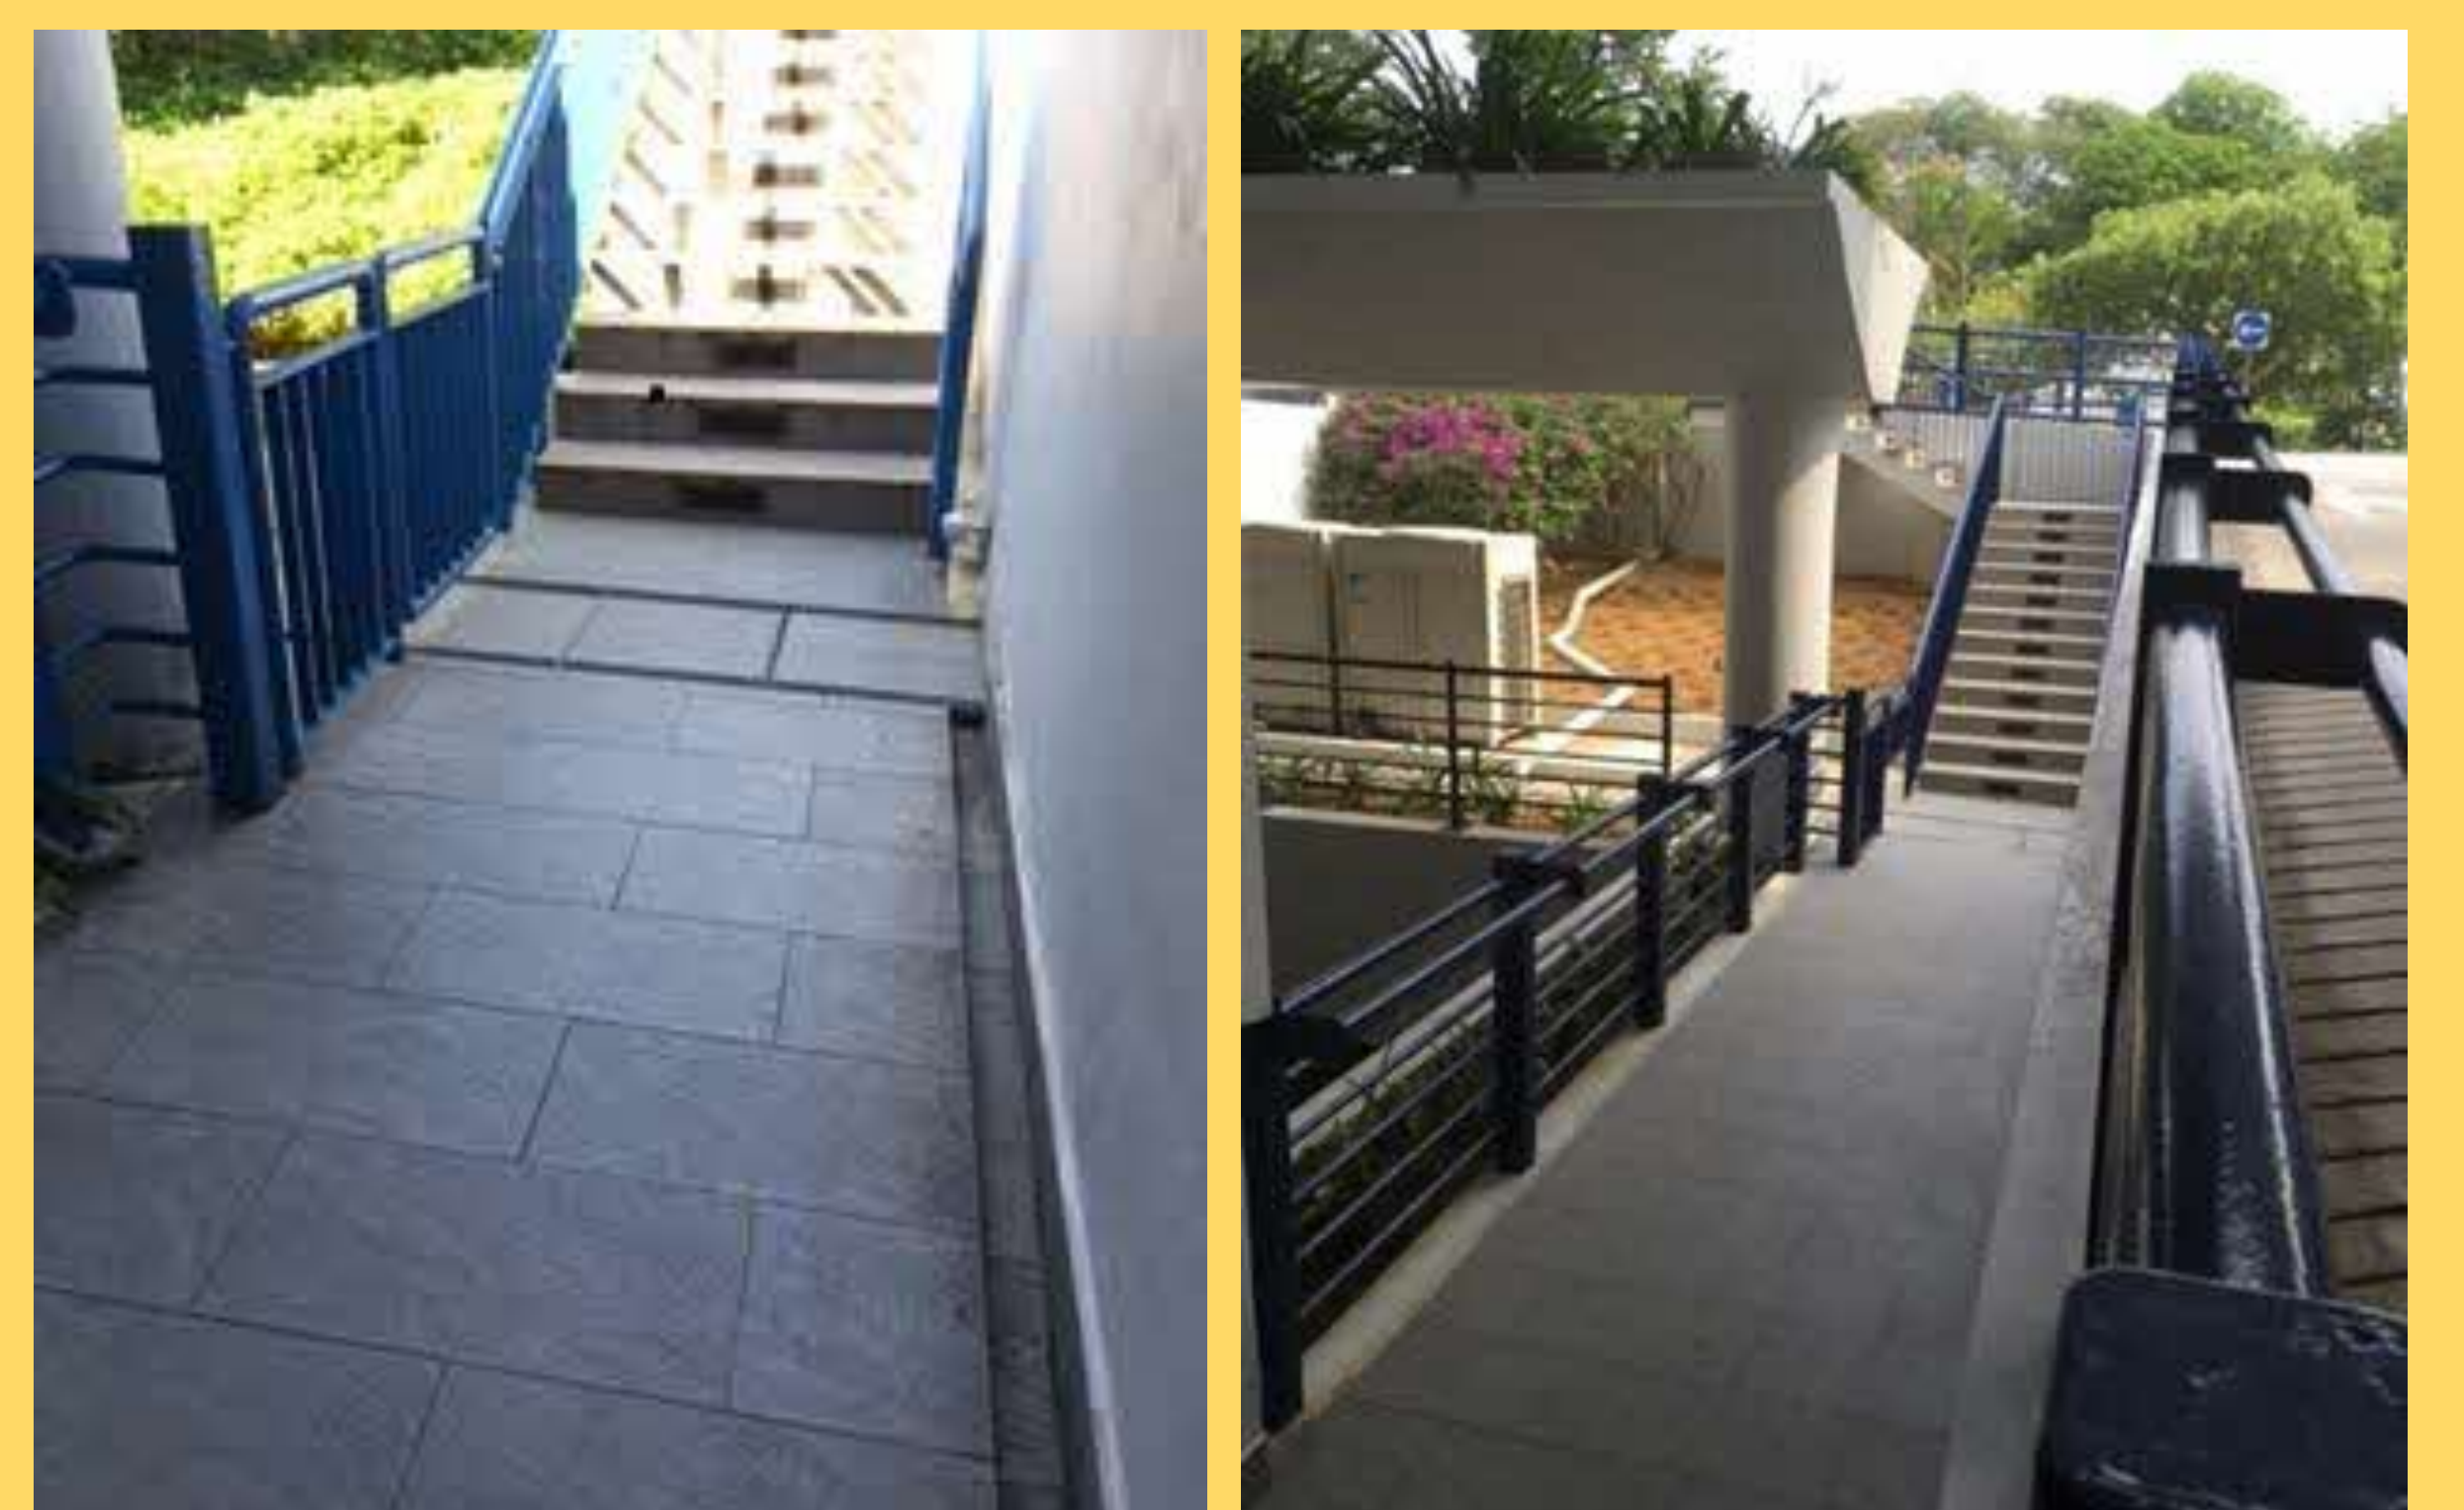
4c. Improved drainage along the footpath beside the ramp to eliminate potential slips & falls due to water-ponding. Resurfaced the footpath with anti-slip tiles to improve pedestrian safety during wet weather.
