Singapore Healthcare Management 2021

Providing a **safe transfer** of Vac-Lok cushions with a new **transportation trolley** implementation

National Cancer Centre Singapore
SingHealth

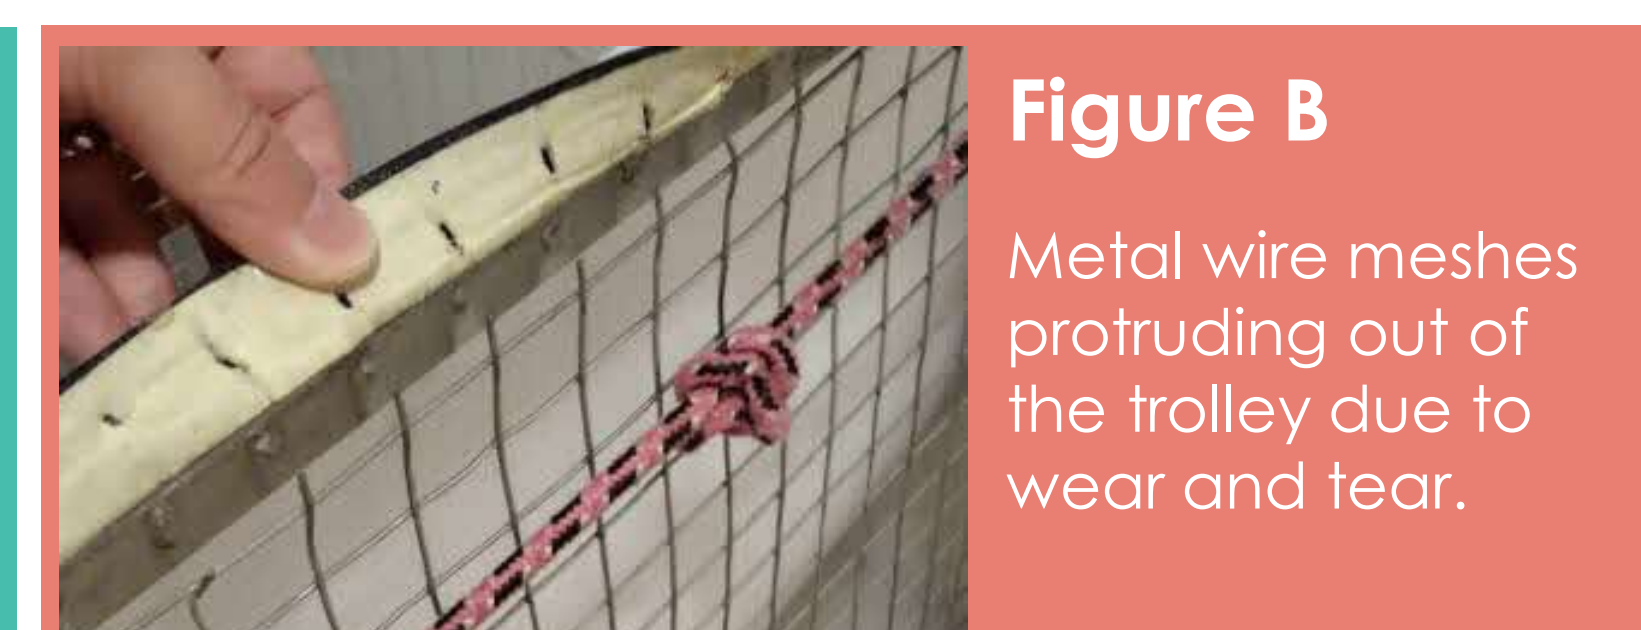
Figure B
Metal wire meshes protruding out of the trolley due to wear and tear.

- Risk on inventory:** Sharp edges on the trolley may puncture the vac-loks during transport as the vac-loks are stacked together without divider, creating risk of frictions between adjacent vac-lok. (Figure B)
- External stakeholders:** any damage/mishandling of vac-loks could potentially result in leakage causing interruptions to patients' treatment journey.
- Risk on internal stakeholders:** requires ancillary staff to lift the cushion (~5-8kg) 1-metre high during loading/unloading into the old trolley. Staff feedback on manoeuvring difficulties the heavy trolley when fully loaded especially when commuting across the ramp in the tunnel. Additional safety concerns as trolley provides no braking access. (Figure C)
