Final Report

FATALITY OF CHIEF OFFICER ONBOARD SEACON OSLO AT SEA ON 28 OCTOBER 2025

TIB/MAI/CAS.216

Transport Safety Investigation Bureau
Ministry of Transport
Singapore

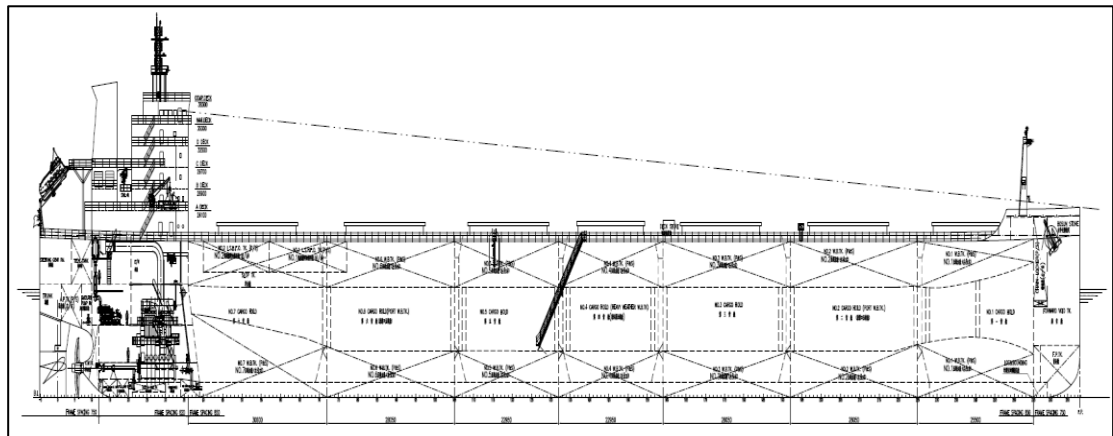
Figure 1 - General Arrangement of Seacon Oslo (Source: the Company)

1.1.1 On 28 October 2025, a gearless⁶, seven-hatch bulk carrier, Seacon Oslo (OSLO) (see **Figure 1**), in ballast condition, was transiting the Mozambique Channel on a voyage to the Port of Durban, South Africa, for the loading of chromite ore. The vessel was scheduled to arrive at the port on 30 October 2025, after discharging coal in Mormugao, India.
