# **Final Report**

## **GULFSTREAM G450, REGISTRATION T7-977 RUNWAY OVERRUN AT SELETAR AIRPORT**

**19 September 2025**

TIB/AAI/CAS.253

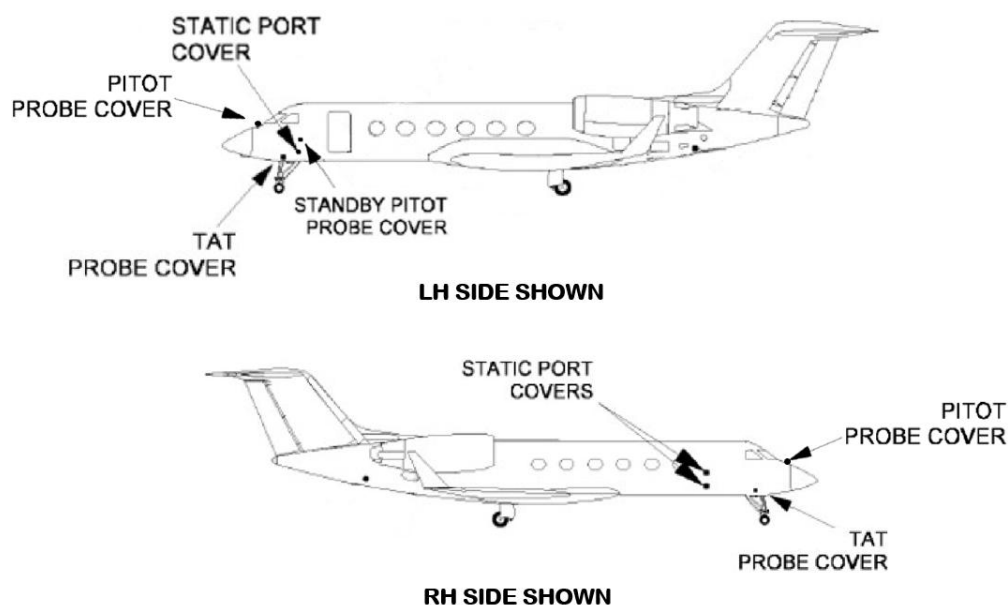
Figure 5: Location of the various probe and static port covers

1.6.2.1 The aircraft had two pitot probes, one standby pitot probe, three static ports and two TAT probes. **Figure 5** shows the location of these probes and static ports.

2.1.1 During the take-off roll, the flight crew observed an abnormal airspeed indication. Post-occurrence inspection found that the cover for the LH pitot probe was found on the pitot probe and had not been removed for the flight. The RH pitot probe cover was found on the ground near the aircraft where it stopped. The heat damage to the RH pitot probe cover and the melted residue observed on the RH pitot probe (see paragraph 1.3.2.1(b)) suggest that the cover for the RH pitot probe had also not been removed before the flight and had dislodged during the overrun.

2.2.2 While the FE was inspecting the general condition of the aircraft, he removed the protective covers for the standby pitot probe, the three static ports, and the two TAT probes. He did not remove the covers for the LH and RH pitot probes. According to the operator's OMM, the responsibility for ensuring the aircraft was ready for flight was the PIC's. The preflight inspection checklist, which was

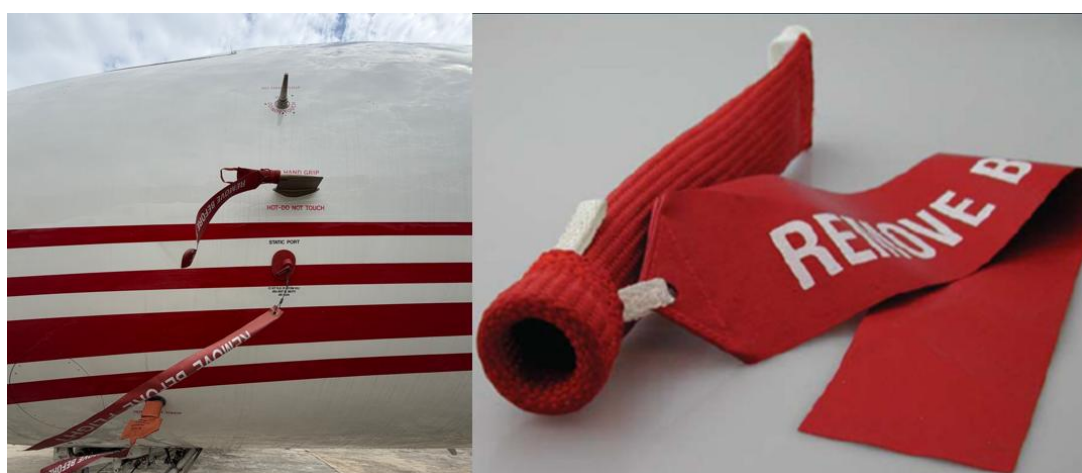
Figure 6: Typical pitot probe cover with streamer

- 1.6.2.3 In particular, the pitot probe is a forward-facing sensor for measuring total air pressure. Comparing this total air pressure with the ambient air static pressure from the static ports allows the airspeed to be computed by the air data system.
- 1.6.2.4 Blockage of the pitot probes or static ports will result in erroneous computation of flight parameters. Thus, when an aircraft is on ground for a prolonged period, these pitot probes and static ports must be covered to prevent ingestion of debris pieces and building of nests inside the pitot probes and static ports by insects. Streamers are normally attached to the pitot probe and static port covers as a visual enhancement to remind a flight crew or ground personnel that the covers must be removed before flight (see **Figure 6**).

- 1.6.2.5 The set of protective covers carried on board the aircraft were manufacturer-approved except for the LH, RH and standby pitot probes. According to the FE, the aircraft did not come with pitot probe covers when the aircraft owner acquired the aircraft in March 2025. The FE fabricated the covers for the three pitot probes himself, but he did not include any streamer. The FE fabricated the probe covers without referencing any technical specifications (e.g. material, dimension, temperature rating as recommended by the aircraft manufacturer).
- 1.7 Aerodrome information
- 1.7.1 Seletar Airport has one paved runway strip that is 1956m x 150m. Runway 21 is 1836m x 46m with a paved clearway, which is 60m x 150m, after the runway. The reciprocal runway, Runway 03, has identical dimensions.

2.4.3 The occurrence reiterates the importance of using probe covers that conform to manufacturer's standards. Although pitot probe protective covers are for use on ground, their design specification, material suitability and visibility are safety significant because they are installed on components that provide air data inputs to the aircraft's airspeed indication system. More importantly, missing the removal of protective covers before flight would result in erroneous air data being presented to pilots.
