Final Report

B777-300ER, 9V-SWM Turbulence Event over Myanmar

21 MAY 2024

TIB/AAI/CAS.231

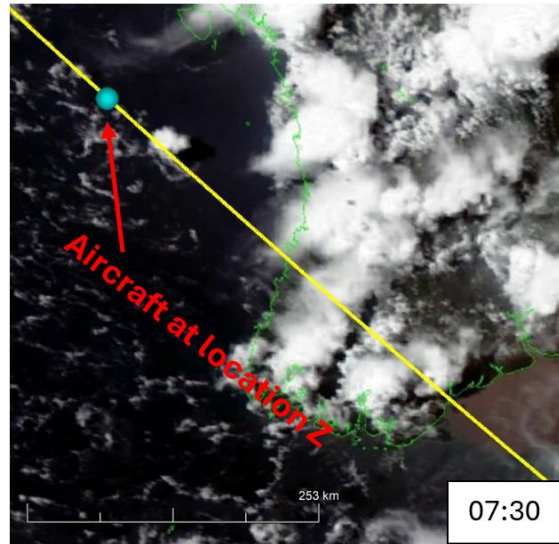
Figure 2: Location Z – location of aircraft about 15mins to PTN

crew's navigation displays⁵ (NDs). (For easy referencing in this report, the location at about 15 minutes prior to overflying PTN is hereinafter referred to as Location Z (see **Figure 2**). Location Z is about 135nm from waypoint PTN.)

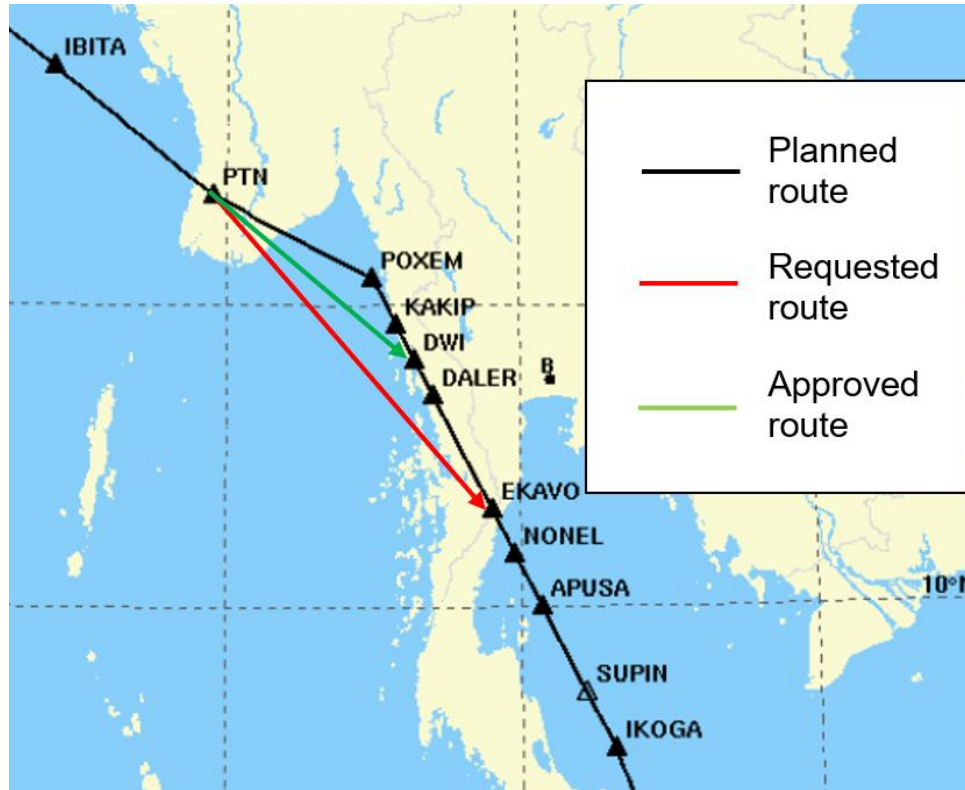
Figure 3: Flight route and deviation

1.1.8 At 07:44:52, the aircraft was approaching waypoint PTN while on its way to waypoint POXEM. The flight crew contacted Yangon air traffic control (ATC) to request for a direct route to waypoint EKAVO due to weather¹³. Yangon ATC counter-offered a direct route to waypoint DWI. The flight crew accepted this route (see **Figure 3**).

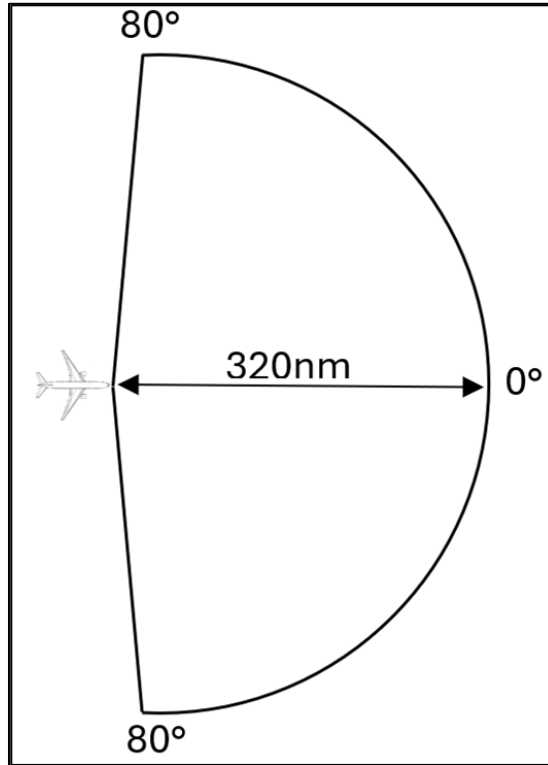
Figure 10: Rainfall detection range and azimuth of WXR

1.5.2.2 According to the WXR original equipment manufacturer (OEM), the WXR can detect rainfall above an intensity of 0.7mm/hr up to 320nm in front of the aircraft and 80 degrees left and right³² (see **Figure 10**).

³² The WXR detects rainfall in convective clouds. It does not detect such clouds as cirrus clouds and stratus clouds, which consist mainly of ice crystals and no rainfall.

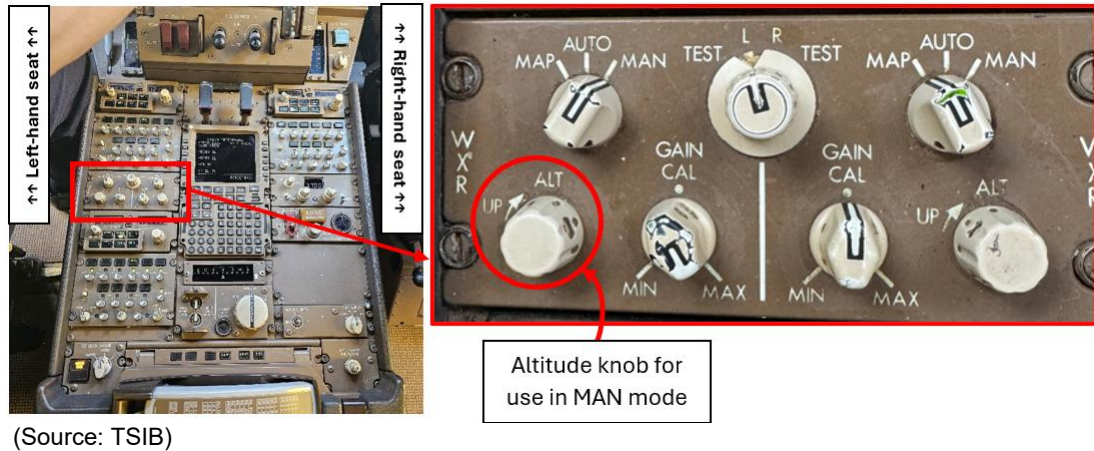
Figure 11: WXR control panel (CP)

1.5.2.4 **Figure 11** shows the CP via which the Mode selection and GAIN knob can be set. The left half of the CP is used by the pilot seated on the left and the right half by the pilot seated on the right.

1.5.2.5 The GAIN knob used by either flight crew member can be adjusted between MIN and MAX to vary the intensity of the weather return displayed on their respective ND, e.g. higher gain may change a green area into a yellow or even red area. The flight crew can adjust the GAIN knob to seek an optimum setting. There is a CAL (calibrated) detent position in the centre of the MAX-MIN control range. When the GAIN knob is out of the CAL detent, an annunciation in the form of a VAR (variable) text will appear on the ND.

1.5.2.7 The WXR OEM recommends that the WXR be operated in AUTO mode with GAIN knob set to CAL.

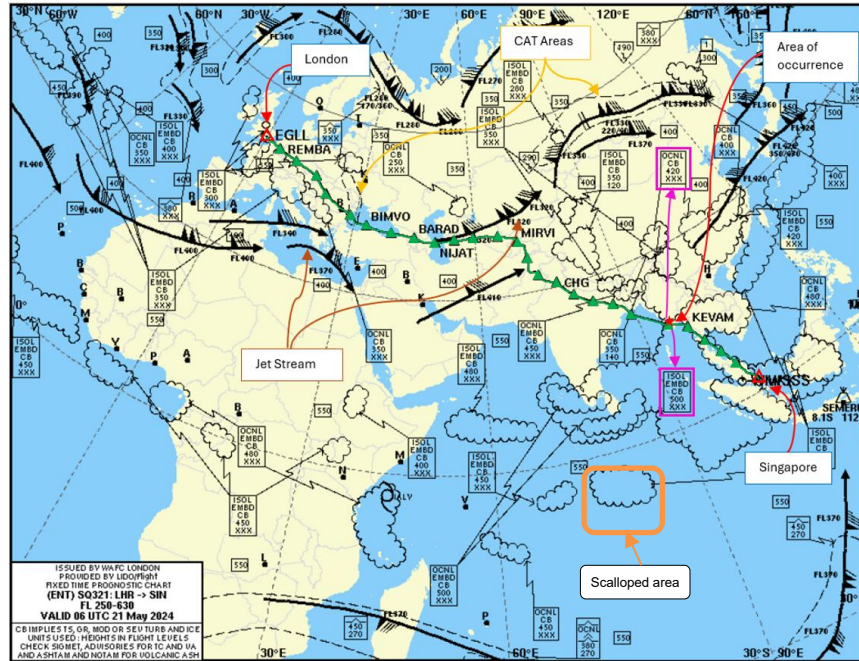
Figure 12: Weather forecast map covering the flight route from London to Singapore

1.6.2.1 Before the flight crew departed Heathrow Airport on 20 May 2024, they received a pre-flight briefing package prepared by the operator. The package included a weather forecast map covering the flight route from Europe to Asia (see **Figure 12**). The flight crew noted the following from the weather forecast map:

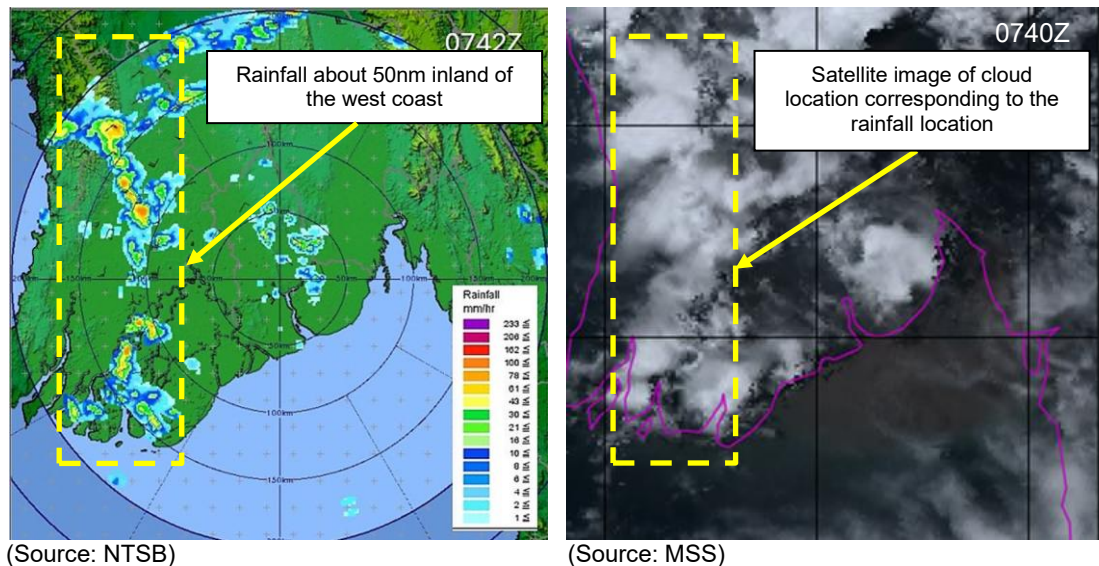
Figure 13: Ground WXR image (left) of rainfall and satellite image (right) inland of the west coast of Southwest Myanmar at 07:42 and 07:40 respectively

- 1.6.4.1 In a meteorological report provided by the US National Transportation Safety Board (NTSB) to the investigation team, a Yangon ground WXR image at 07:42 was included. The WXR image depicts rainfall over Southwest Myanmar (see the left image in **Figure 13**). It shows that there was rainfall about 50nm inland of the west coast of Southwest Myanmar. The right image in **Figure 13** shows the satellite image at 07:40 depicting the cloud location corresponding to the rainfall image.

- (a) There were groups of clouds in Southwest Myanmar, including towering cumulus clouds⁴³ (TCU) about 50nm inland from the west coast of Southwest Myanmar (see paragraph 1.6.4.1) (hereinafter referred to as Cloud A.) There was rainfall associated with the TCU (see **Figure 13**). According to MSS' analysis of the satellite data, the cloud-top height in this area, from 07:40 to 07:50, was stable and was between 45,000ft and 52,000ft, which was above the aircraft cruising altitude. As mentioned in paragraph 1.6.3, the flight crews of the four aircraft then flying in the vicinity had similar observations.

2.3.1 As mentioned earlier, the investigation team believes that there was widespread cloud coverage in Southwest Myanmar, including TCU and rain clouds, around the time the occurrence aircraft was flying through the area. The Yangon WXR images (see **Figure 13**) shows rainfall, ranging from 1 to 100mm/hr, in the area about 50nm inland of the west coast of Southwest Myanmar. According to the WXR OEM, their WXR can detect rainfall above 0.7mm/hr which would be painted on the NDs. These clouds were within the detection range of the WXR. Yet, the flight crew told the investigation team that the NDs of the occurrence aircraft did not show any weather returns. Summarised below are the flight crew's observations on the NDs:

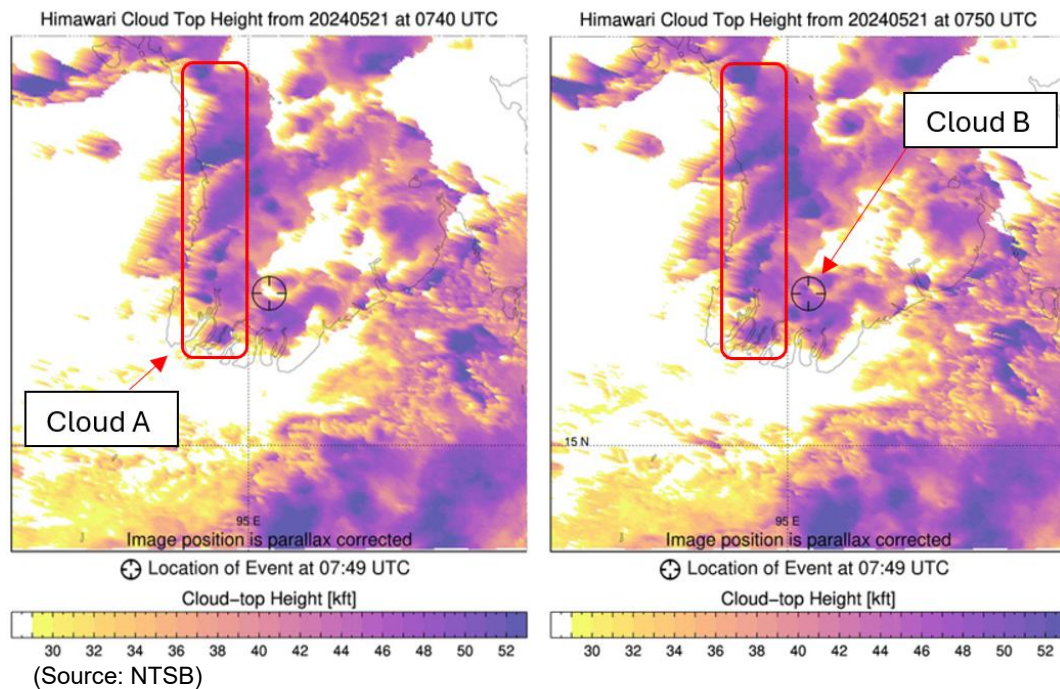
Figure 15: Himawari cloud-top height images at 07:40 and 07:50

1.6.4.4 NTSB also provided Himawari cloud-top height images at 07:40 and 07:50 (see **Figure 15**). These images show that there were clouds in the west coast of Southwest Myanmar, although, according to **Figure 13** above, there was no rainfall in the west coast. Similar to the satellite images, cloud-top height images do not identify the type of clouds that are covering an area and they do not provide information on the clouds' vertical profile.

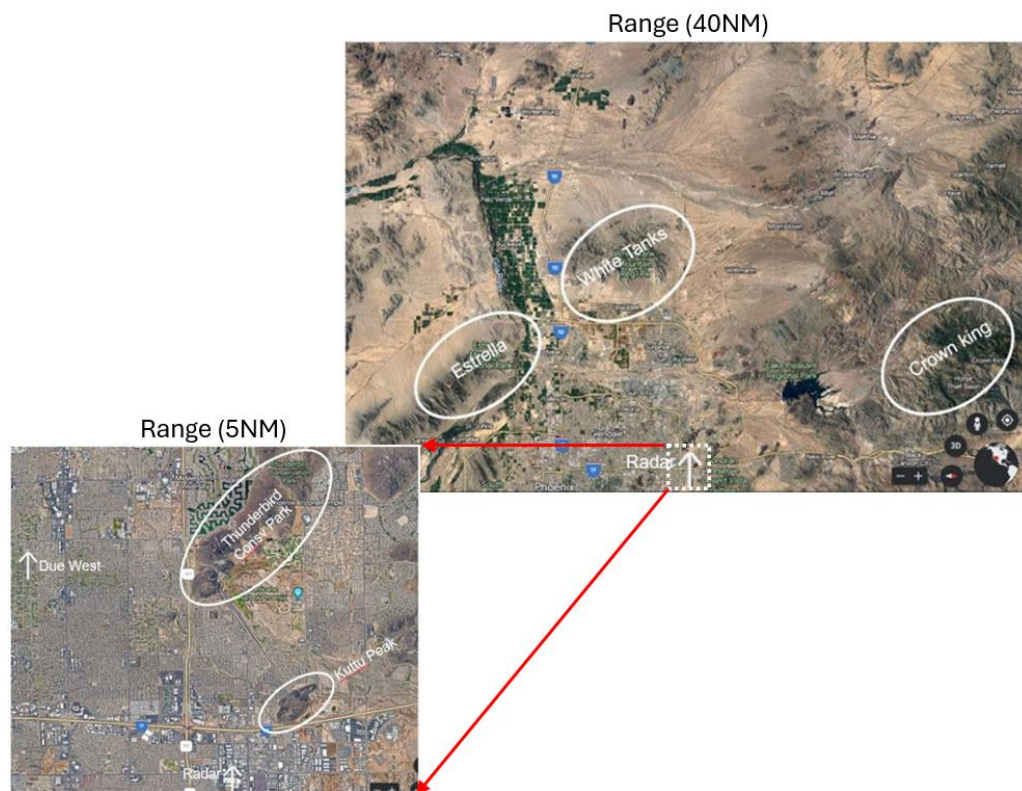
Figure 17: WXR transmission and reception operational test targets

A1.2 The test was conducted at a testing ground of the WXR OEM. The testing ground comprised certain terrain features, which had names as shown in **Figure 17**. They served as targets for the test. The test involved utilising the WXR MAP mode function and pointing the WXR at these targets and recording the painted terrain returns. The painted terrain returns from the occurrence WXR and RU were then compared.
