# **Final Report**

## **FATAL INJURY OF CHIEF OFFICER ONBOARD THE CONTAINER VESSEL EVER WISH AT SEA ON 23 OCTOBER 2025**

TIB/MAI/CAS.213

Transport Safety Investigation Bureau of Singapore  
Ministry of Transport  
Singapore

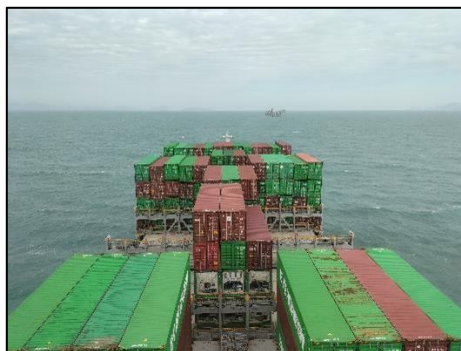
- 1.2.2 Due to the containers stacked on deck and the design of the windbreaker at the forward part of the ship, the watchkeeping officer on the bridge could not see the forecastle deck and activities at that location (see **Figure 3**)

Figure 3 – View from EW's bridge looking forward (*Source: the Company, photograph was not taken at the occurrence time, for illustration purpose*)
