# **Final Report**

## **FATAL INJURY OF SECOND ENGINEER ONBOARD VIYADA NAREE AT SEA ON 20 JANUARY 2026**

TIB/MAI/CAS.224

Transport Safety Investigation Bureau of Singapore  
Ministry of Transport  
Singapore

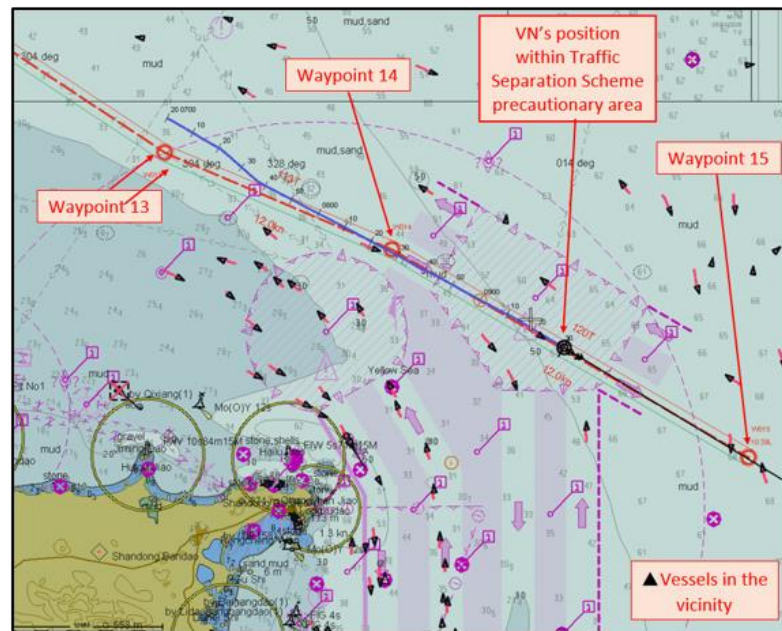
Figure 4 – VN's position within the TSS prior to the occurrence  
(Source: the Company, annotation by TSIB)

- 1.1.17 The Master went to the bridge and instructed 3O to make a public address announcement for responding to the emergency. However, as VN was within the precautionary area of the Traffic Separation Scheme<sup>10</sup> (TSS, see **Figure 4**). VN was facing multidirectional traffic at the TSS and the surroundings vessels posed difficulty for VN to alter her course. Thus, there was a delay in altering the ship's heading. 3O altered the ship's heading to reduce vessel's

rolling motion when the traffic situation permitted.

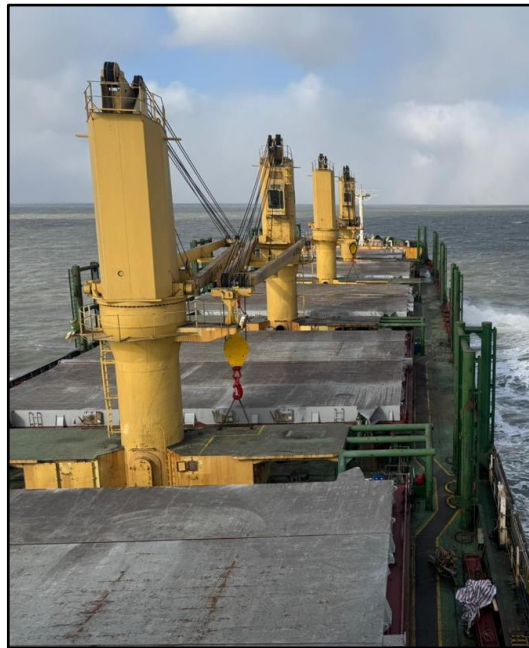
Figure 5 – View of the four cranes and their securing arrangements for sea passage looking forward (*Source: the Company*)

- 1.4.2 The four cranes were secured in pairs for sea passage, with the jibs of No. 1 and No. 2 resting on each other's U-shaped steel supports, the same securing arrangement was used for No. 3 and No. 4 cranes (see **Figure 5**). The crane

block with swivel hook was secured by wires onto the opposite crane's mast house top platform.

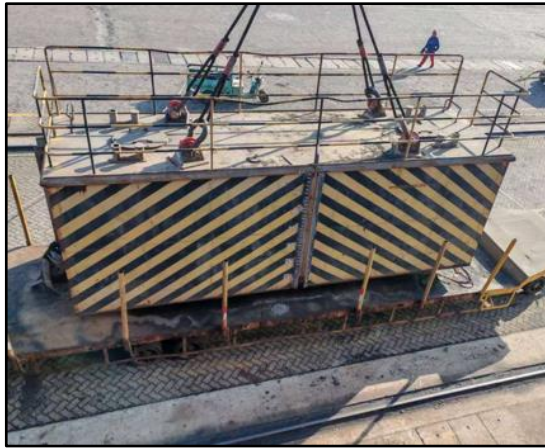
Figure 6 – Performing load test of No. 2 crane (*Source: ClassNK*)

the loose gears such as cargo blocks, hooks, swivels under the class Rules, 2.4.5 (2), were subject to the attending surveyor's consideration if deemed necessary. Based on ClassNK's records, the overhauling of No. 2 crane block and renewal of its components were not made known to the attending surveyor during the 19 January 2026 examination. The attending surveyor therefore only carried out visual examination on loose gears and the load test (see **Figure 6**) on all four cargo cranes on 19 January 2026.
