Final Report

B777-300ER, 9V-SWM Turbulence Event over Myanmar

21 MAY 2024

TIB/AAI/CAS.231

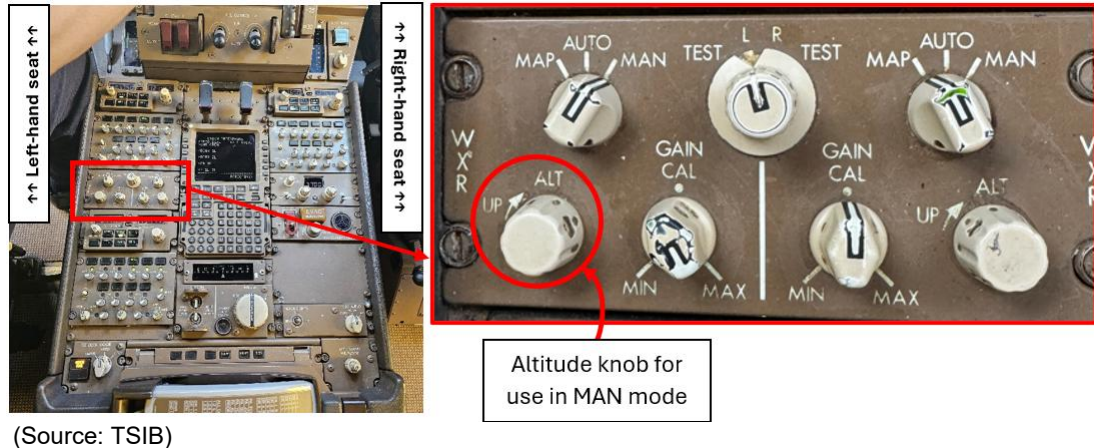
Figure 11: WXR control panel (CP)

- 1.5.2.5 The GAIN knob used by either flight crew member can be adjusted between MIN and MAX to vary the intensity of the weather return displayed on their respective ND, e.g. higher gain may change a green area into a yellow or even red area. The flight crew can adjust the GAIN knob to seek an optimum setting. There is a CAL (calibrated) detent position in the centre of the MAX-MIN control range. When the GAIN knob is out of the CAL detent, an annunciation in the form of a VAR (variable) text will appear on the ND.

1.5.2.7 The WXR OEM recommends that the WXR be operated in AUTO mode with GAIN knob set to CAL.

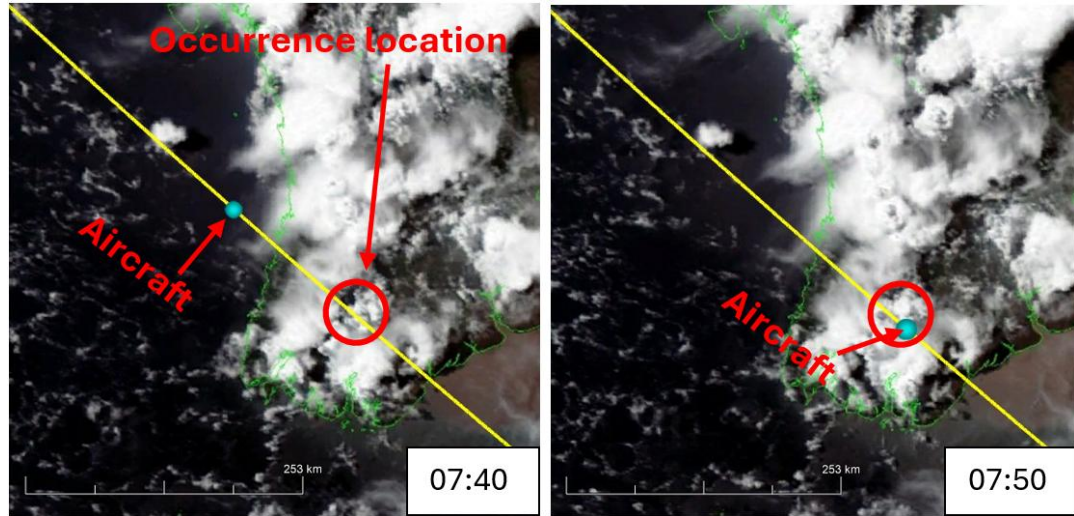
Figure 14: Occurrence aircraft location and cloud conditions

1.6.4.2 NTSB and the Meteorological Service Singapore (MSS) also provided Himawari-9 satellite images at 07:40 and 07:50 (see **Figure 14**). These images show the weather over Southwest Myanmar at 07:40 and 07:50 (the turbulence incident occurred at about 07:49). It is to be noted that these satellite images provide only top-down views indicating the cloud coverage of the highest clouds. They do not provide information on the clouds' vertical profile (e.g. what is under the cloud tops, whether there are empty spaces under the layer clouds, and how low are the cloud bases).

1.6.4.3 The investigation team noted from **Figure 14** that there were widespread clouds in the following two areas over Myanmar:

- (a) There were groups of clouds in Southwest Myanmar, including towering cumulus clouds⁴³ (TCU) about 50nm inland from the west coast of Southwest Myanmar (see paragraph 1.6.4.1) (hereinafter referred to as Cloud A.) There was rainfall associated with the TCU (see **Figure 13**). According to MSS' analysis of the satellite data, the cloud-top height in this area, from 07:40 to 07:50, was stable and was between 45,000ft and 52,000ft, which was above the aircraft cruising altitude. As mentioned in paragraph 1.6.3, the flight crews of the four aircraft then flying in the vicinity had similar observations.

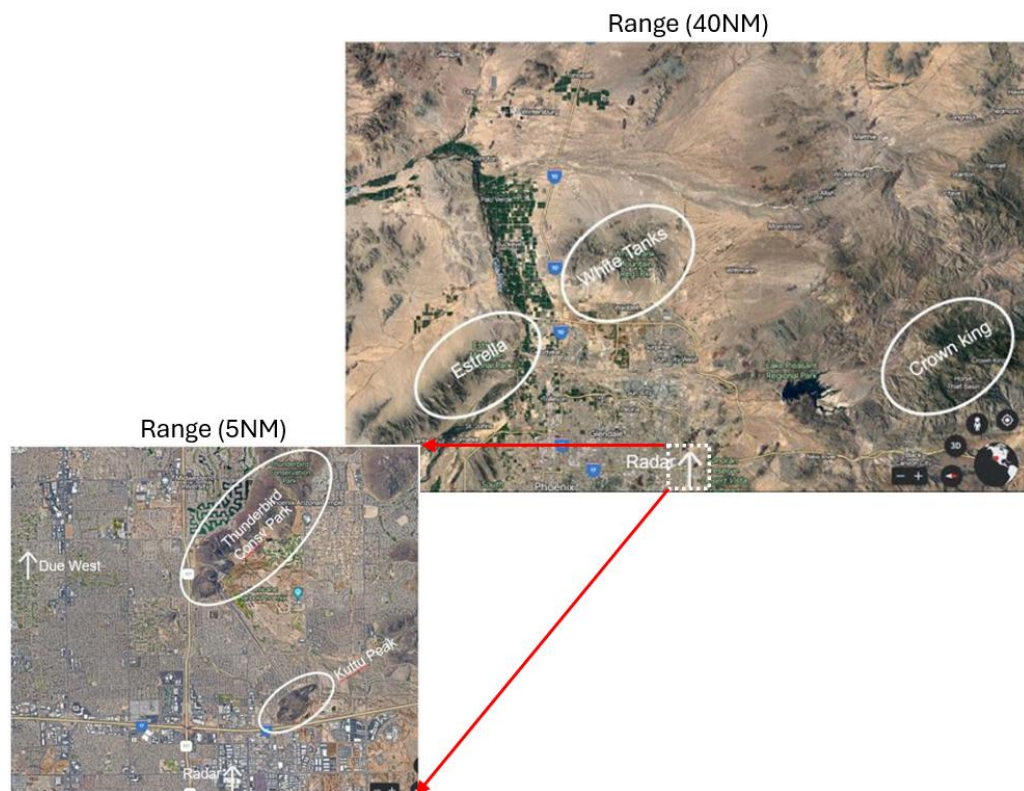
Figure 17: WXR transmission and reception operational test targets

A1.1 The test compared the performance of the occurrence WXR (as reconstituted from all the occurrence components of the WXR system of the occurrence aircraft that had been sent to the WXR OEM for testing) with the performance of a reference WXR unit (RU) of the WXR OEM.

A1.2 The test was conducted at a testing ground of the WXR OEM. The testing ground comprised certain terrain features, which had names as shown in **Figure 17**. They served as targets for the test. The test involved utilising the WXR MAP mode function and pointing the WXR at these targets and recording the painted terrain returns. The painted terrain returns from the occurrence WXR and RU were then compared.
